Detector Support Group

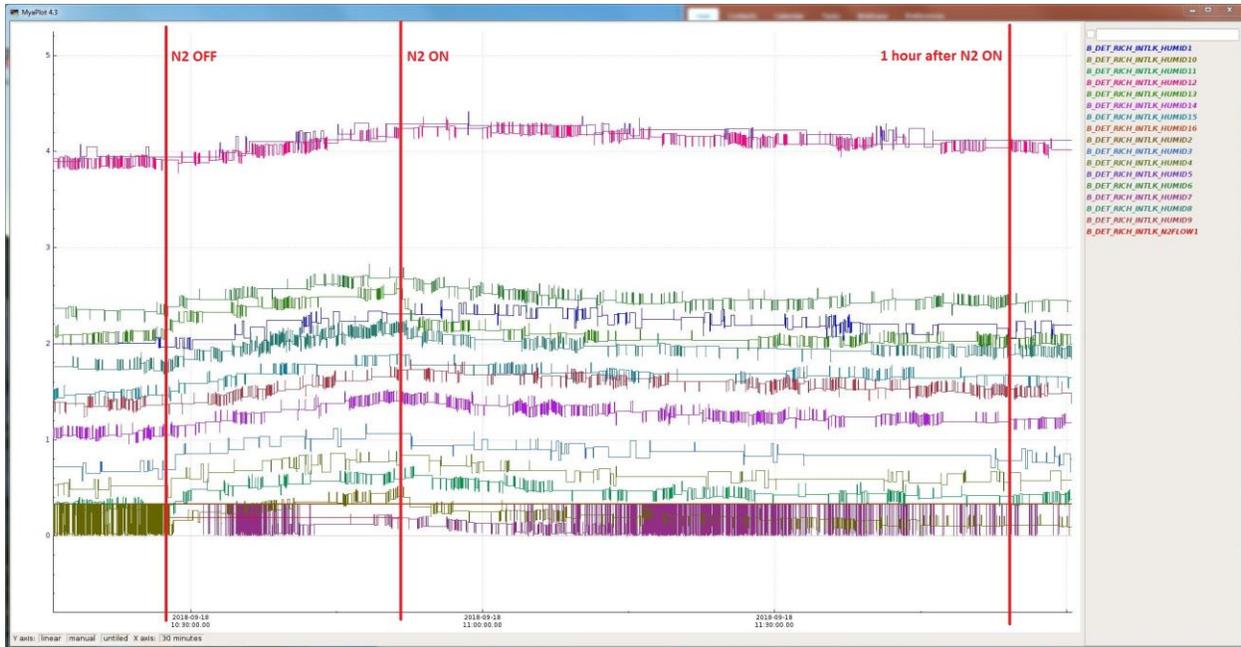
- Analyzed data from N2 flow loss on September 18, 2018 at 10:27AM.
 - ★ N2 flow lost in Hall B due to installation of isolation valve in the hall's nitrogen supply line.
 - New isolation valve allows flow to Forward Carriage or Space Frame to be stopped without affecting flow to the other.
 - N2 Flow lost for ~27 minutes.
 - ★ During period with no N2 flow, humidity increased ~0.3% RH in N2 volume.
 - ~30% overall increase in humidity.
 - ★ One hour after N2 flow was restored, humidity had decreased ~ 0.18% RH in N2 volume.
 - ~ 16% overall decrease in humidity.

RICH N2 Volume humidity sensors during time with no N2 flow to about one hour after flow was restored.

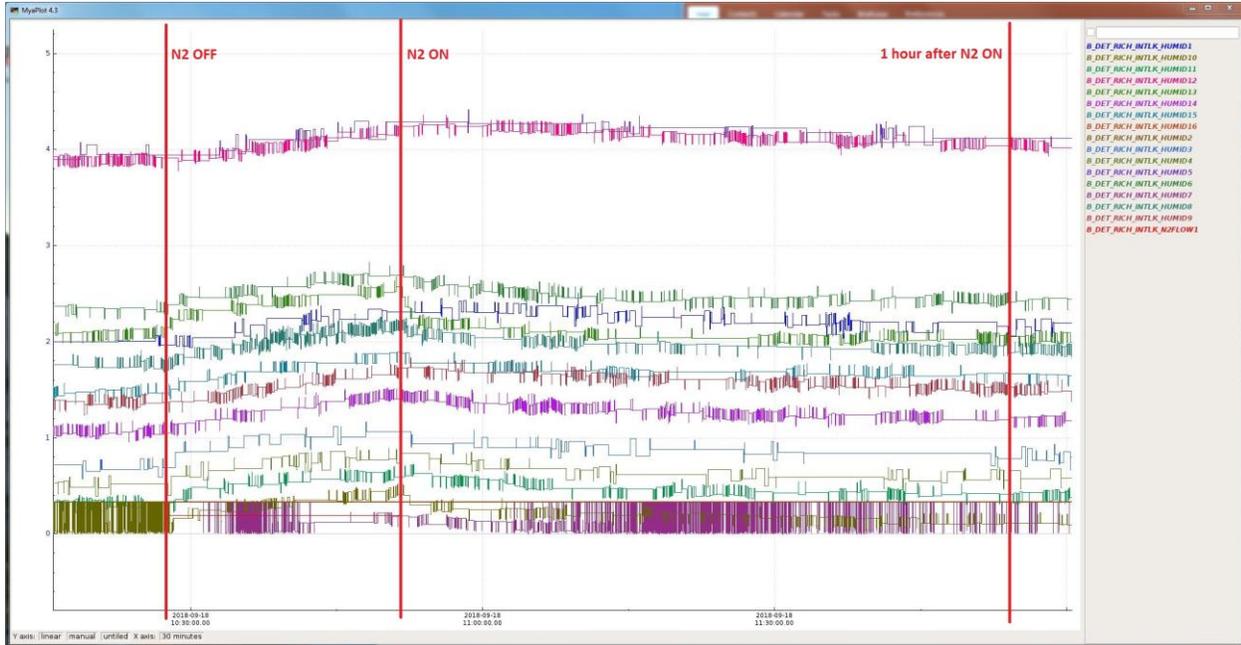
- Analyzed data from N2 flow loss on September 18, 2018 at 10:27AM.
 - * N2 flow lost in Hall B temporarily for installation of isolation valve into the hall's nitrogen supply line.
 - New isolation valve allows flow to Forward Carriage or Space Frame to be stopped without affecting flow to the other.
 - N2 Flow lost for ~27 minutes.
 - * During period with no N2 flow, humidity increased ~0.3% RH in N2 volume.
 - ~30% overall increase in humidity.
 - * One hour after N2 flow was restored, humidity had decreased ~ 0.18% RH in N2 volume.
 - ~ 16% overall decrease in humidity.

RICH N2 Volume humidity sensors during time with no N2 flow to about one hour after flow was restored.
