**FALL PROTECTION SURVEILLANCE AT THOMAS JEFFERSON NATIONAL
ACCELERATOR FACILITY**

**Final Report
Fall Protection Surveillance
at the
Thomas Jefferson National Accelerator Facility**

December 2008

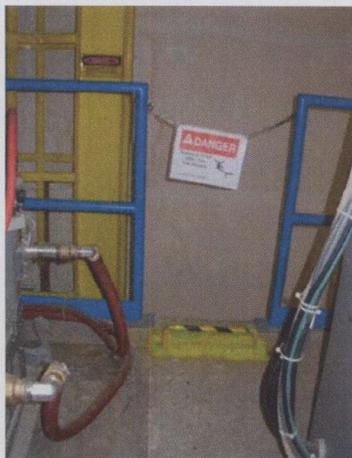
Figure 1. Test Lab (Building 58)
Ladderway Opening

Installation of chains for protection of openings in standard guardrail systems, including ladderways, needs to be evaluated. OSHA 29 Code of Federal Regulation (CFR) 1910.23(a)(2) requires that ladderway openings be protected by a swinging gate or be offset to prevent a person from walking into the opening. An OSHA interpretation does allow the use of chains for top and intermediate rails of a ladderway opening, provided they afford employees protection "at least as effective as" the swinging gate. The chain used for the protection of a ladderway on the mezzanine level of the Test Lab (Figure 1) does not meet these requirements. The installed chain is lightweight material and is installed with significant slack which would not provide support to an individual falling against the chain, and there is no intermediate level protection. **(FIND P2-001)** In addition, the upper grab installed in the floor as part of the original fixed ladder presents a significant trip hazard to personnel accessing the ladder from the mezzanine level.

- FIND P2-001** Chains being used in lieu of swinging gates or offset access for ladderway in the TJNAF Test Laboratory do not meet the requirements of 29 CFR 1910.23(a)(2) or the standard OSHA interpretation for the use of chains.

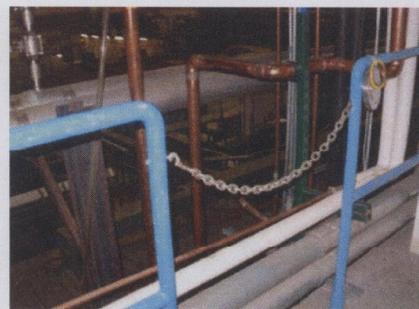
Figure 2. Test Lab Guardrail Opening

Chain was also used as part of a guardrail system to allow access to piping (Figure 2) on the 2nd level walkway of the Test Lab. This chain does not meet the requirements for standard guardrails or of alternative acceptable arrangements as defined by 29 CFR 1910.23(e). The chain was draped loosely across the opening, and the hook attaching the chain to the guardrail did not have a closing mechanism. Besides not providing stable support, it is likely that this chain would release if an individual fell against it. **(FIND P2-002)**

- FIND P2-002** Chains being used in lieu of a standard guardrail in the TJNAF Test Laboratory do not meet the requirements for a guardrail as defined in 29 CFR 1910.23(a)(2) or (e).

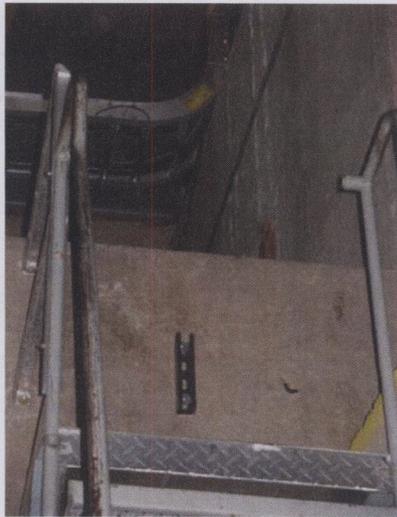
Figure 3. Test Lab - Top Landing of Mobile Ladder Stand

Near the Test Cave area of the Test Lab, a mobile ladder stand was permanently installed in lieu of a fixed industrial stair (Figures 3 and 4). This installation required modification of the ladder stand handrail, as well as resulting in a configuration that prevented the ladder stand from functioning as designed. The ladder mechanism is designed to lower the front legs for stability, and the lowering mechanism also levels the bottom step. As installed, the leveling mechanism could not be actuated, resulting in the bottom step being sloped from front to back resulting in a trip hazard for anyone using the ladder. Use of a mobile ladder stand as a fixed industrial stair does not meet the requirements of 29 CFR 1910.24 for fixed industrial stairs. **(FIND P2-003)**

- FIND P2-003** Use of a mobile ladder stand as a fixed industrial stair does not meet the requirements of 29 CFR 1910.24 for fixed industrial stairs.
- FIND P2-004** Modification of mobile ladder stands and other portable ladders results in ladders that may no longer conform to standard specifications of strength to safely support the design working load (29 CFR 1910.29(a)(2)(iii) and ES&H Manual 6132, paragraph 3.1).

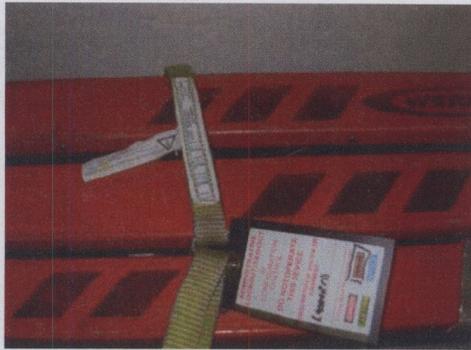
Figure 5. Hall B - Administrative Control on Defective Ladders

The portable ladders inspected during facility walkdowns were being maintained in good condition, proper labeling was present and legible, and an adequate selection of various ladder types was available for use. Ladders determined to be defective, as evidenced in Experimental Hall B (Figure 5) were properly segregated and tagged with an administrative lockout/tagout tag.

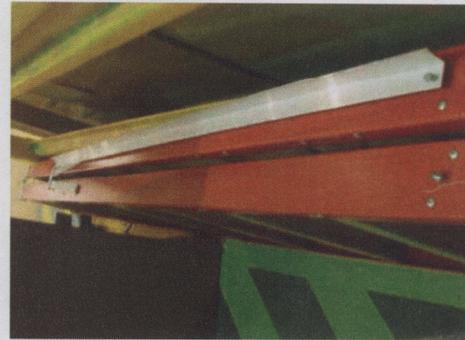
Figure 6. Test Lab – Modified Step Ladder

One stepladder was identified in the Test Laboratory that had been modified by the addition of a spreader bar (Figure 6). Ladders should not be modified without approval of the manufacturer or without a documented evaluation by a professional engineer to determine that the structure of the ladder has not been compromised. (Reference: Environment, Safety & Health (ES&H) Manual Section 6132, paragraph 3.1) **(FIND P2-004)**

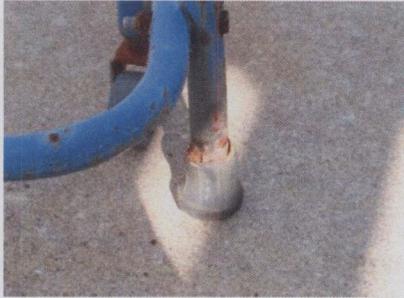
Figure 10. EEL Machine Shop -
Damaged Mobile Ladder Stand

A mobile ladder stand that had significant rust and deformation of the support caster was also available for use (i.e., not tagged out of service) in the outside storage yard south of the Experimental Equipment Lab (Building 90) machine shop (Figures 10 and 11). This concern was immediately brought to the attention of a machine shop representative. This ladder should be removed from service as required by ES&H Manual Section 6132, paragraph 3.1,

“Withdraw ladders from service that have developed defects. Destroy any defective ladder or tag it “Dangerous, Do Not Use,” and send it to Facilities Management for repair...”
(FIND P2-005)

- FIND P2-005** Defective ladders shall be removed from service as required by ES&H Manual Section 6132, paragraph 3.1 "Withdraw ladders from service that have developed defects. Destroy any defective ladder or tag it "Dangerous, Do Not Use," and send it to Facilities Management for repair..."

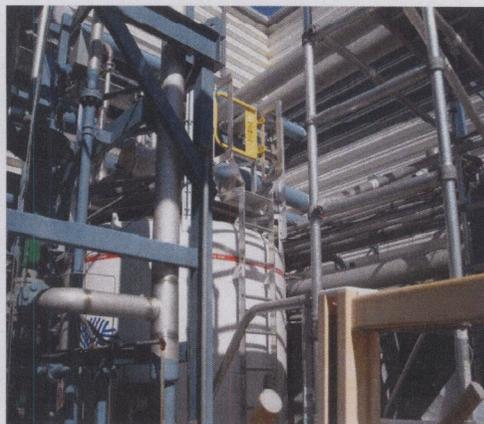
Figure 12. Cryo-Werner Section
Aluminum Scaffold

Within the Cryogenics group, there were two styles of scaffolding identified in their possession. The Werner aluminum scaffolding system was found to be installed outdoors at the Central Helium Liquefier during this assessment. A signed inspection checklist was attached to the unit near the base and included a previously signed and dated inspection from a Laboratory recognized competent person. Per feedback with Laboratory staff, anyone who has received scaffold specific training satisfies the "competent person" criterion and is able to approve scaffold assembly and pre-shift inspection checklists. The assembled Werner scaffold unit appeared to have all of the appropriate railings, working surfaces, lateral struts, and matching outrigger assembly.

The type of training received by the Cryogenics group for the Perry mobile scaffolding was characterized as generic scaffold training, while the training received for the Werner aluminum scaffold was characterized as system specific, including practical (hands-on) demonstration of assembly and disassembly. The Perry scaffolding was being stored in a transportation (Sea-Land) unit and protected against direct exposure to the element; however, some of the caster assemblies had evidence of surface oxidation, likely attributable to prolonged exposure to humidified air.

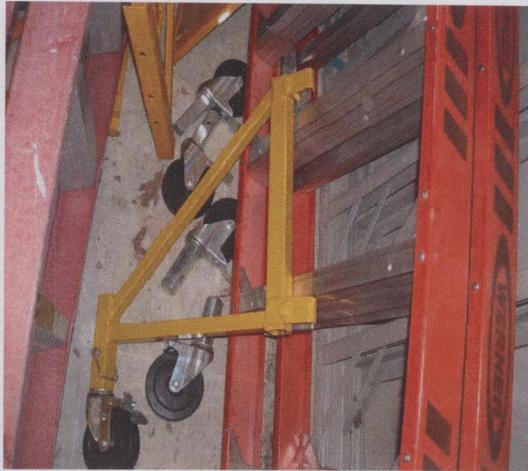
Figure 14. Building 13 – Unmarked Scaffolding Components

In the summer of 2008, Facilities Management acquired a portable scaffold system to support the replacement of burned-out ceiling lamps in the Lab's auditorium. The scaffold was acquired from an internet business, Badger Ladder and Scaffold, through a credit card purchase. An excerpt from the vendor's website makes the following statement: "BADGER QUALITY ASSURANCE: All our products meet and/or exceed the OSHA & ANSI requirements for steel scaffold." Upon review of the Badger scaffolding sections currently in storage, none of the system components were labeled in a manner that allows identification of the manufacturer, part number, or reference to a design or construction specification. The scaffold training received by the Lab's electrical subcontractor was presented by ESH&Q staff, as neither the supplier nor the manufacturer directly offer training programs on their product. The literature eventually obtained from the vendor was received, and it failed to identify the outrigger attachments that were acquired in conjunction with the system.

There is no identifiable means to verify that the scaffold system components acquired by Facilities Management are traceable to a given manufacturer or matched product line, or that it had been designed and constructed in accordance with a recognized standard. (FIND P2-007)

- FIND P2-007** There is no identifiable means to verify that the scaffold system components acquired by Facilities Management are traceable to a given manufacturer or matched product line or that if they had been designed and constructed in accordance with a recognized standard.

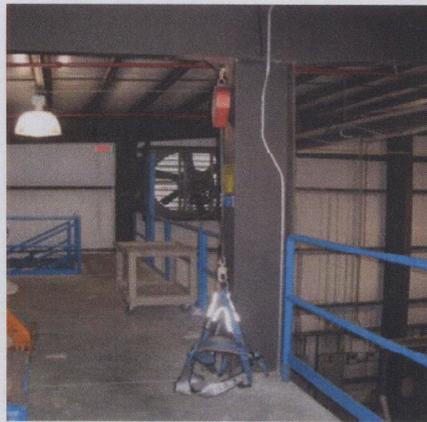
**Figure 19. Building 72 - I-Beam Anchored
Web-Type Retractable Lanyard**

In Building 72, multiple web-type retractable lanyards are attached to I-beams on the upper level for use as fall arrest when the standard handrails are removed from the platform (Figure 19). If the fall-arrest system was engaged as a result of an employee falling from the platform, the web would strike the edge of the I-beam with the full force of the suspended employees fall. In at least one instance, the beam edge was extremely sharp resulting in a high potential to cut the webbing. Softening should be added to the beam edges or the retractable lanyards should be replaced with wire-type lanyards **(FIND P3-009)**

- FIND P3-009** I-beams used for fall protection anchor points in Building 72 should have softening added to the beam edges or the retractable lanyards should be replaced with wire-type lanyards.
