DSG Weekly Report – August 19, 2015

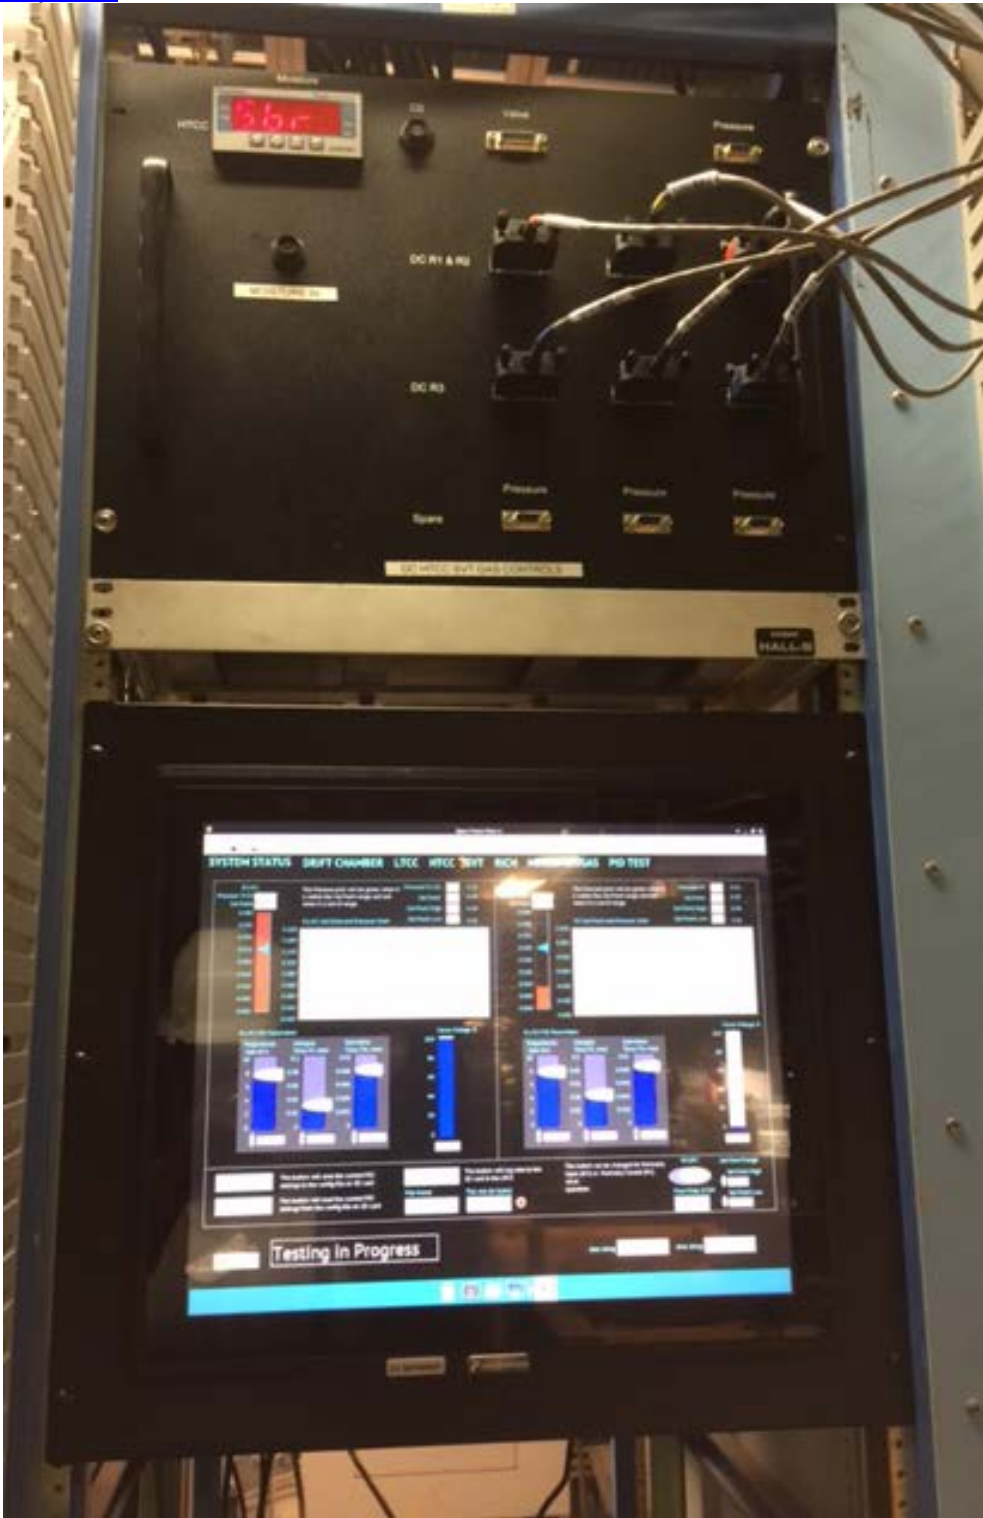
PID loop test: control panel

- Worked on PID loop test.

- ★ Determined that there is noise from the MKS 223 transducer
- ★ Noise looks like sine wave at about 12.5KHz and an amplitude of 70mV.
- ★ Trying to filter out noise by changing cRIO from a Scan Mode (limits data acquisition to 1KHz) to Hybrid mode (this will utilize the FPGA in the cRIO for the data acquisition at 40 MHz).
- ★ FPGA has plenty of *horsepower* to sample at 50 KHz (double the Nyquist rate required for alias free sampling).
- ★ Plan to use either a Notch or Butterworth low pass filter.
- Ordered another sensor, MKS 226, better suited for the control range of the PID loop.
 - ★ Explore using the current 0.535 " (1 Torr) H₂O sensor and the new 0.1 "H₂O sensor in conjunction to build a two-tiered PID scheme that would be less aggressive as pressure reaches set-point.

- Measured noise of chassis power supply and MKS 223 pressure sensor with oscilloscope during troubleshooting of PID loop test.

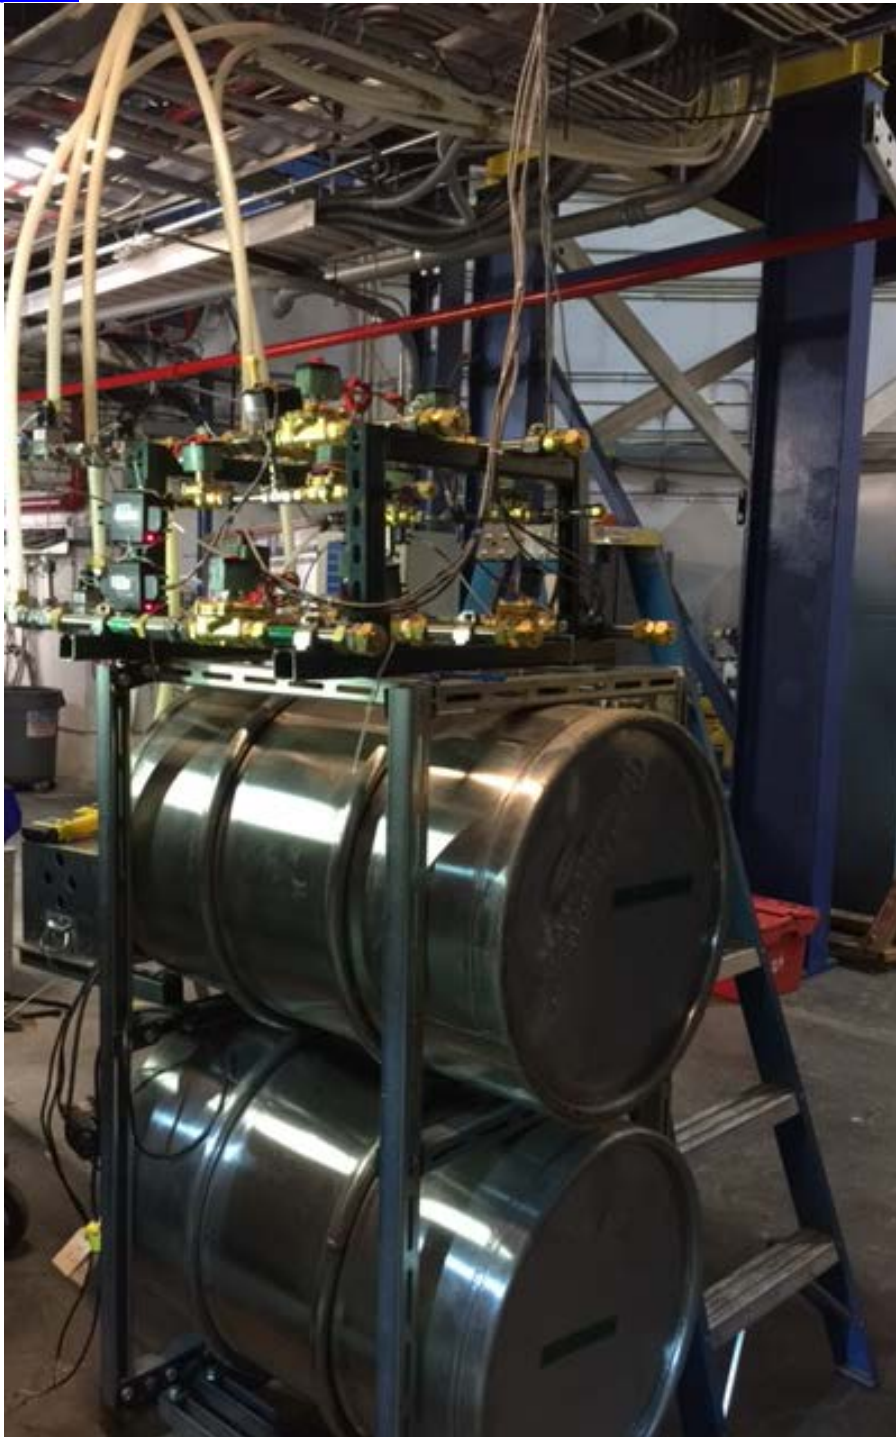
PID loop test: hardware setup

- Working on DCGAS PID controls development
 - ★ Trouble shooting cables, connections, and the power chassis.

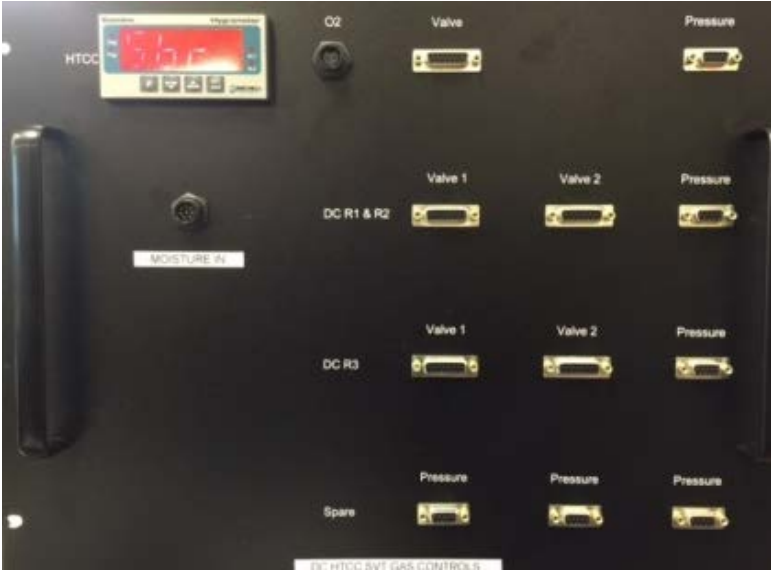
Chassis: front panel

- Troubleshooting PID test stand for pressure control.
 - ★ Tested MKS 223 (capacitance manometer) output using external and chassis supply. Found no difference.
 - ★ Removed chassis from hall, and tested for voltage offset; recorded findings of less than 0.2 mVAC when all returns, commons, and grounds are tied together.
- Set up test stand for measuring MKS 223 on the bench with Dave and Brian using the same supply and the chassis and double shielded cable.
- Started assembly of the LTCC/RICH detector gas system chassis (#3).
- [SVT](#)
- Pulser cables were delivered; all procurements are complete.
- Conducted tour of SVT for the power supply vendor and the project manager of the HFCB from Compunetics with Amrit, Dave, and Sahin.

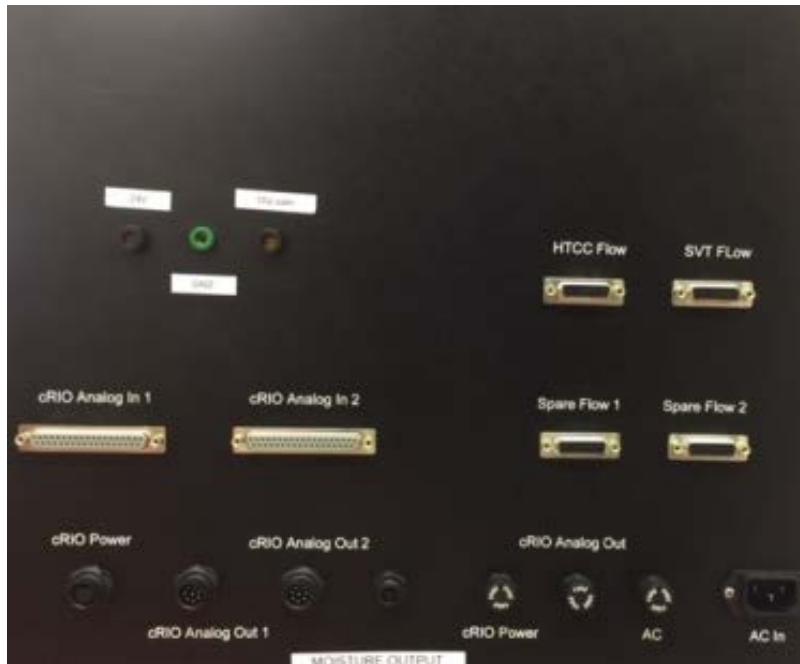
Chassis: rear panel
