Detector Support Group

Weekly Report, 2018-01-10

RICH

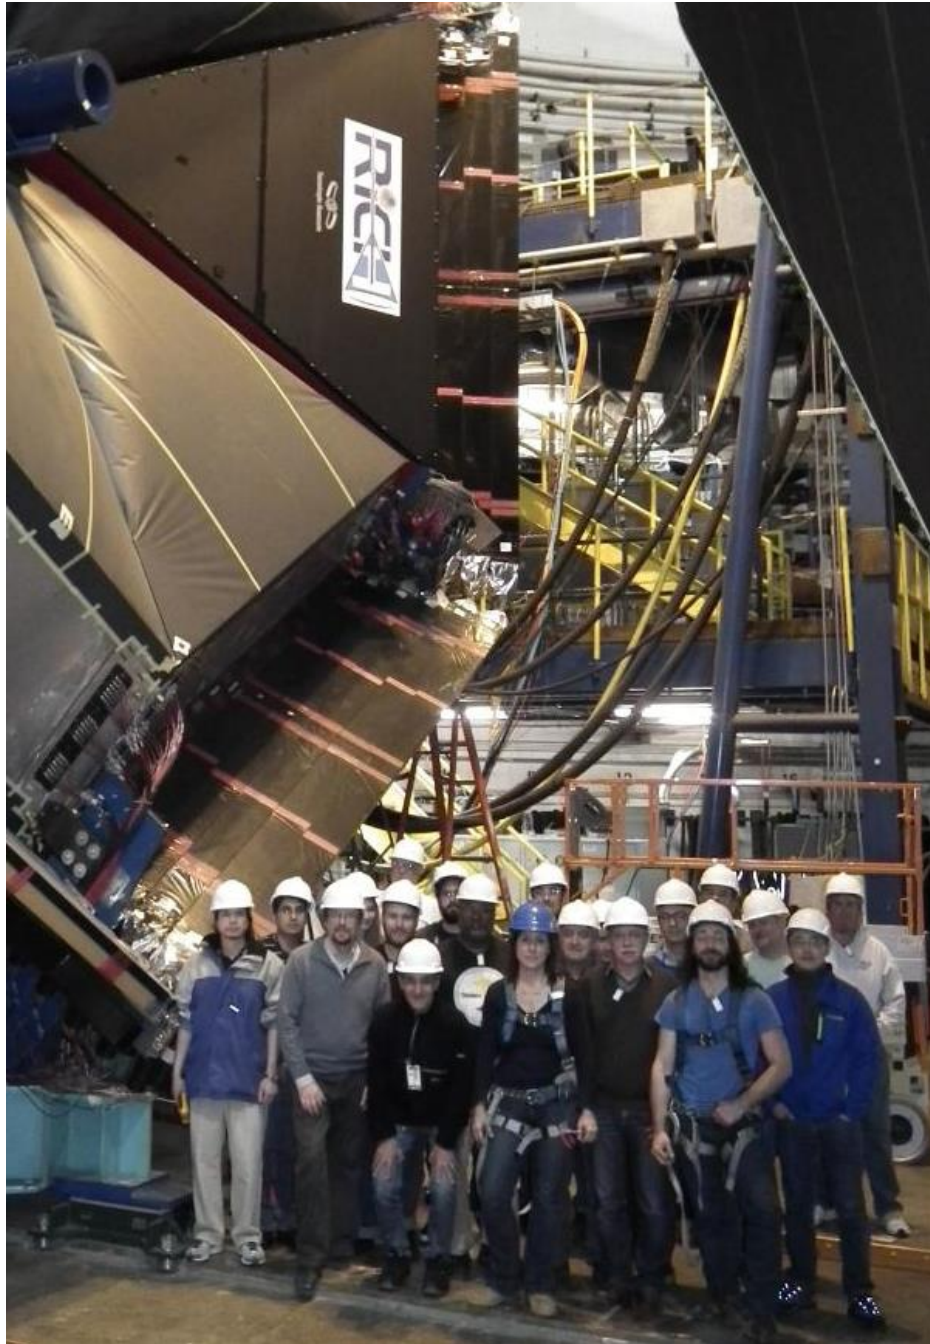
DSG and RICH collaborators in front of RICH installed on Forward Carriage.

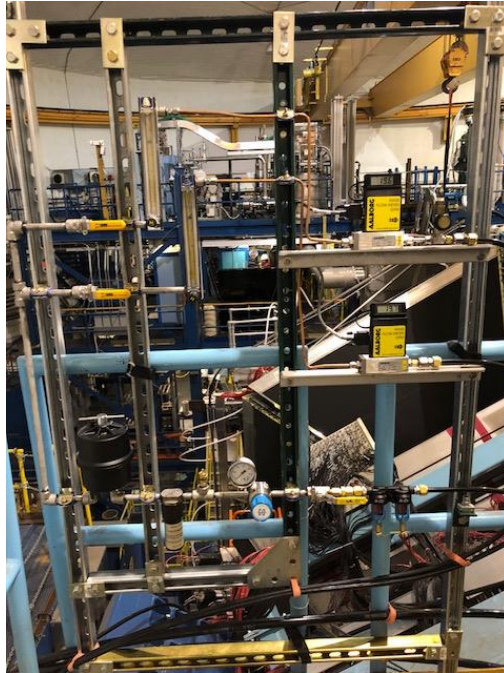
Nitrogen panel on top deck of Forward Carriage. Nitrogen flow set to ~20 L/min for each output, providing a total flow to RICH of ~40 L/min.

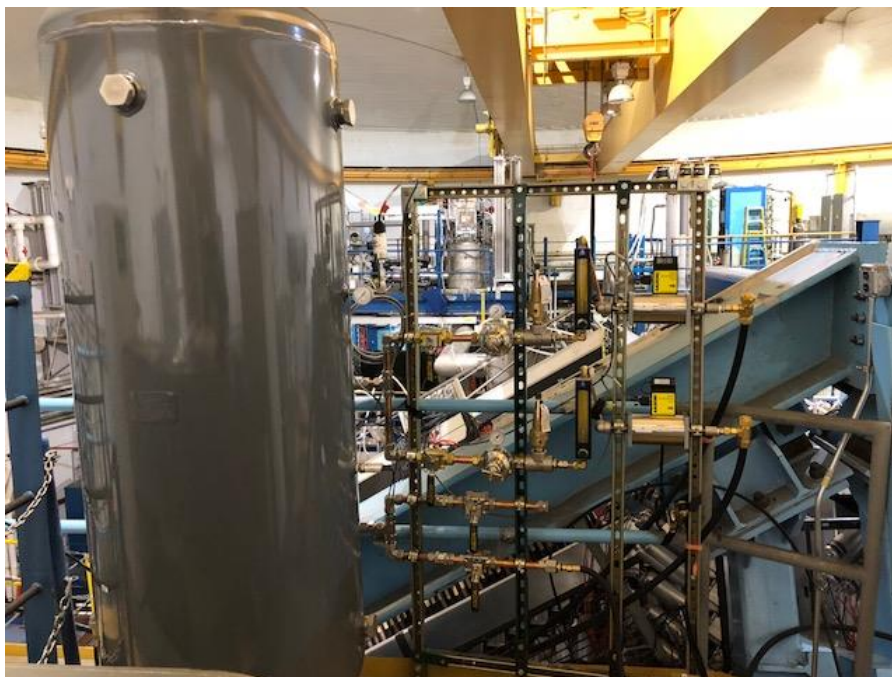
Air-cooling tank and panel on top deck of Forward Carriage.

- * Monitoring for UPS status in development.
- Test of air-cooling system in Hall B performed.
 - * Able to provide maximum of ~600 L/min per output on panel, providing a maximum total ~1200 L/min.

- Performed test of air-cooling system in Hall B with INFN collaborators.
 - ★ Able to provide maximum of ~600 L/min per output on panel, providing a maximum total ~1200 L/min.
