Notable Event Worksheet

Title of Event					
Event Title:	RadCon Electrical Line Strike				
Date and Time of Occurrence:	4/10/12	09:57am	<table border="1" style="width: 100%; border-collapse: collapse;"> <tr> <td style="width: 60%;">Notable Event Number:</td> <td>TEDF-12-0410</td> </tr> </table>	Notable Event Number:	TEDF-12-0410
Notable Event Number:	TEDF-12-0410				
Event Location:	Transformer North of Process Support Building	<table border="1" style="width: 100%; border-collapse: collapse;"> <tr> <td style="width: 60%;">Date Notable Event Report is Due*:</td> <td>05/10/2012</td> </tr> </table>	Date Notable Event Report is Due*:	05/10/2012	
Date Notable Event Report is Due*:	05/10/2012

Event: Energized electrical line strike TEDF Project

Description: While excavating for a footing for the new Ultra Pure Water (UPW) building on Wednesday April 4, 2012 the contractor struck an unmarked and undocumented energized 480volt line feeding the RadCon trailers. No injuries were reported. Once the area had been surveyed the line was repaired and power restored to the trailer.

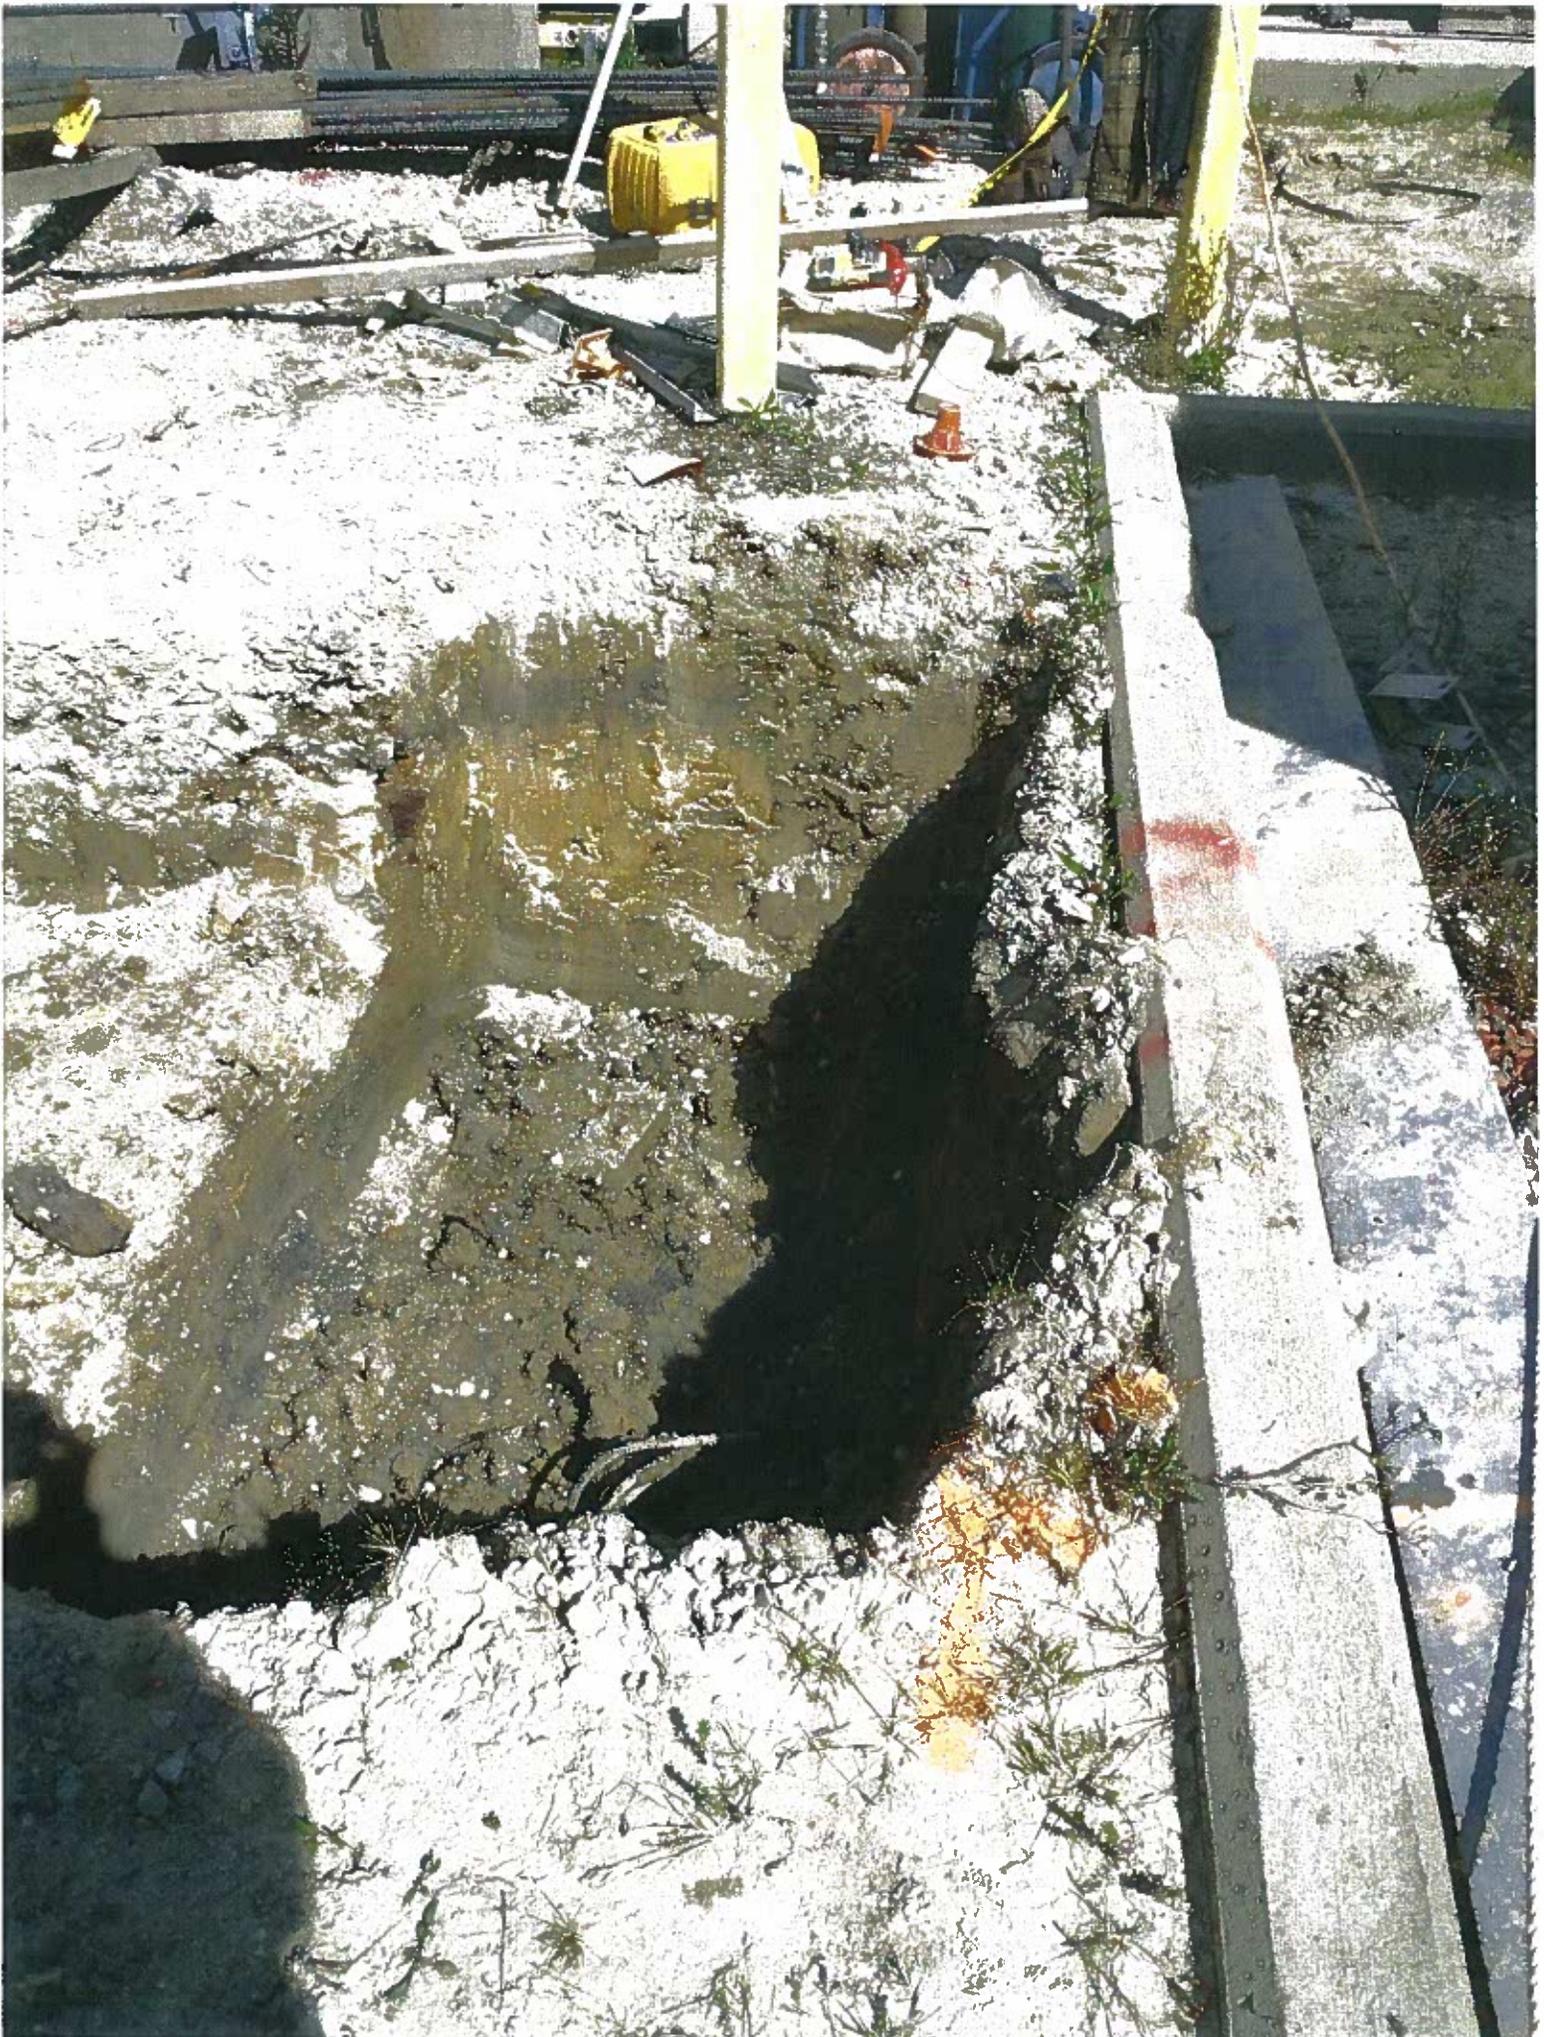
Vicente Velasquez 4-10-012

I WAS STANDING, WATCHING, WITH SHOVEL IN HAND AND CHECKING THE GRADE. THE BUCKET OF THE MACHINE MOVING BRCK SLOWLY, ALL OF A SUDDEN THERE WAS A LOUD POP AND SPARKS FLEW FROM BUCKET.

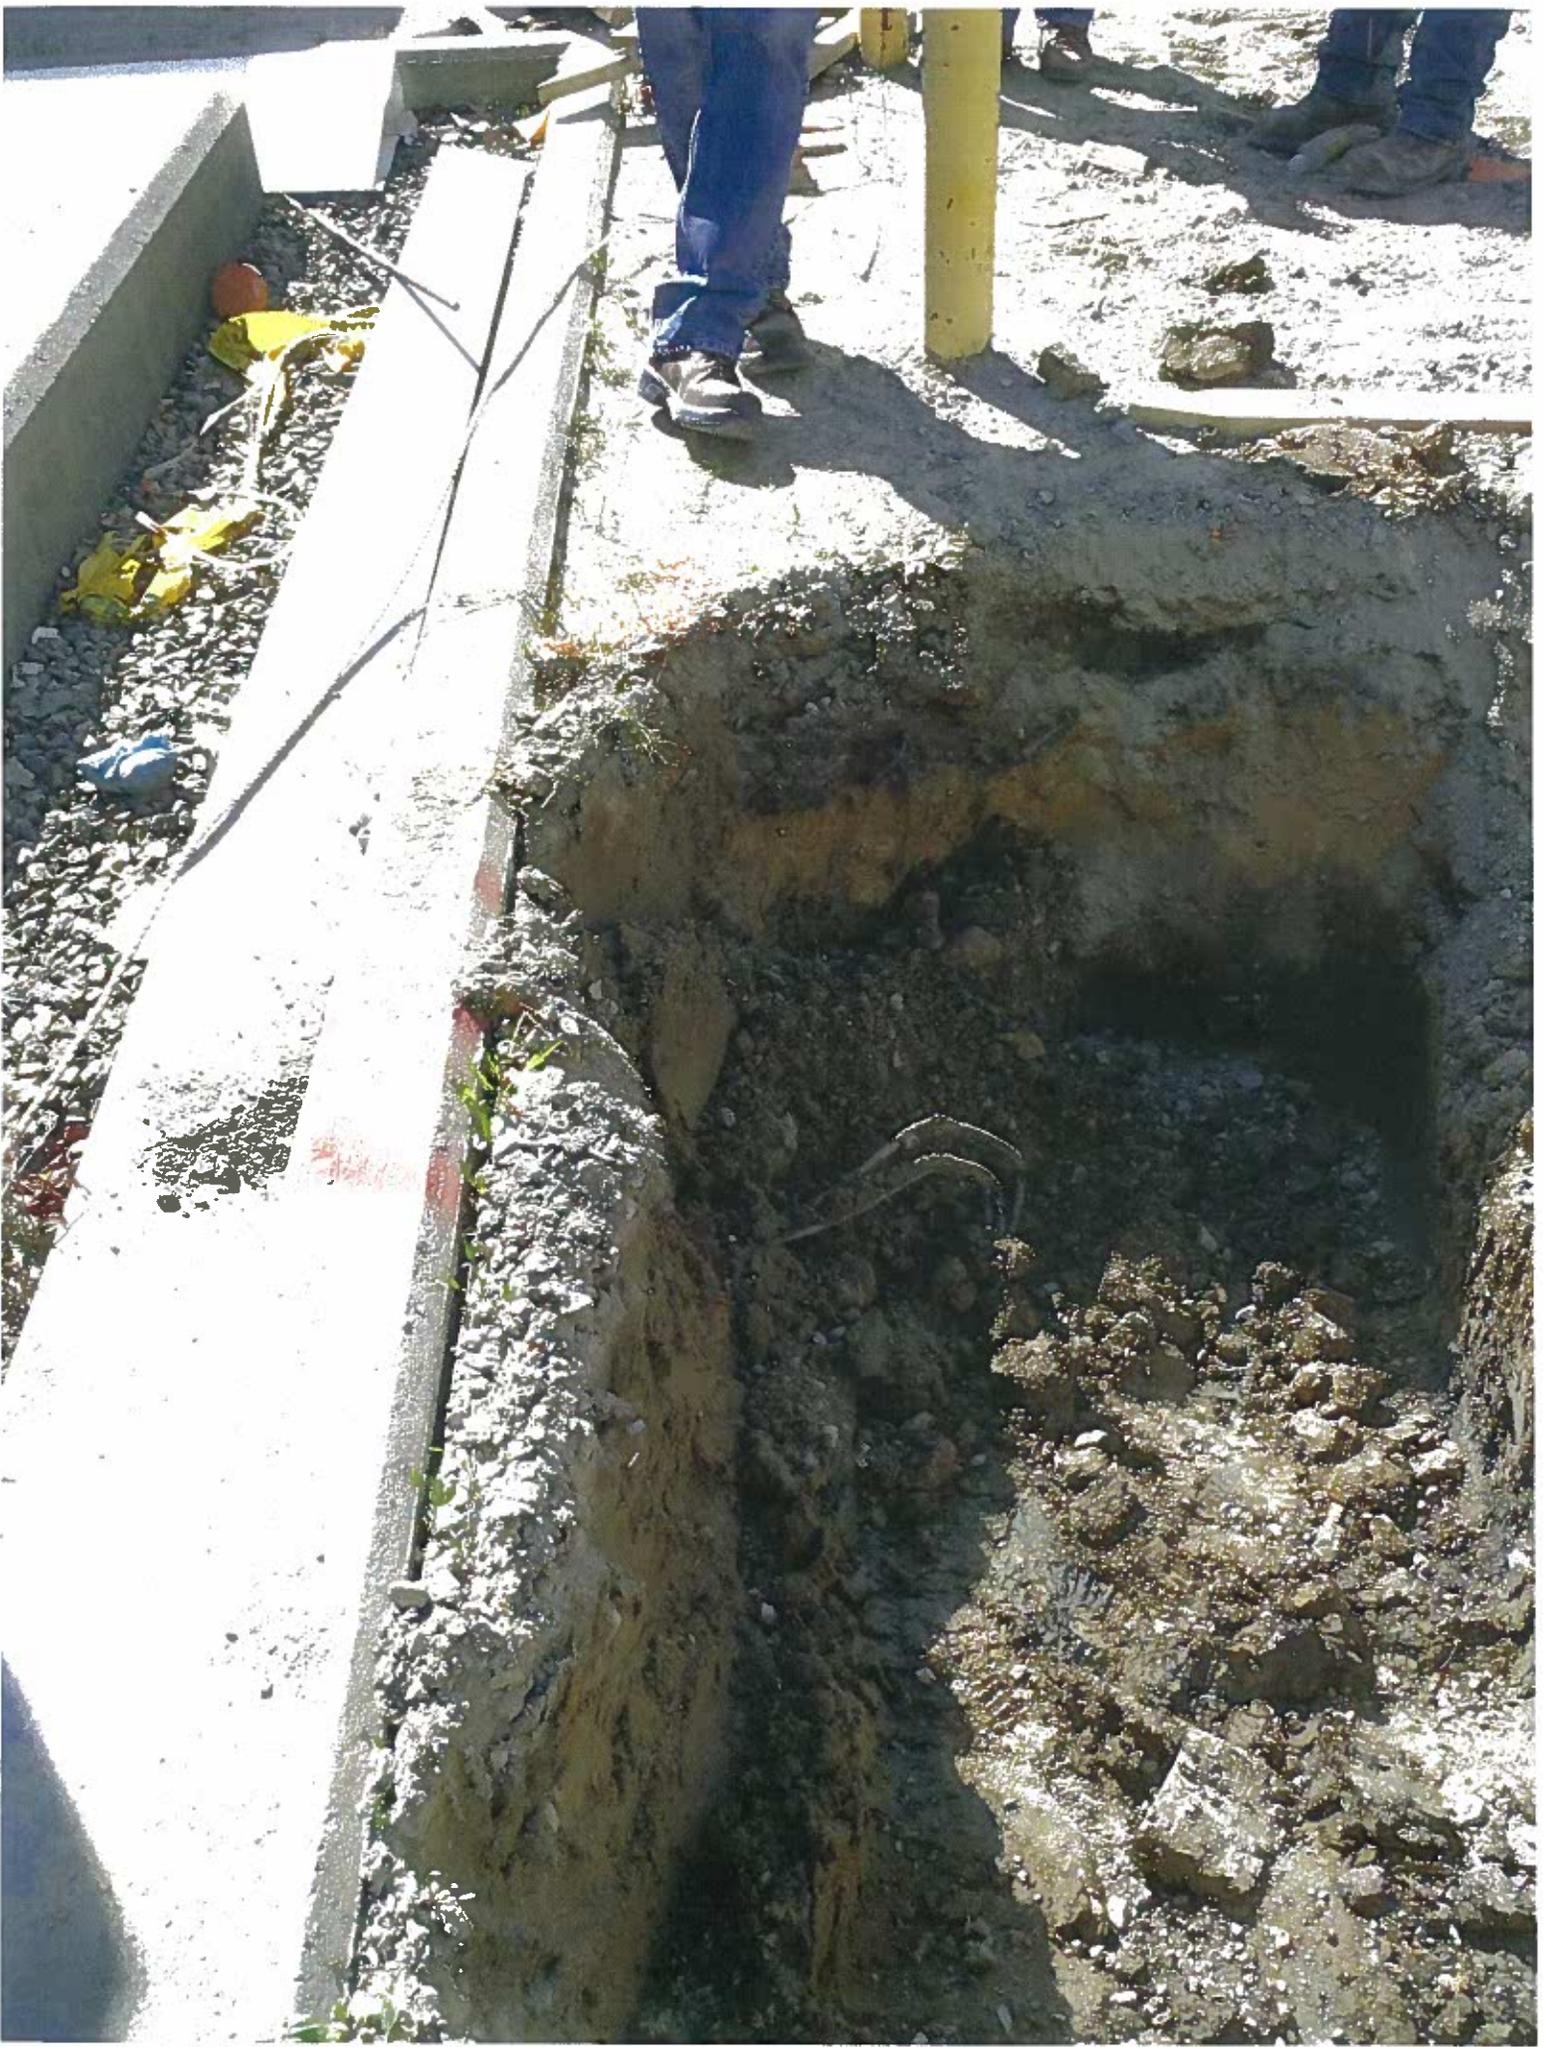
Electrical ductbank from TL East annex to T-SUB-4

Approximate foundation layout

Conduit for
pushed pipe

Conduit from
transformer

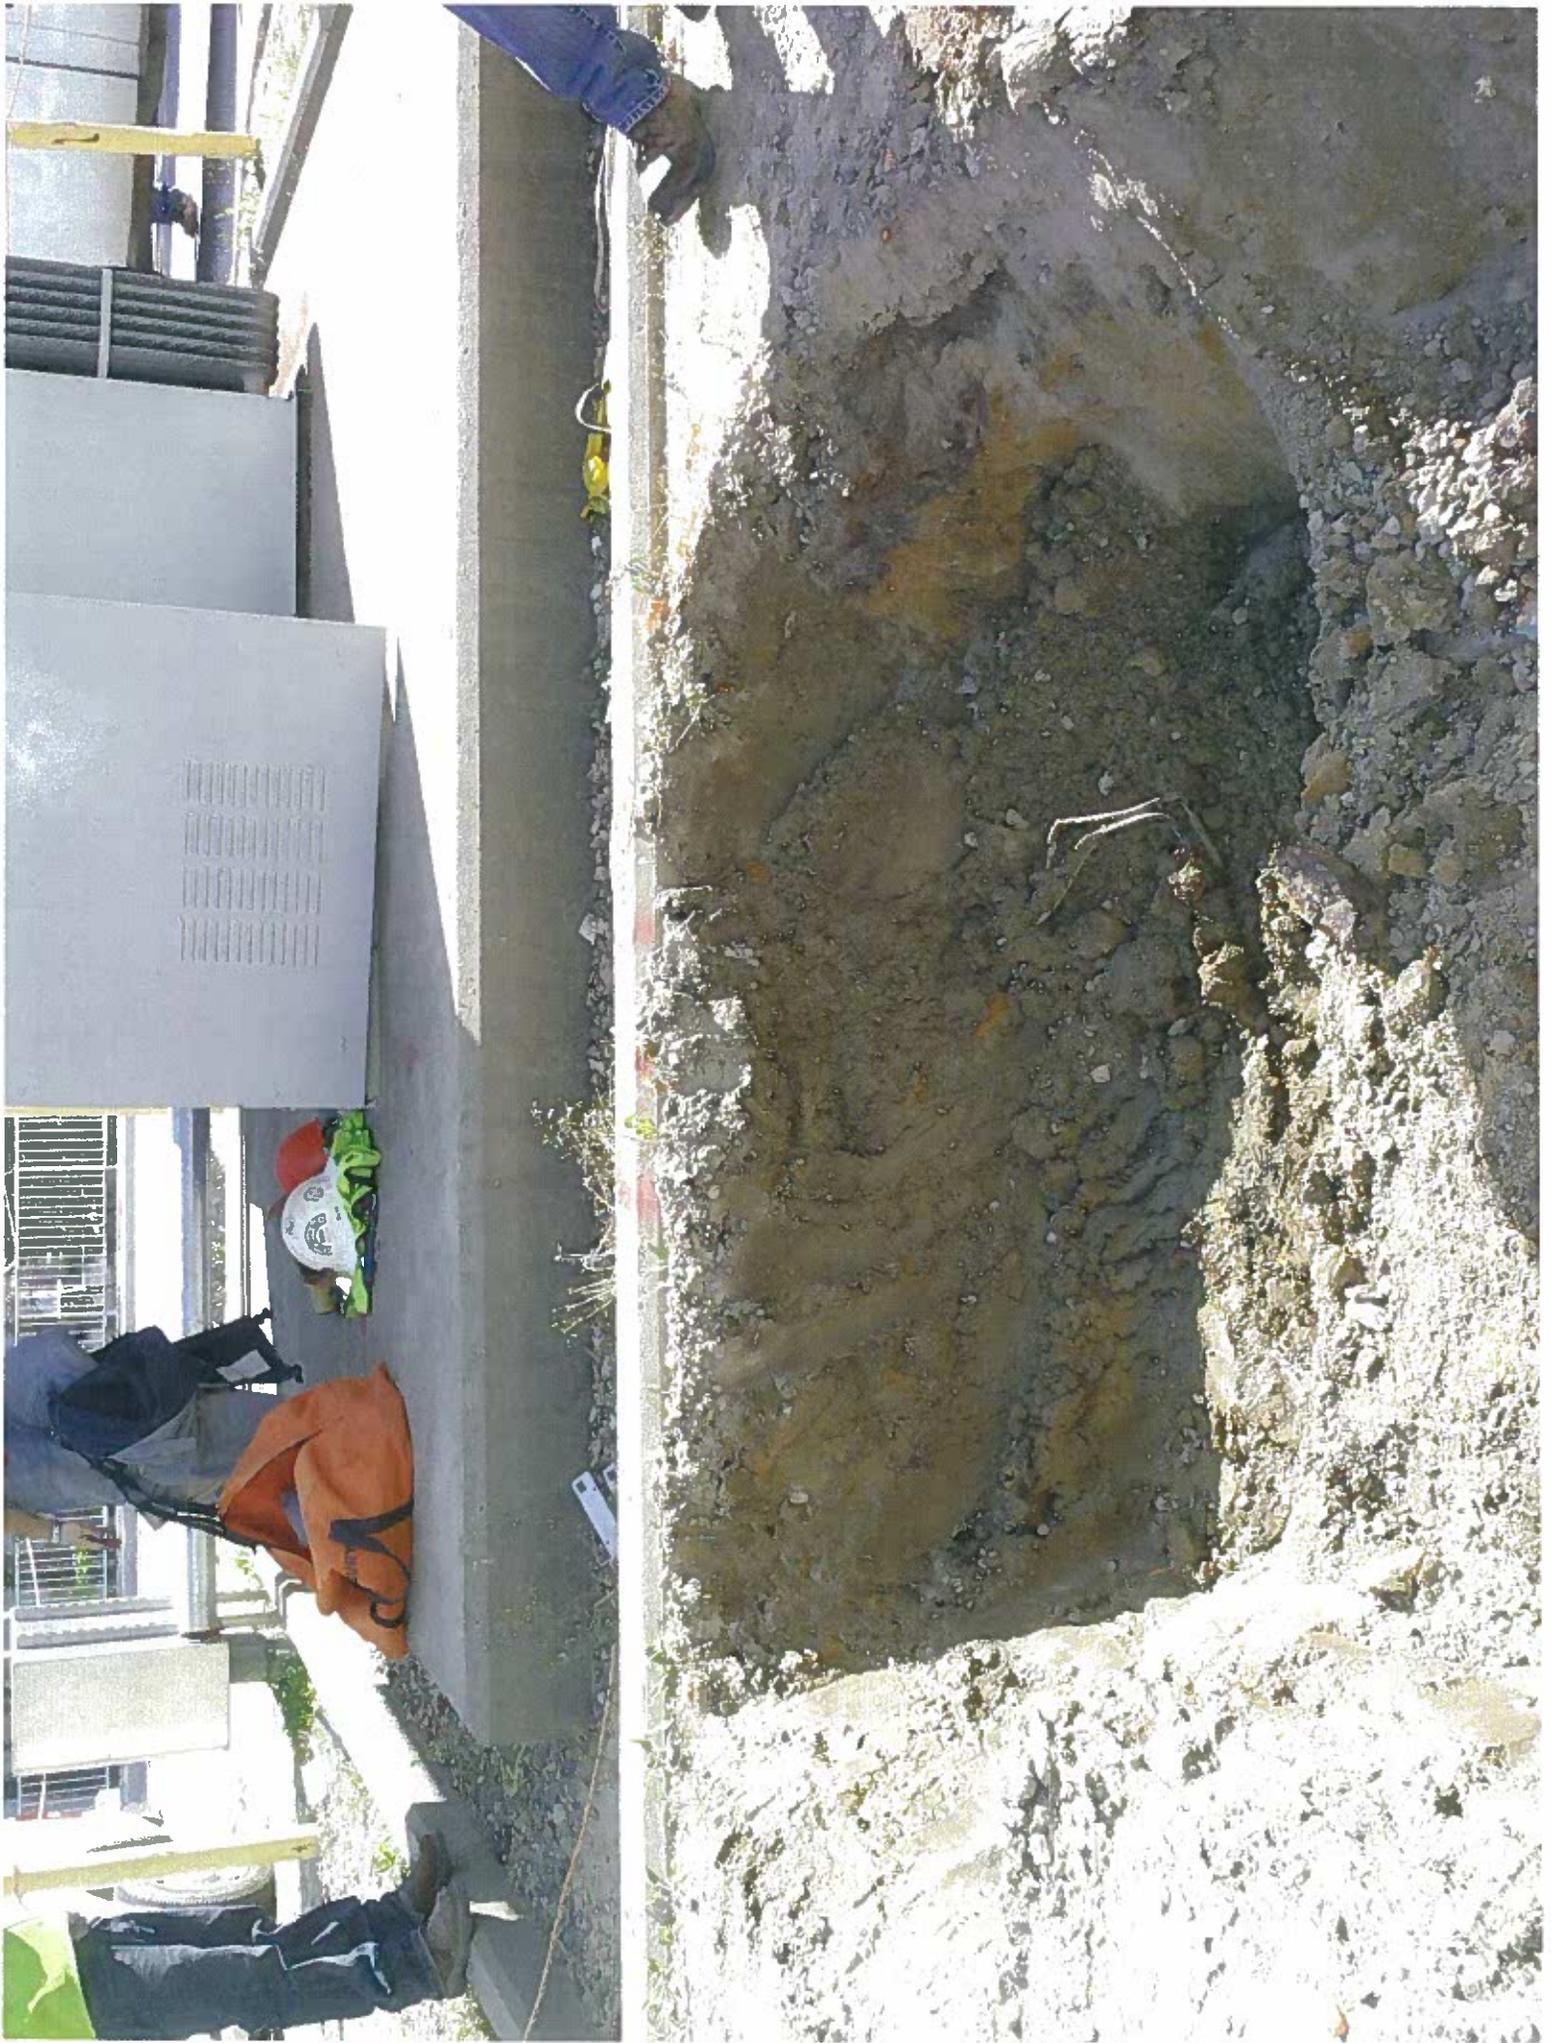
Electrical ductbank above ductbank to T-SUB-4

Struck 400 volt line above electrical ductbank

Utility marks for electrical ductbank

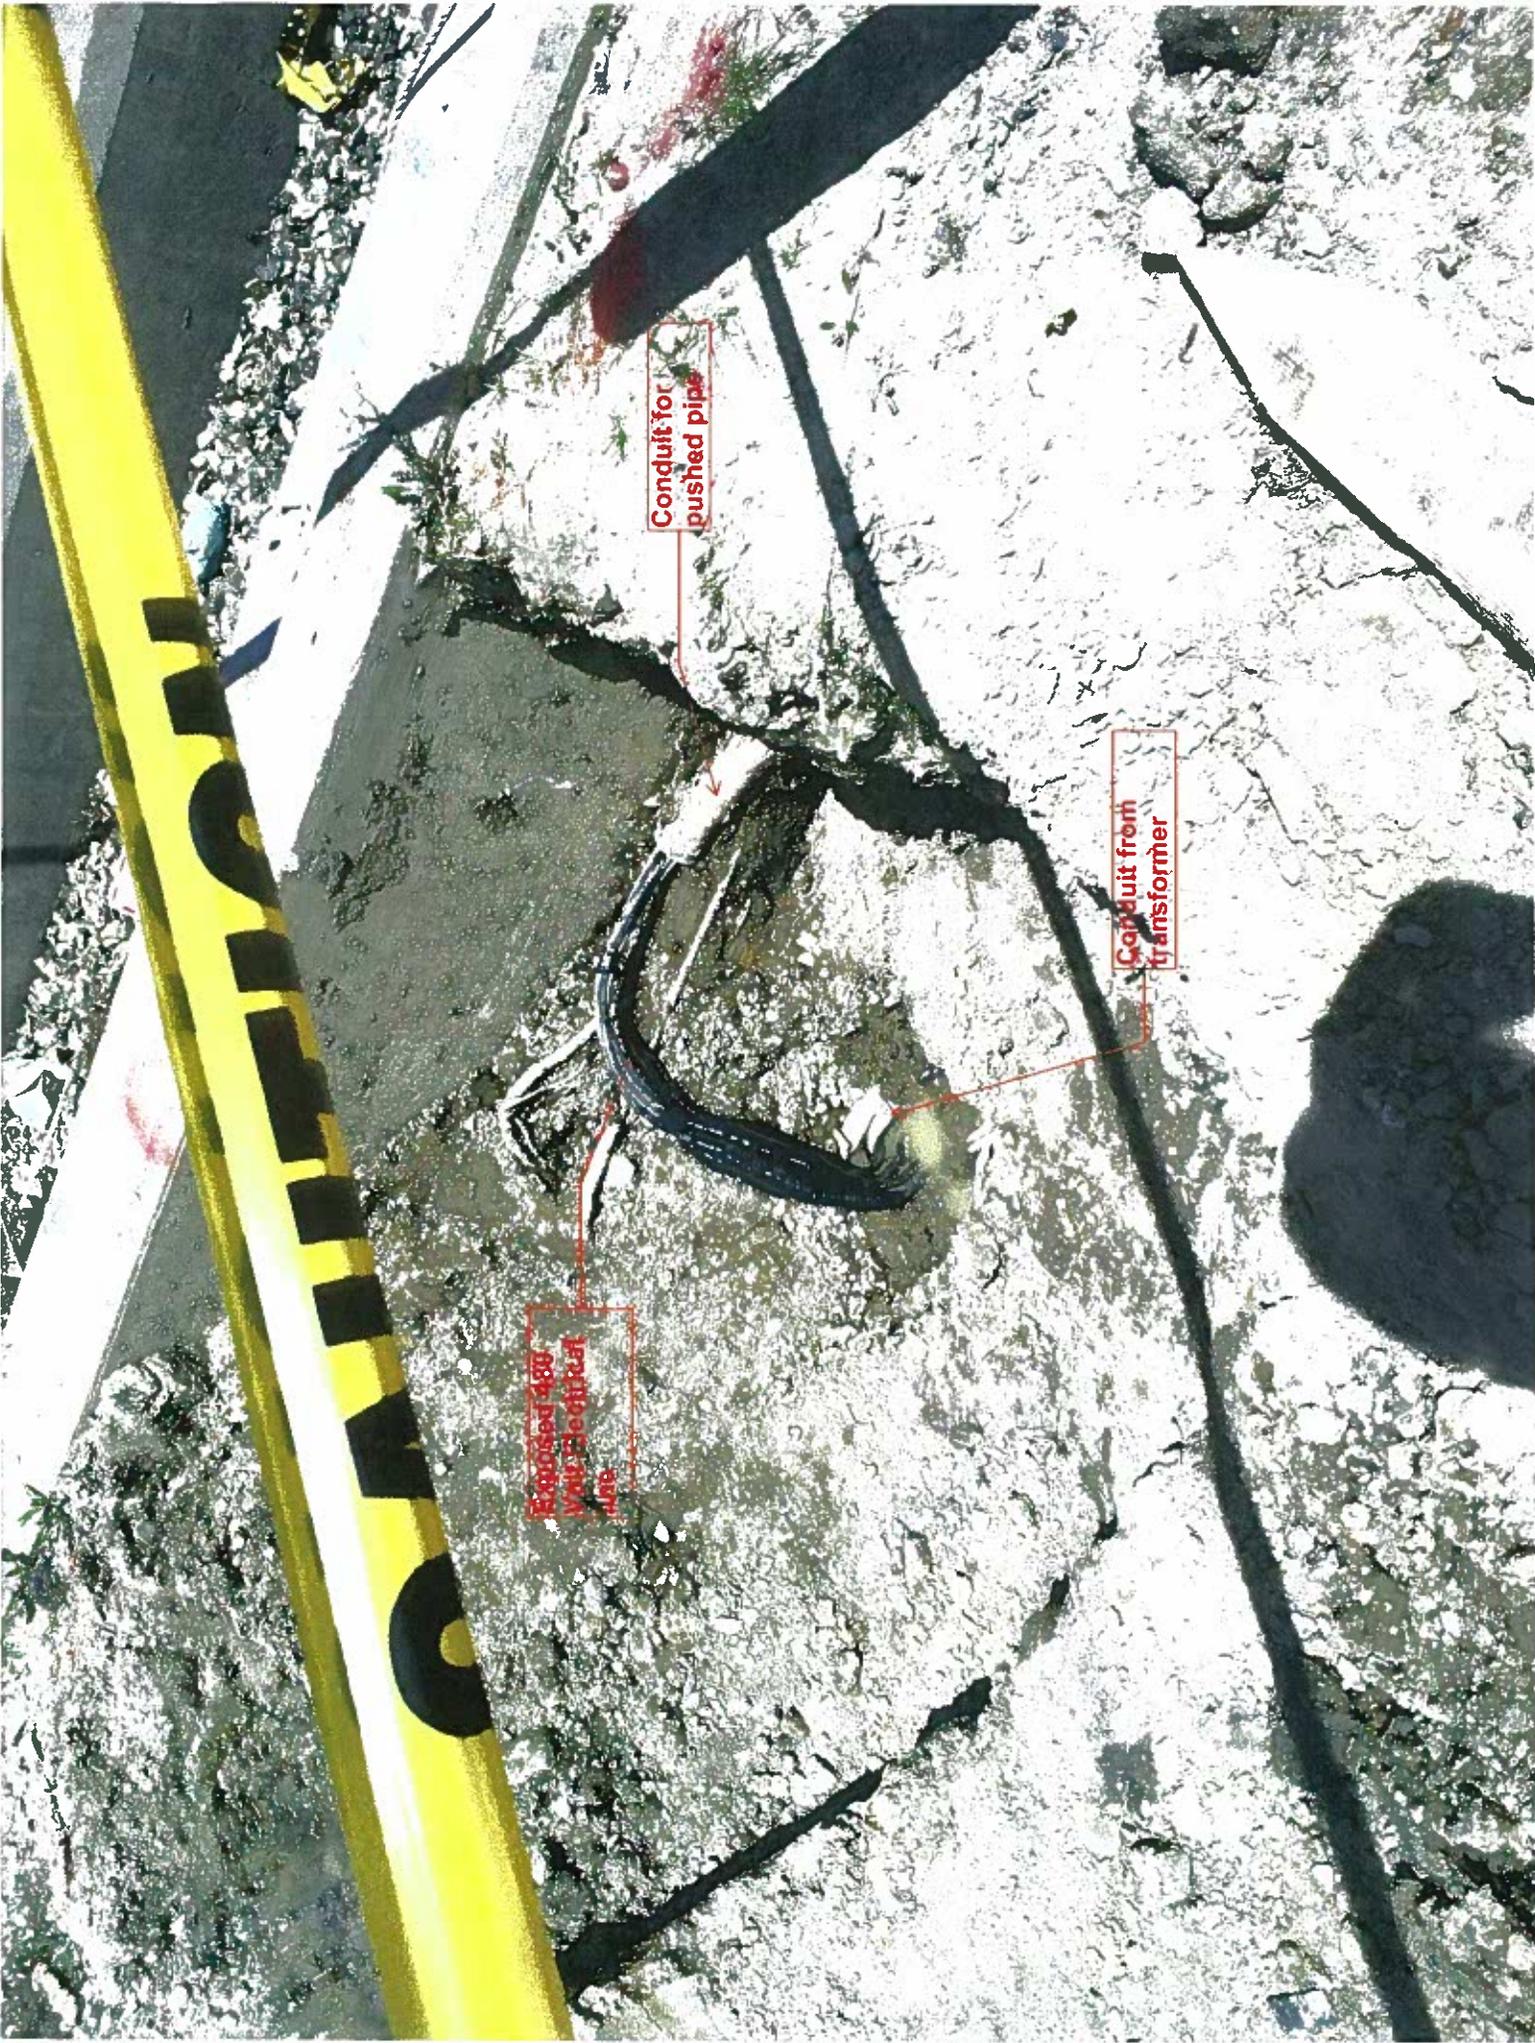
Exposed 480
Volt electrical
cable
