# Hall D Wire Characterization

## Samples F8-1 & F8-2

# Sample F8-1 A, B

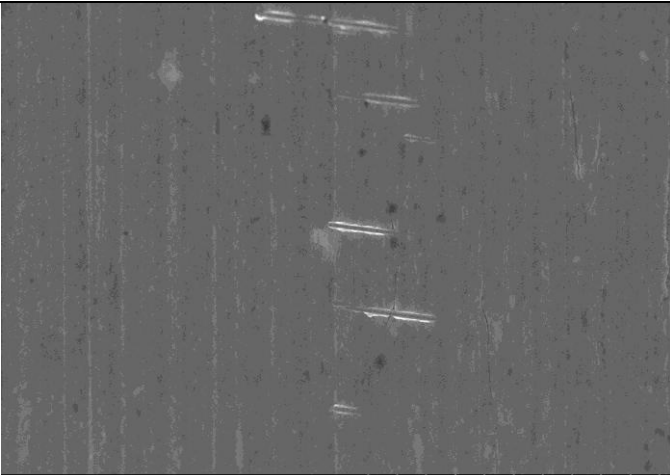
<p style="text-align: center;">EDS Analysis. Scratch. No Cu found.</p>
<p style="text-align: center;">F8-1A-4 Minor scratches.</p>	<p style="text-align: center;">F8-1A-8 Scratches and contamination.</p>

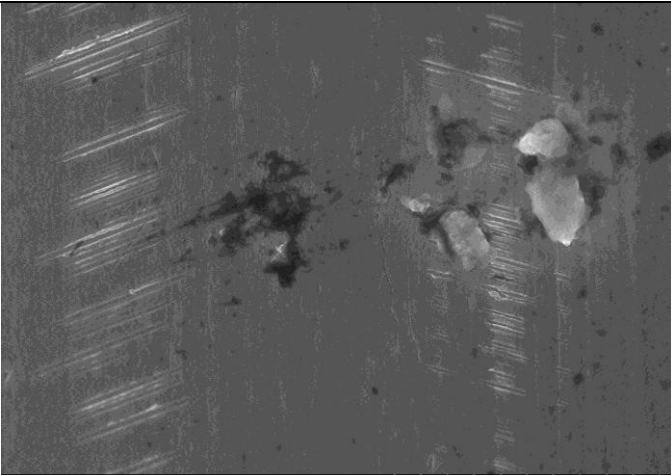
<p style="text-align: center;">Magnification: 10000x</p>
<p style="text-align: center;">F8-1B-5 Environmental contamination</p>	<p style="text-align: center;">F8-1B-5 Environmental contamination</p>
