Hall D Wire Characterization

Samples S4-1 & S4-2

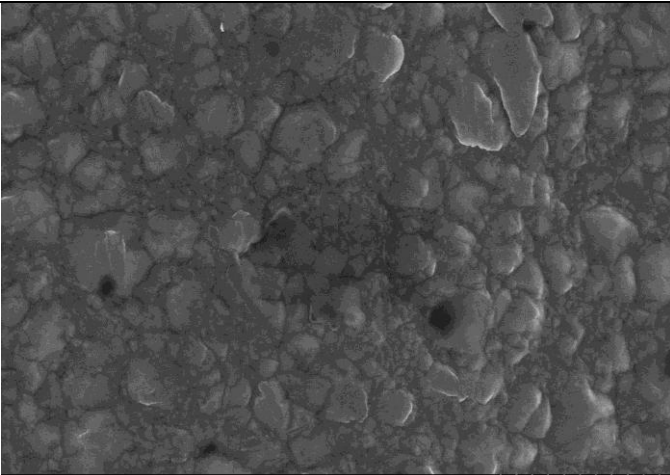
<p style="text-align: center;">EDS Analysis. Surface contamination (white spot)</p>
<p style="text-align: center;">S4-2A-6 Surface structure (high mag, white at low mag)</p>	<p style="text-align: center;">S4-2A-4 Flake-like contamination. Environmental.</p>

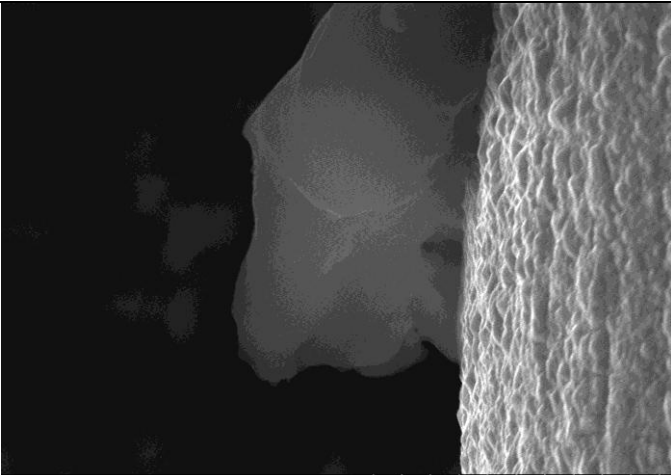
<p style="text-align: center;">Magnification: 18000x</p>
<p style="text-align: center;">S4-2A Needle-like contamination. Environmental.</p>	<p style="text-align: center;">S4-2A EDS analysis of needle-like contamination</p>

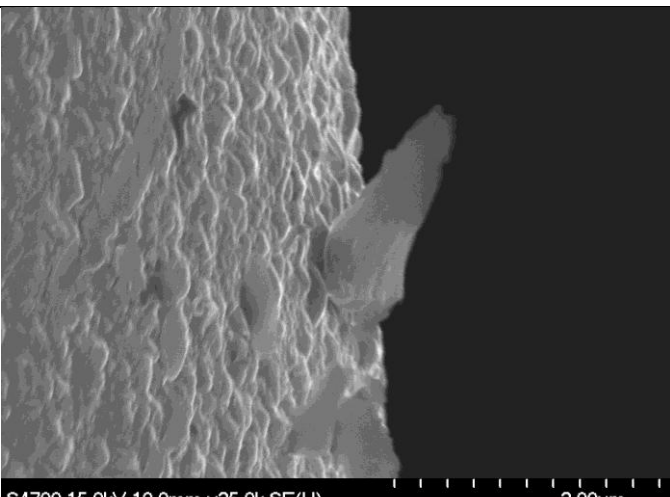
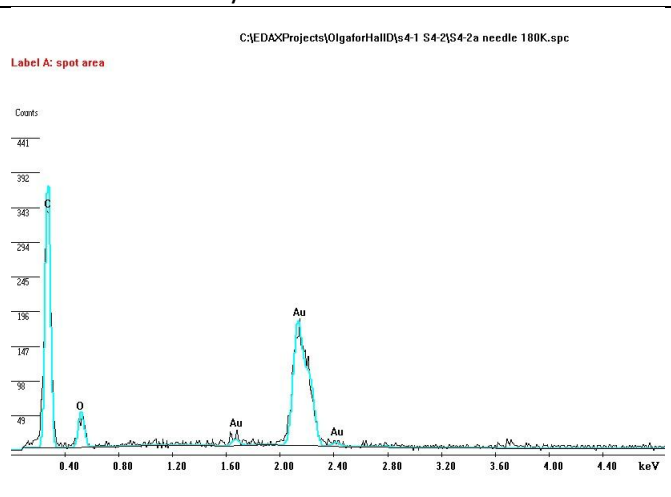
<p style="text-align: center;">Magnification: 25000x</p>	<p style="text-align: center;">S4-2A EDS analysis of needle-like contamination</p> <p style="text-align: center;">C:\EDAXProjects\OlgaforHallID\s4-1 S4-2\S4-2a needle 180K.spc</p> <p>Label A: spot area</p>
