Detector Health Report

Tyler Lemon

Detector Support Group

April 4, 2018

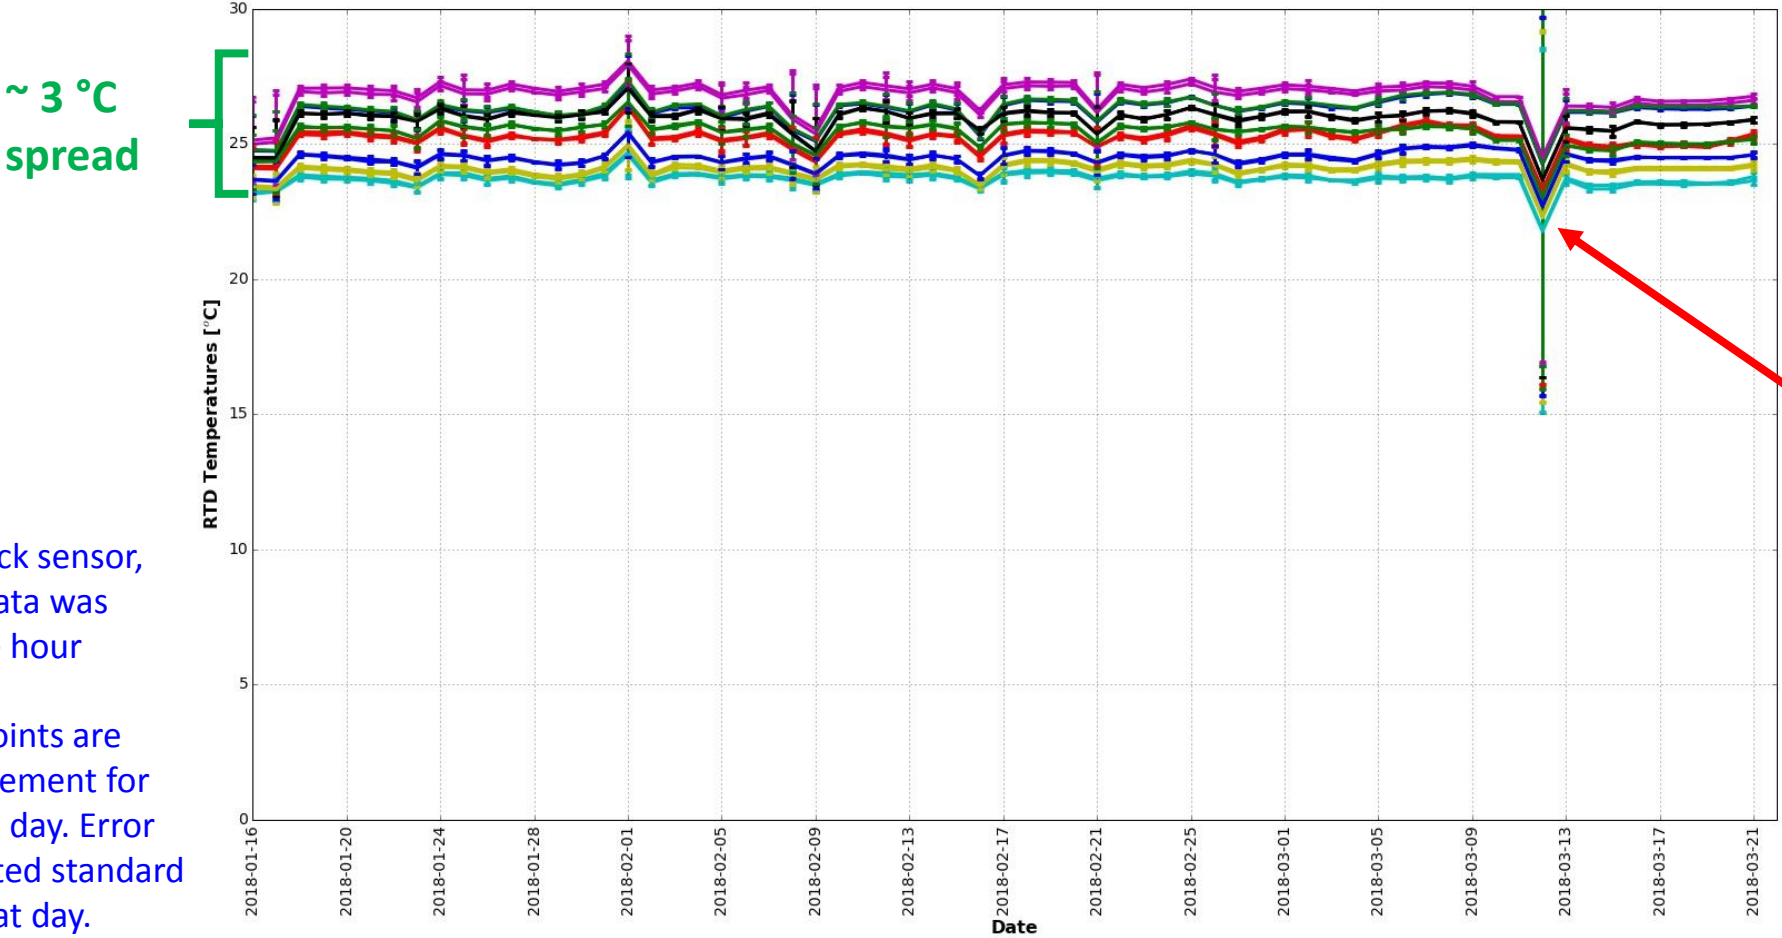
Hardware Interlock N₂ Volume Temperature History

NOTE: Large error bars on 3/12/2018 caused by an issue with EPICS readout. For ~2 hours, all readouts from RICHCRIO were published to EPICS as zero while issue was resolved. The large error bars are seen on all plots generated for report.

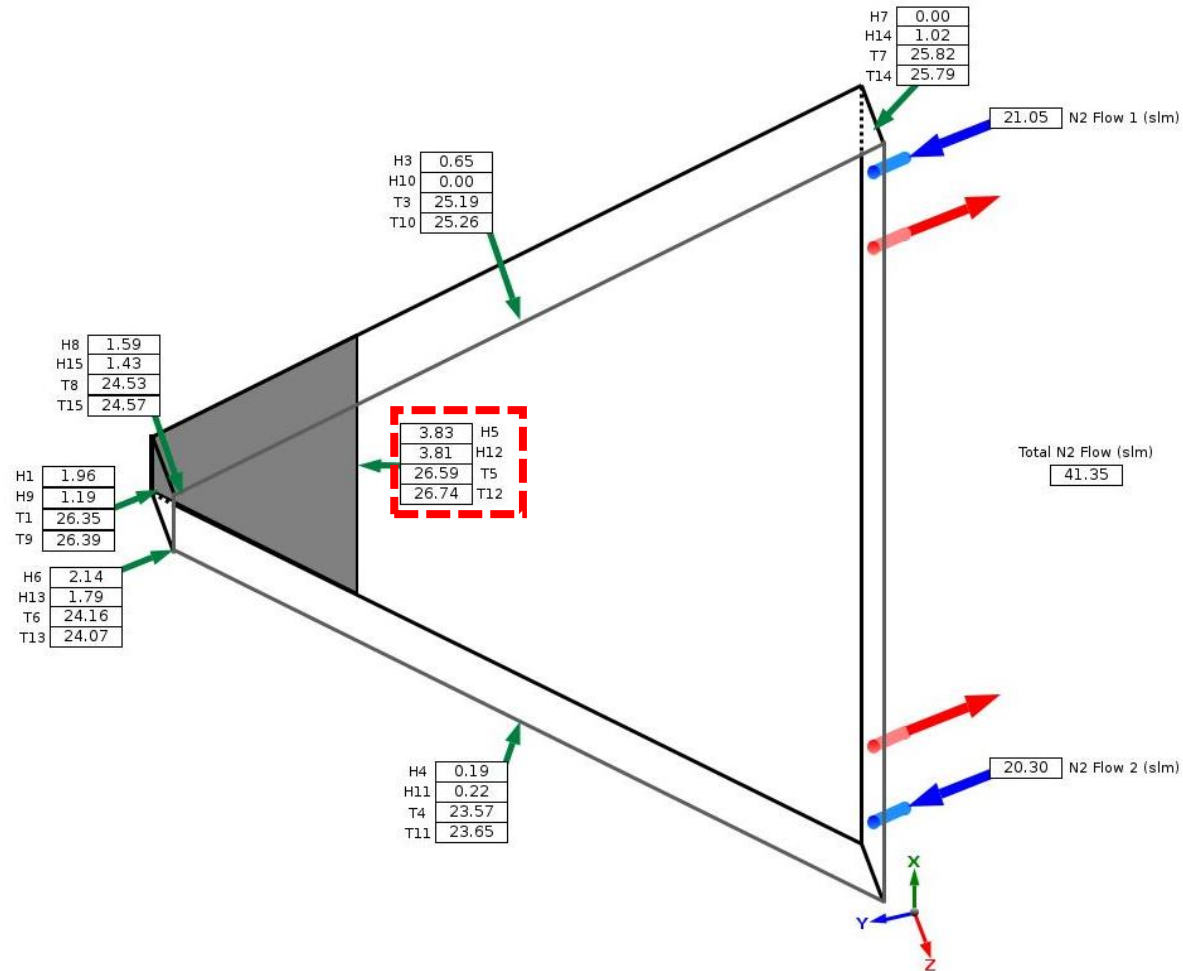
N₂ Volume Humidity History

Humidity
5 and 12
(behind
spherical
mirrors)
are only
sensors
above
3 % RH.

Humidity 5 and 12 thought to be higher due to placement in RICH behind mirrors.

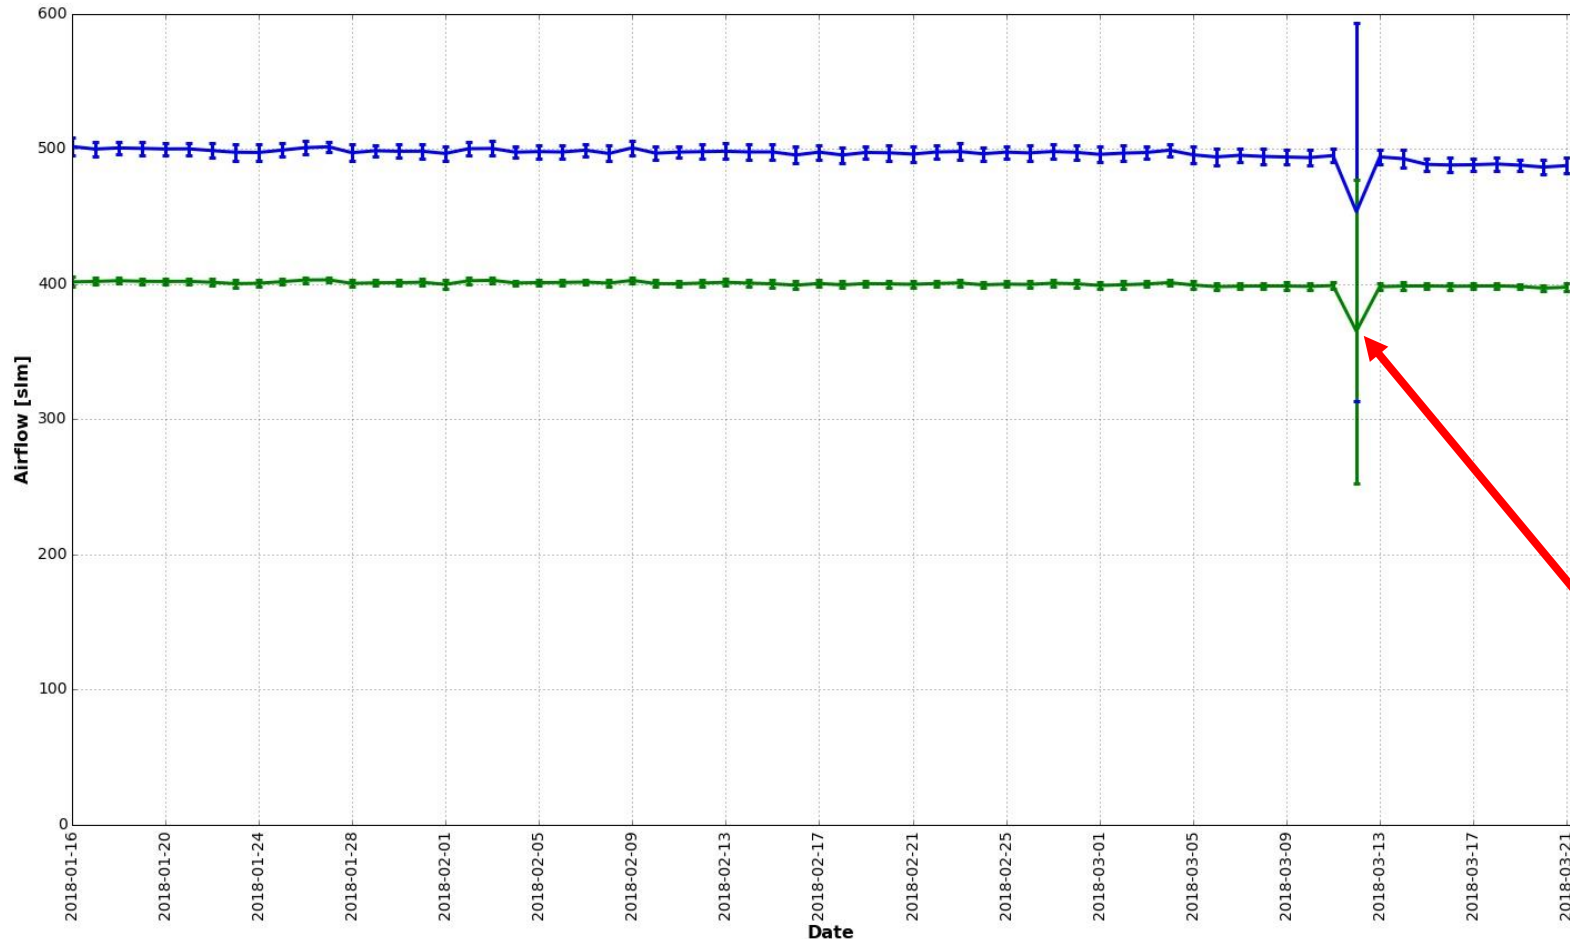
Air Flow History

Airflow 1 is set to 500 slm and Airflow 2 is purposely set lower to 400 slm. This is to flow more air to the portion of the EP that tends to be the highest temperature.

NOTE:
Large error bars on 3/12/2018 caused by an issue with EPICS readout. For ~2 hours, all readouts from RICHCRIO were published to EPICS as zero while issue was resolved. The large error bars are seen on all plots generated for report.

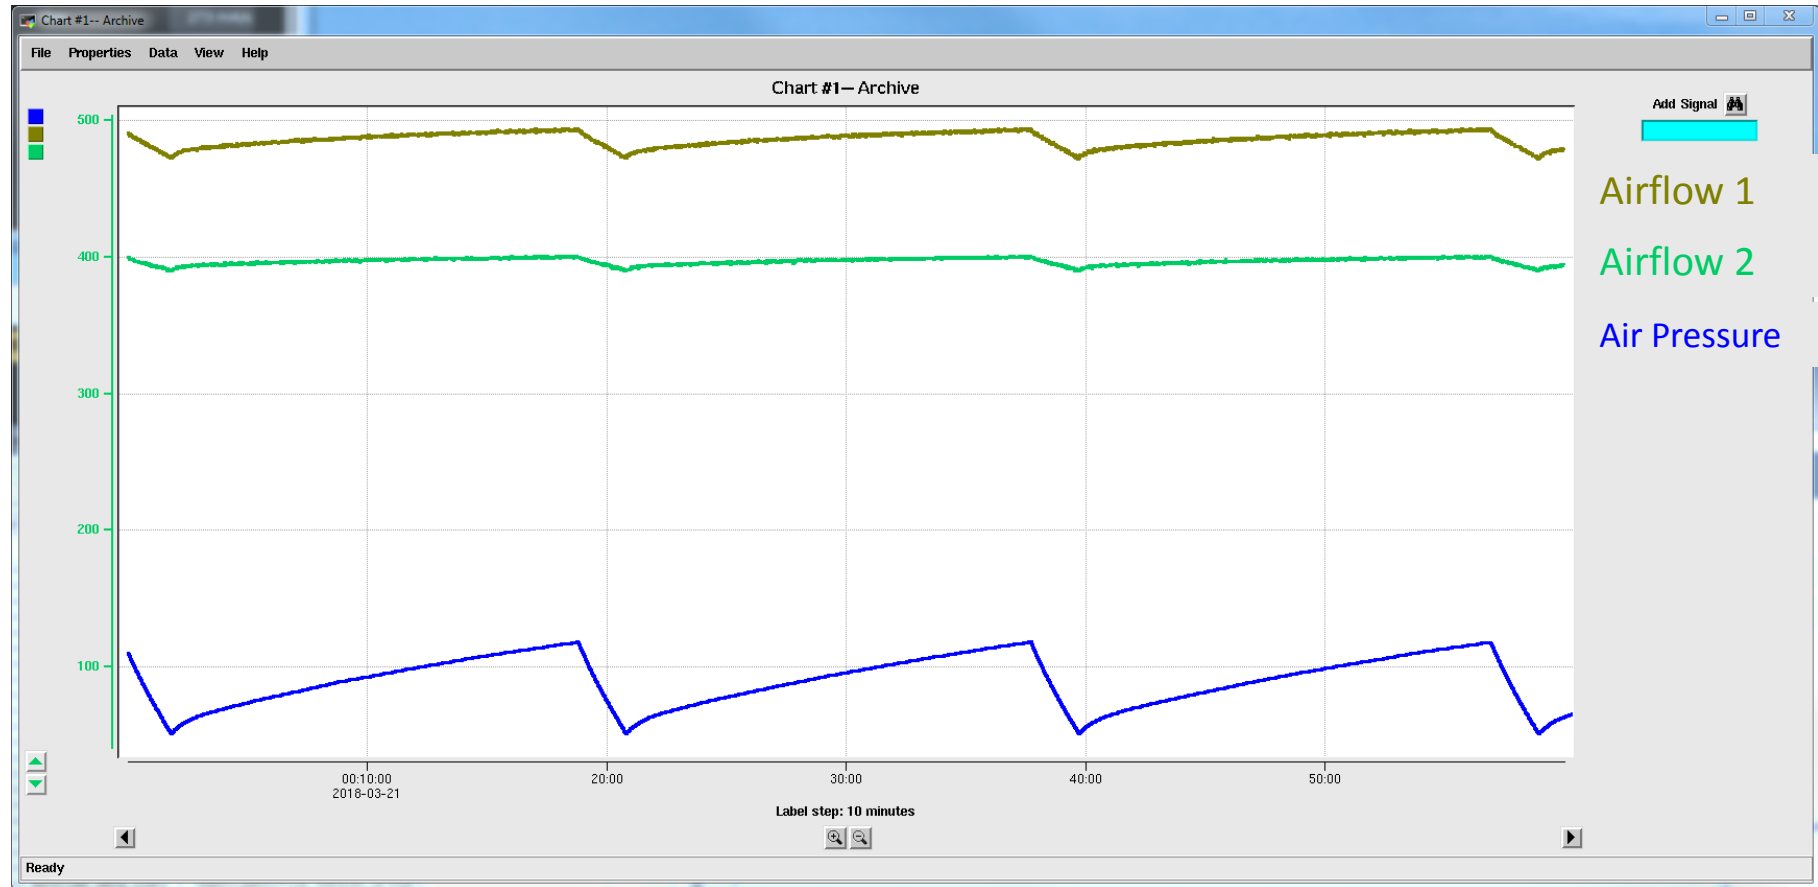
One Hour of MYA Airflow Data Plotted With Air Pressure

Airflow 1 is more sensitive to changes in air pressure because of higher flow rate.

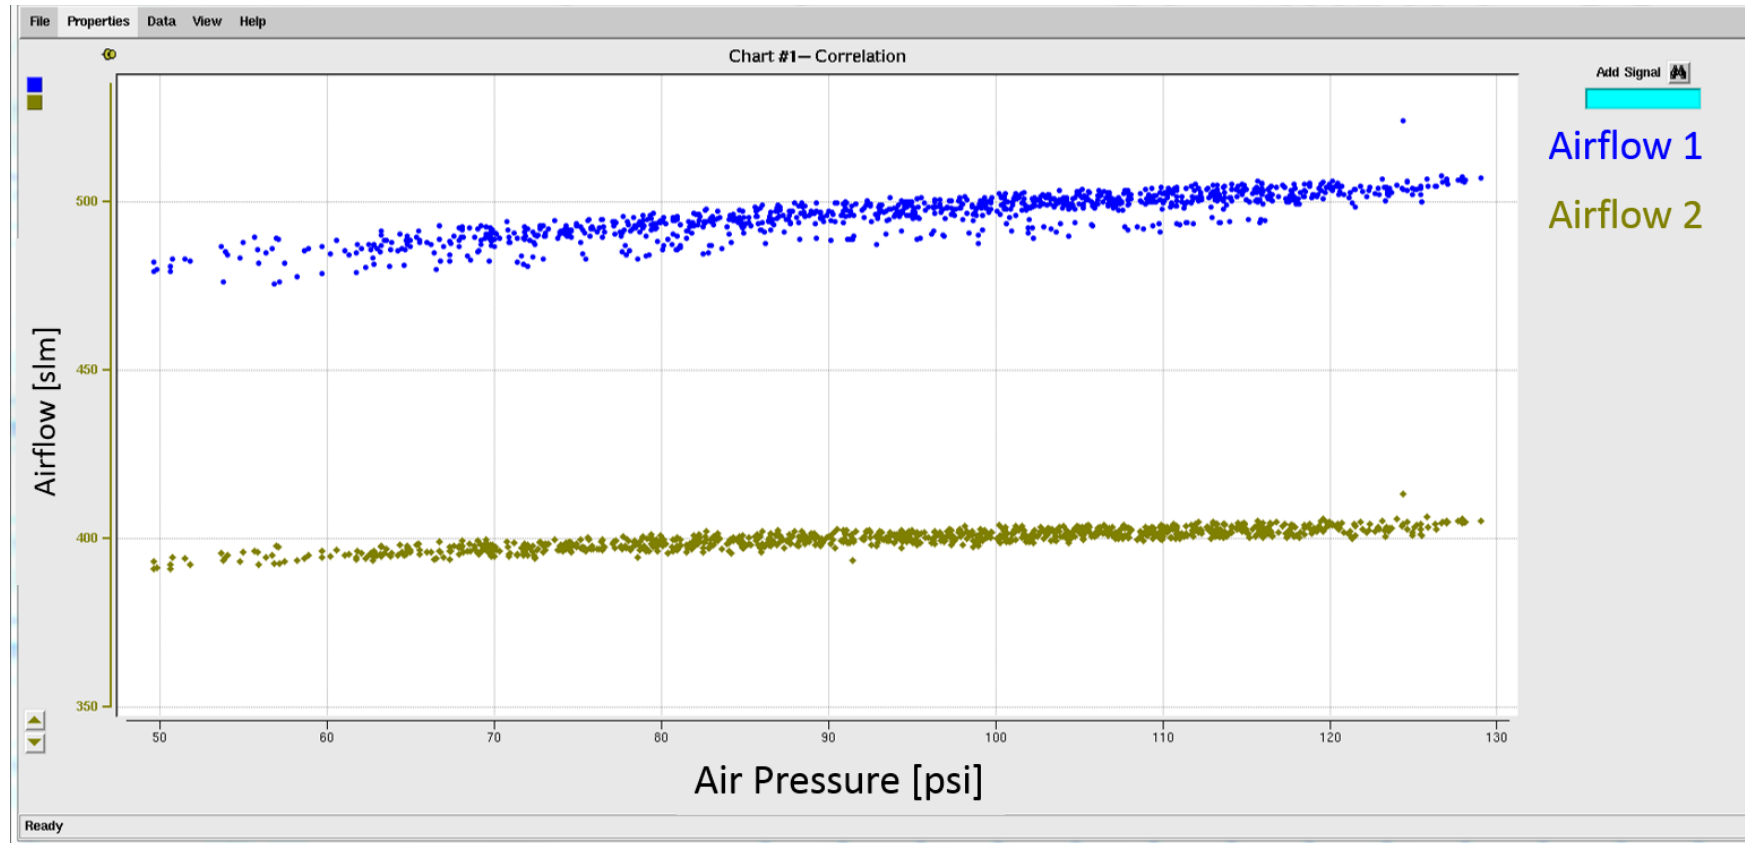
Air Pressure – Airflow Correlation Plot

Airflow 1 is more sensitive to changes in air pressure because of higher flow rate.

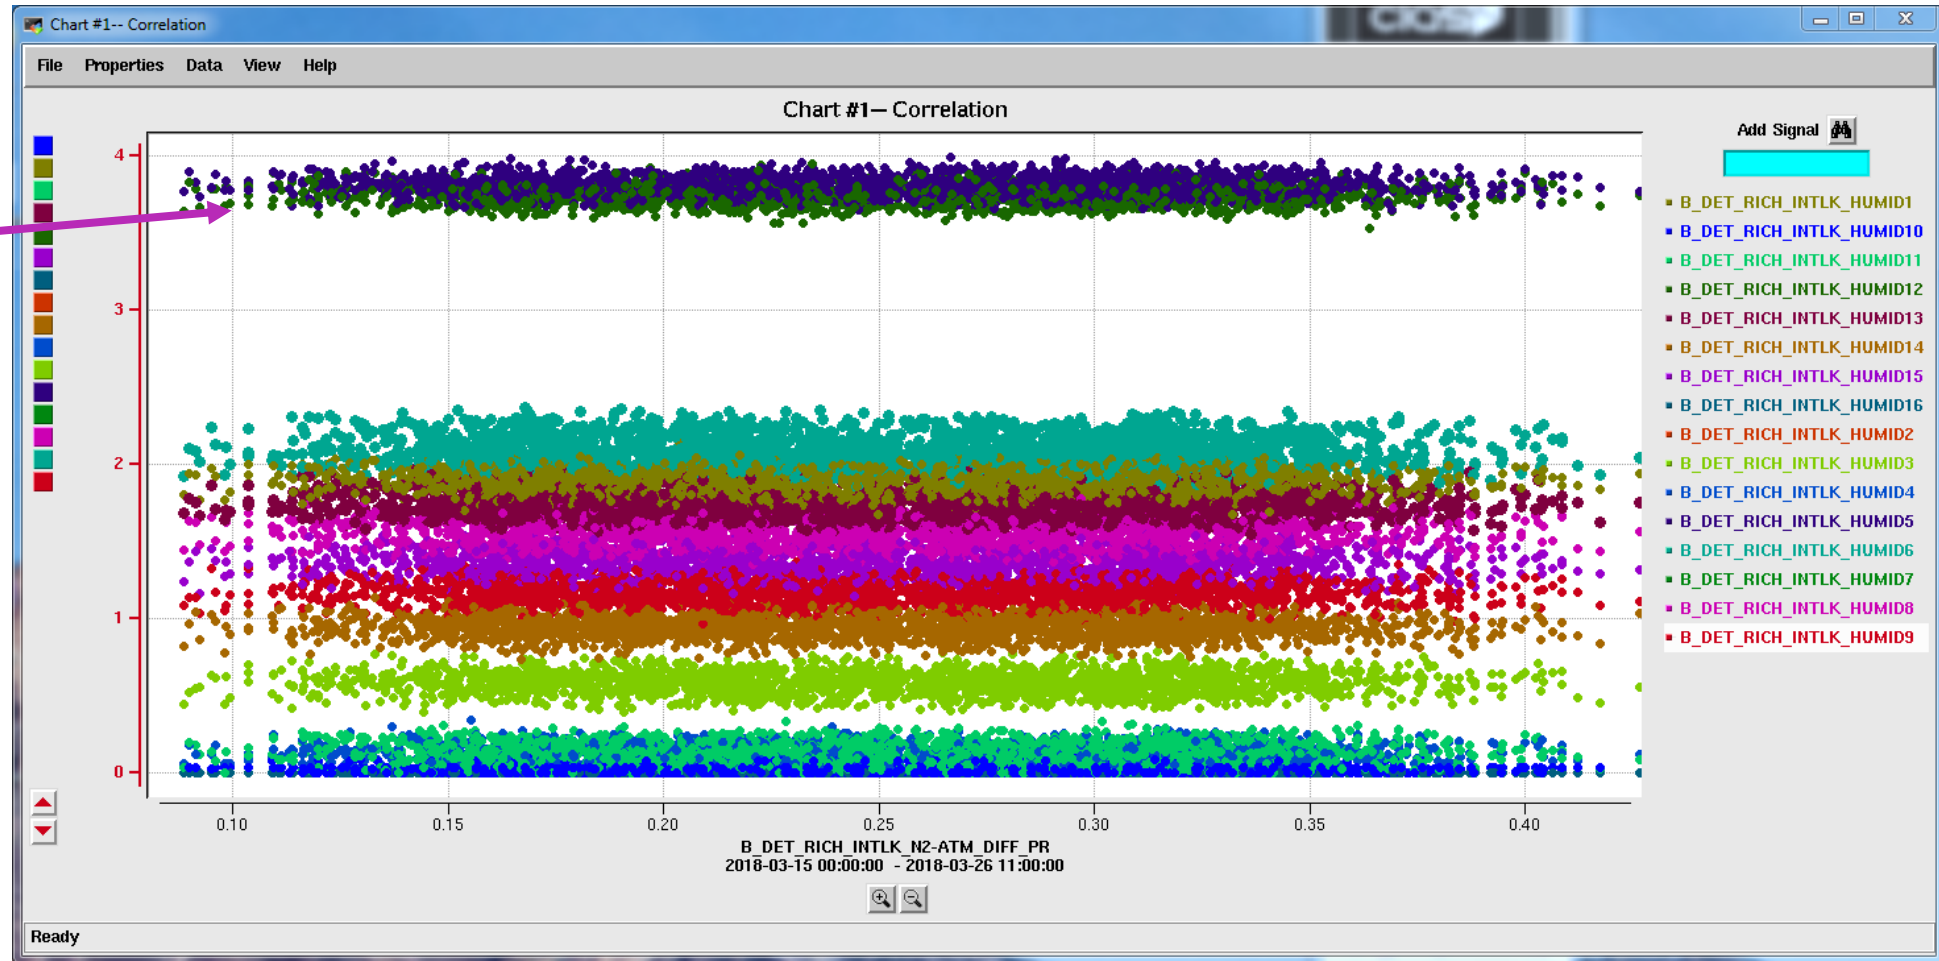
N2 Volume – Atmosphere Differential Pressure Correlation Plot for N₂ Volume Sensors

Only Humidity 5 and 12 are above 3 % RH.

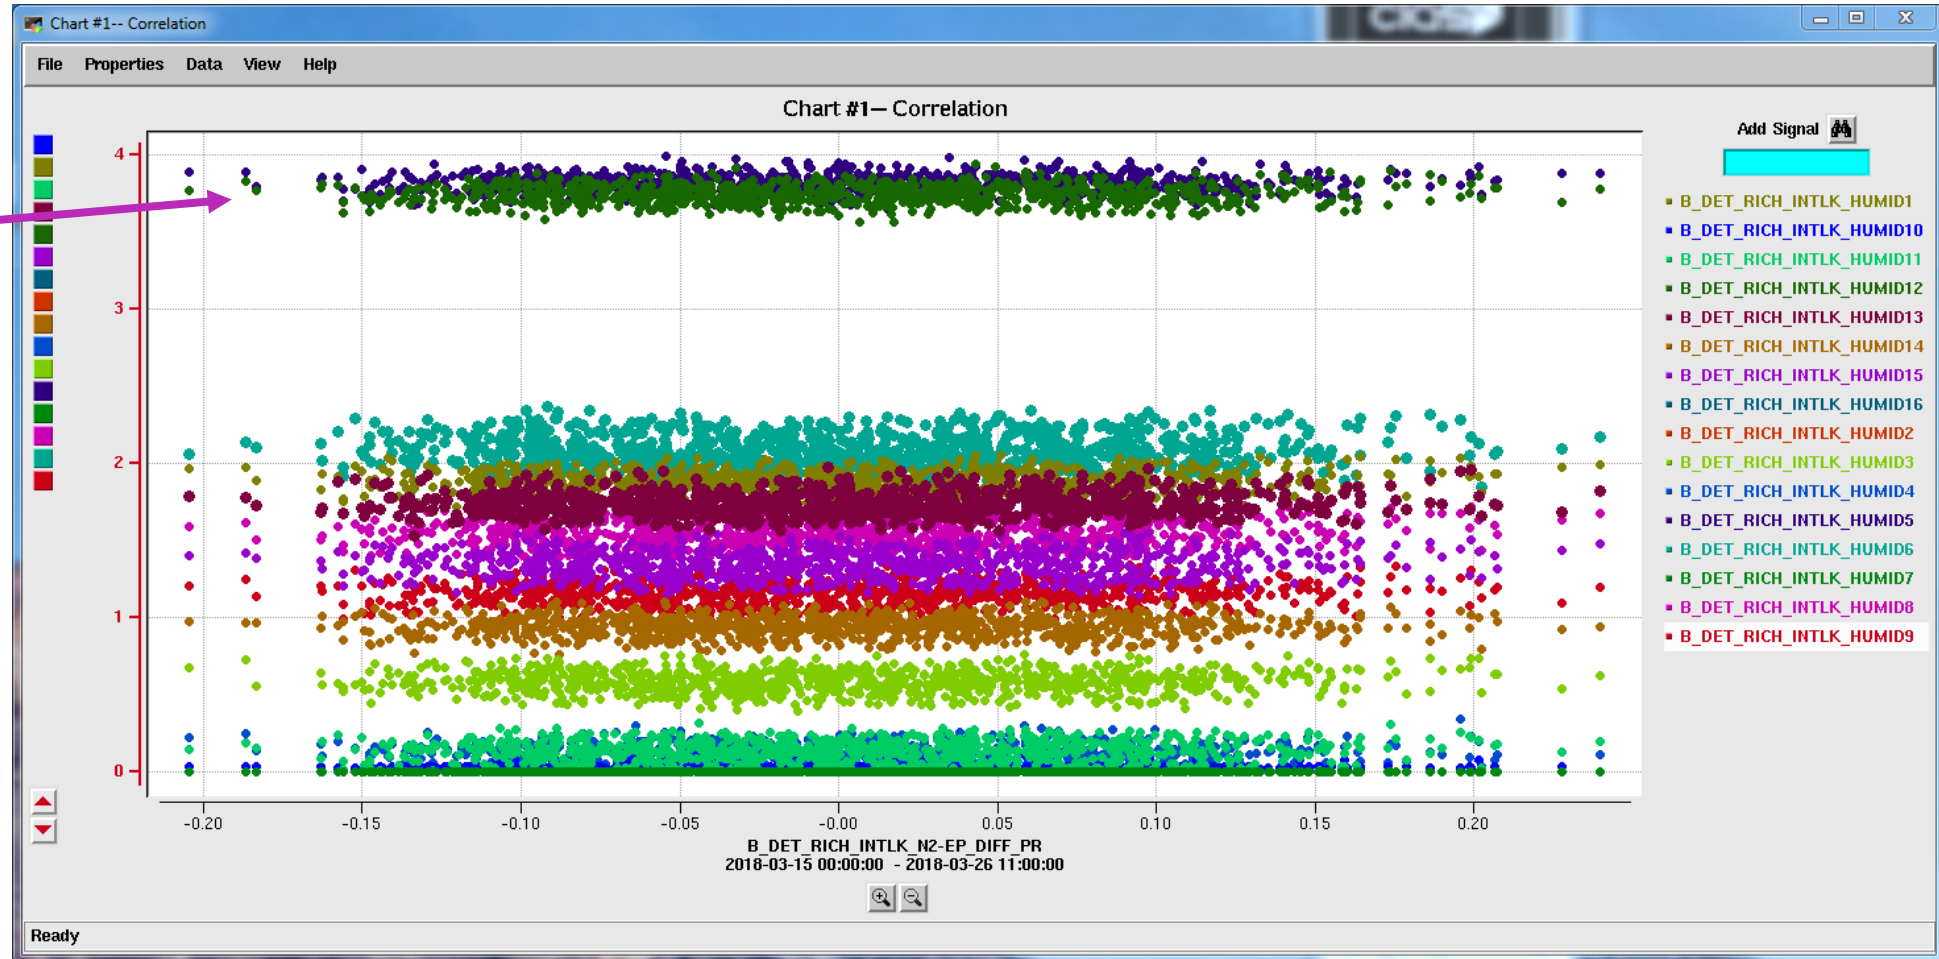
N2 Volume – EP Differential Pressure Correlation Plot for N₂ Volume Sensors

Only Humidity 5 and 12 are above 3 % RH.

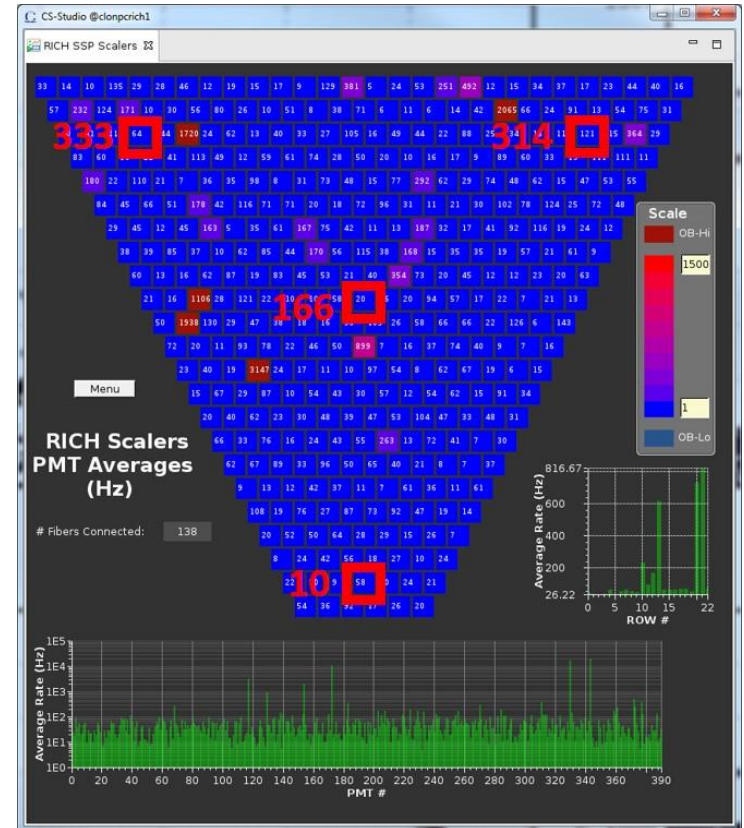
PMT 166 has higher scalers because more particles go through center of EP than at its edges.
