Hall B Solenoid and Torus Health Report (Sep 2017 to April 2018)

Pablo Campero

Detector Support Group

04/11/2018

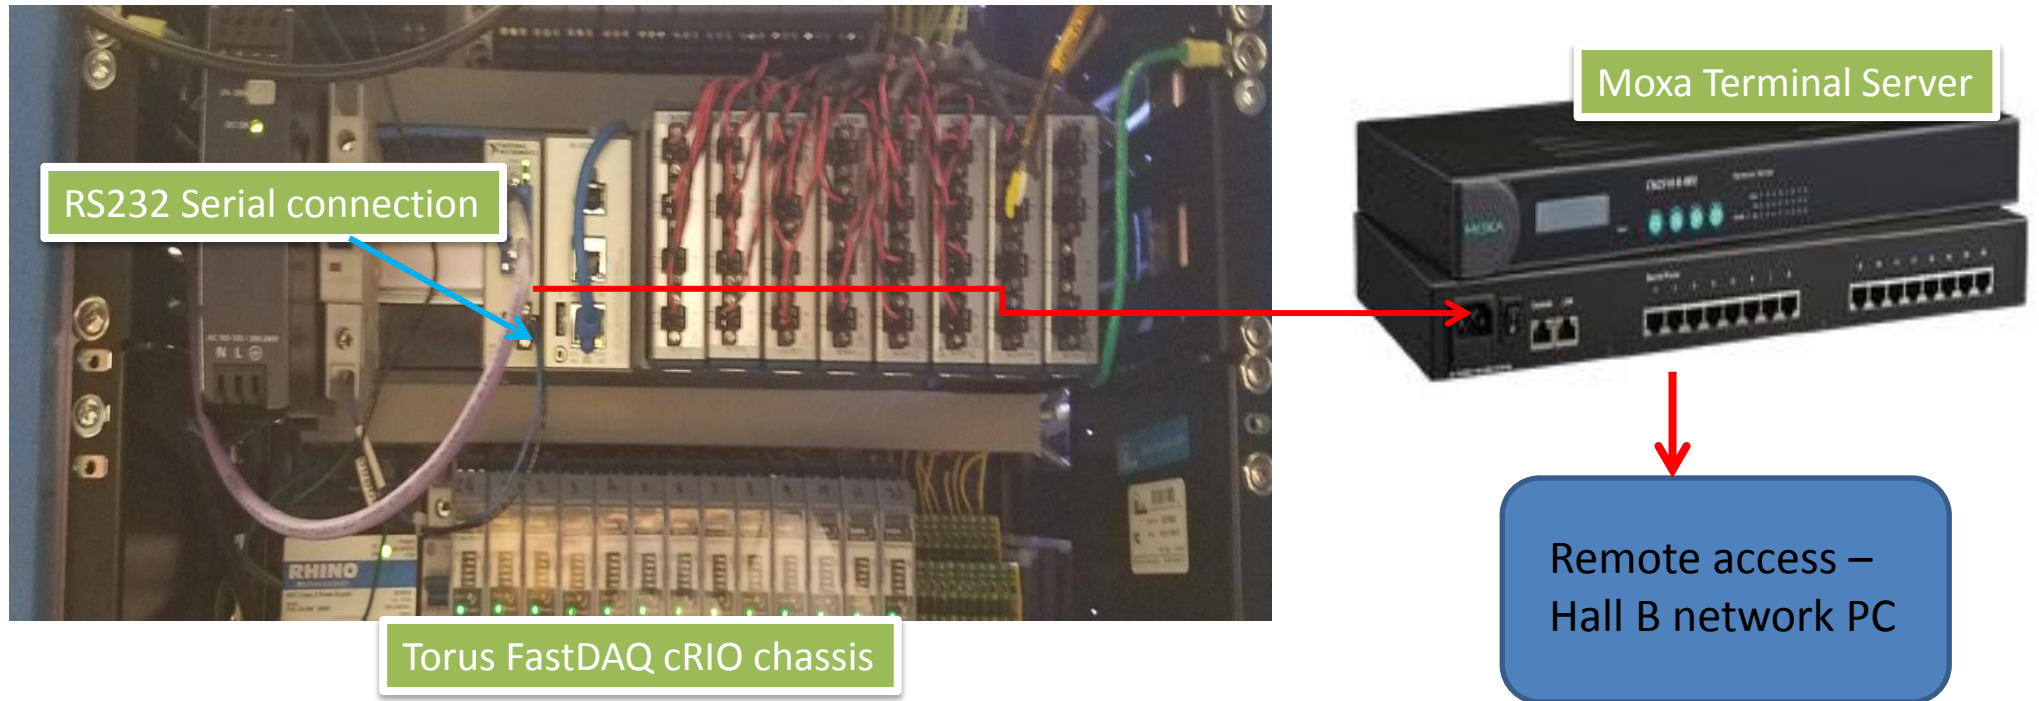
- Installed a Terminal Server to enable remote RS232 serial communication with Torus cRIOs
 - Routed cables between cRIOs on SFL2 and Moxa terminal server on SFL1
 - Console output enables easy access to debugging
 - Provides error log and special features

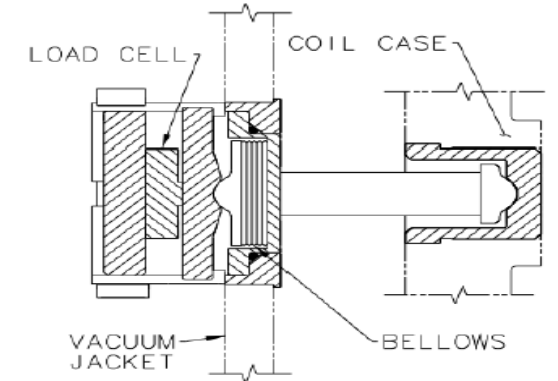
Coil out of plane support detail

Two load cells installed at each face of coils (back and front)

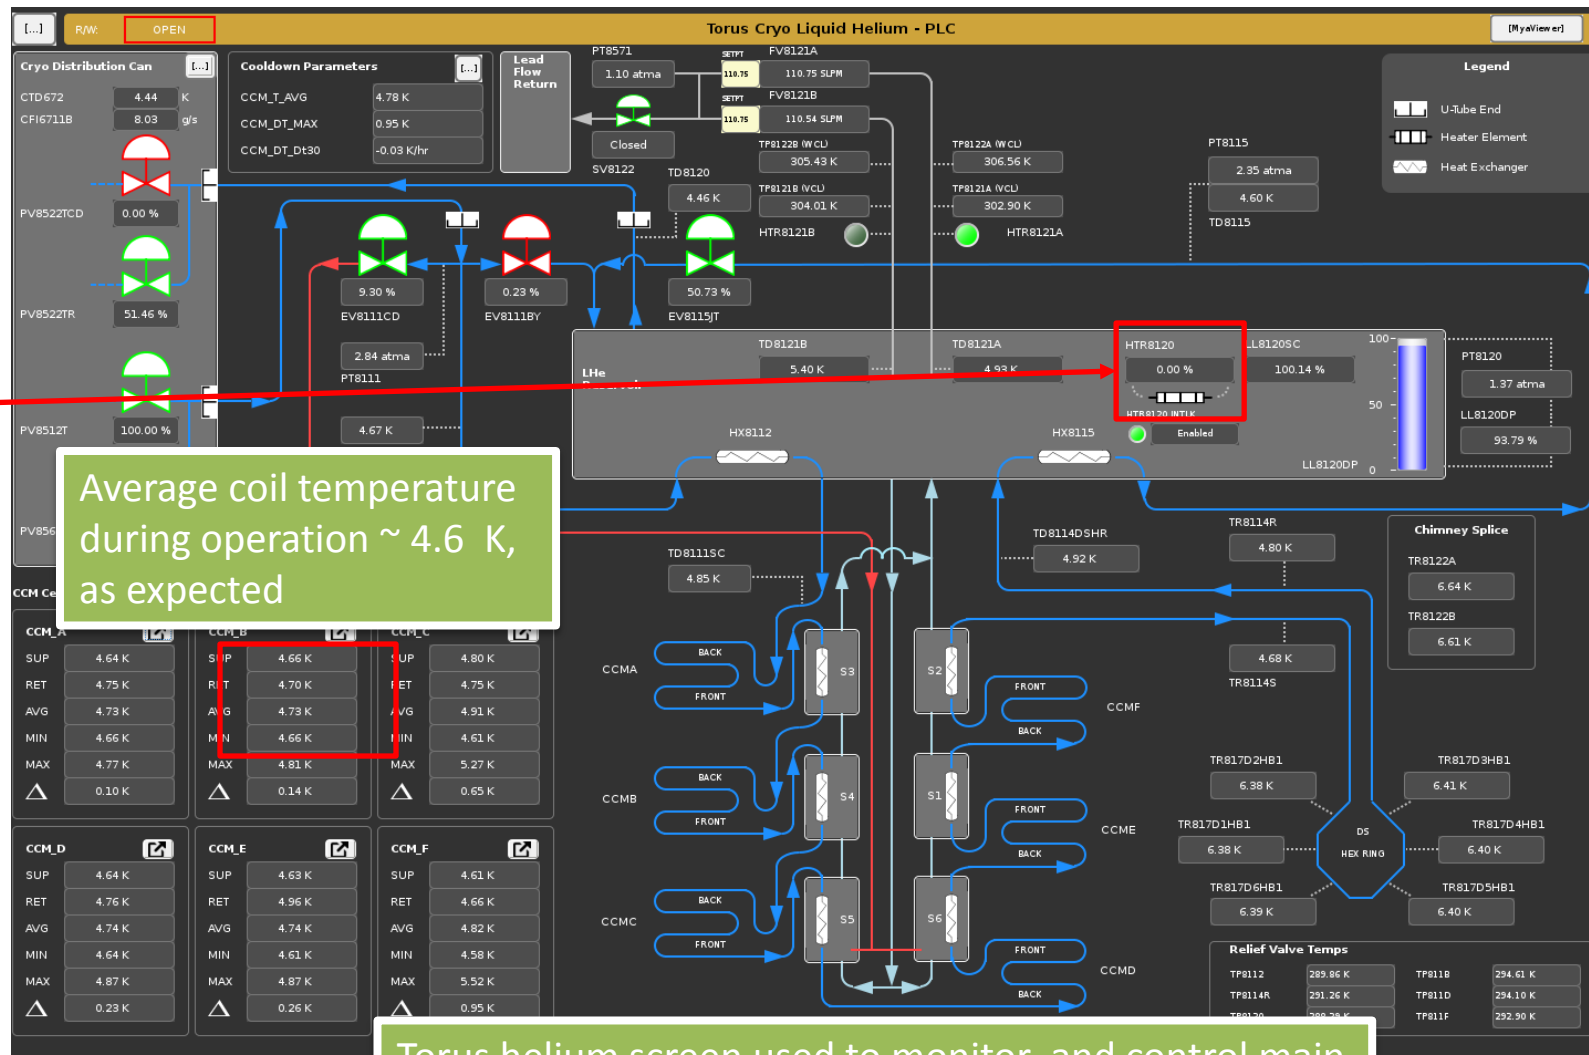
- Six of ten controlled ramp downs were generated by ESR trips and cryogenic variables (P, T, LL) over threshold conditions
- PID parameters that control valves and heater modified to stabilize cryo system
 - Tuning required to find most stable cryogenic conditions based on Solenoid heat loads
- Overall, cooldown recovers with no major problems after trips

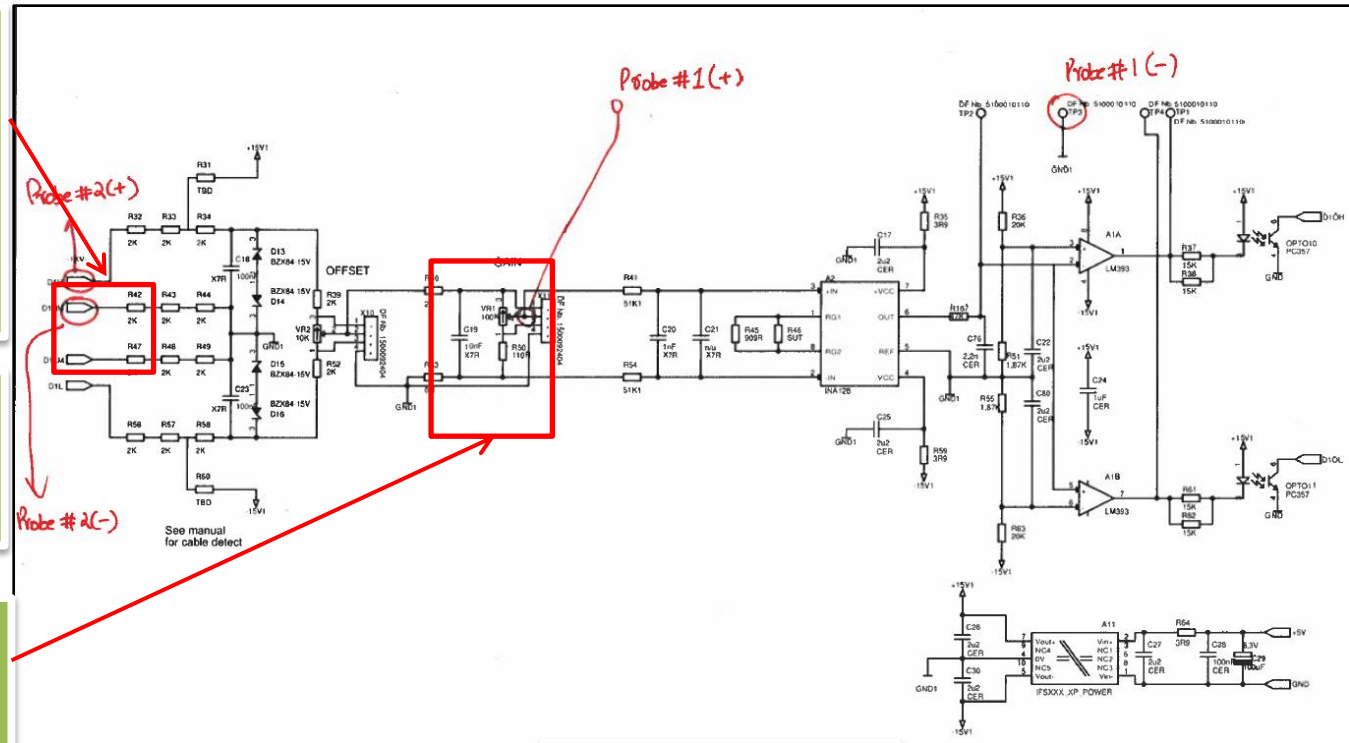
Electrical diagram

Probe #1 connected to monitor voltage spikes generated internally in QD
