RICH EP Temperature Hardware Interlock Trip

August 7, 2018 at 11:46 AM

Tyler Lemon

August 8, 2018

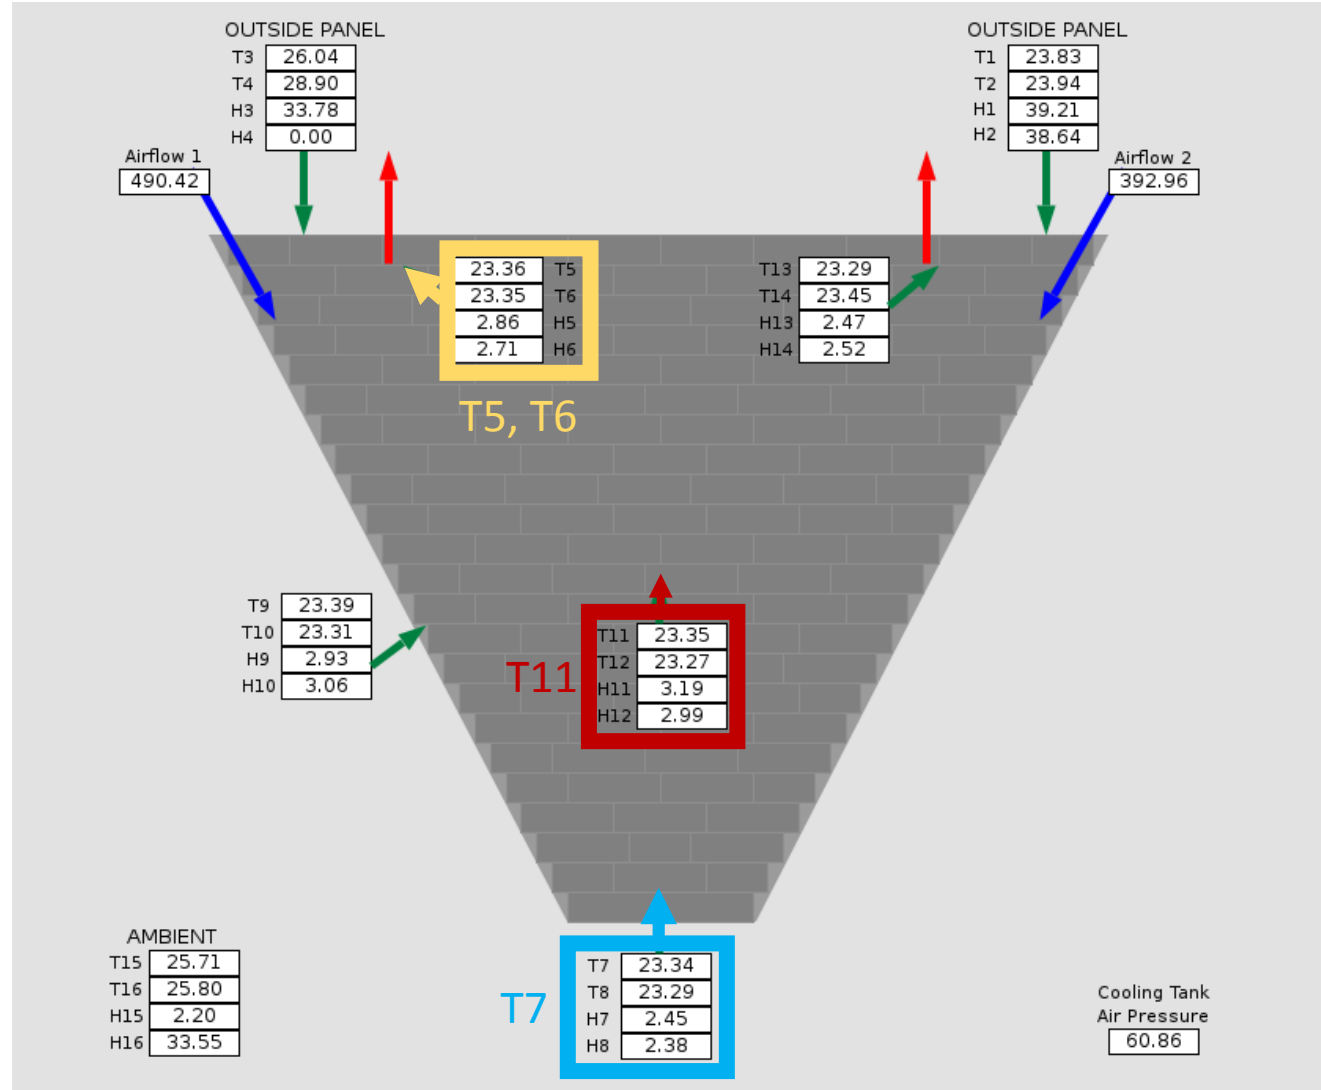
Sensor Locations in EP

Signal	Measurement	Units	High Limit Temp Limit [°C]
Temperature 5	44.0463	°C	44
Temperature 6	43.9583	°C	44
Temperature 7	39.63	°C	42
Temperature 8	39.4737	°C	44
Temperature 9	43.2233	°C	46
Temperature 10	43.074	°C	46
Temperature 11	44.2864	°C	46
Temperature 12	44.1679	°C	46
Temperature 13	42.0359	°C	45
Temperature 14	42.1515	°C	44
Airflow 1	482.394	slm	N/A
Airflow 2	397.811	slm	N/A

Interlocks that tripped

Difference between Highest and Lowest EP temperature
4.6564 °C

- Thresholds for EP temperature sensors increased by 2 °C.
- RICH will remain powered off until Hall B ambient conditions become more stable or cause of changes is found
- DSG will move the Ambient EP temperature sensors (T15,16) from the rack near the cRIOs to the air-cooling buffer tank on the top deck of Forward Carriage.
 - Would give better indicator of temperature of cooling air before it flows into RICH.

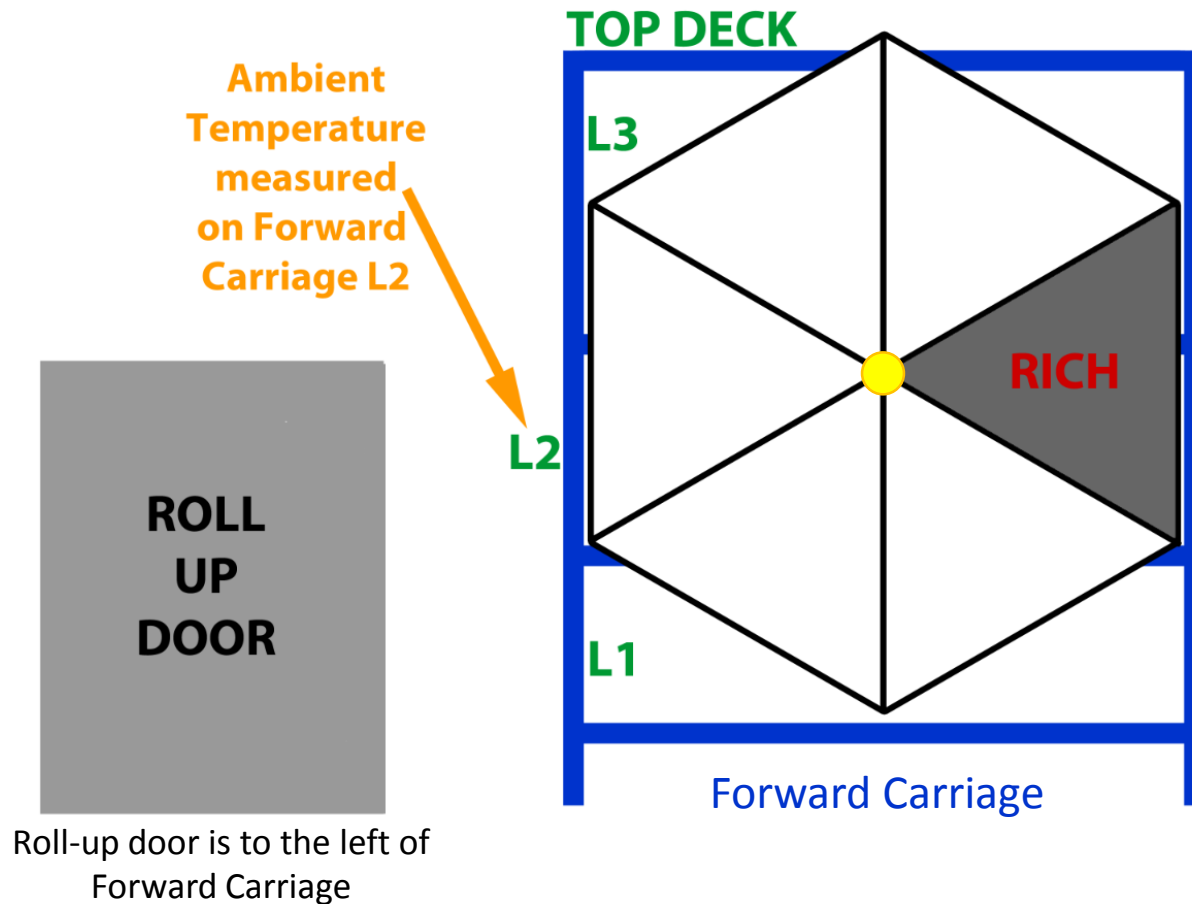
Sketch of RICH Locations in Hall B

View is looking downstream with respect to beam

- Changes in Hall B ambient pressure due roll-up door opening affecting cooling airflow.
 - Unlikely, as drop in pressure is small (only 1.5 IWC or 0.003 atm)
- Increase in ambient temperature in Hall B during day.
 - Most likely cause since Mass Flow Transducers are affected by changes in temperature.
 - Direct correlation observed between increases and ambient temperature and increases in EP temperatures.
