# RICH Spherical Mirror Reflectivity Tests

Tyler Lemon

Detector Support Group

August 30, 2017

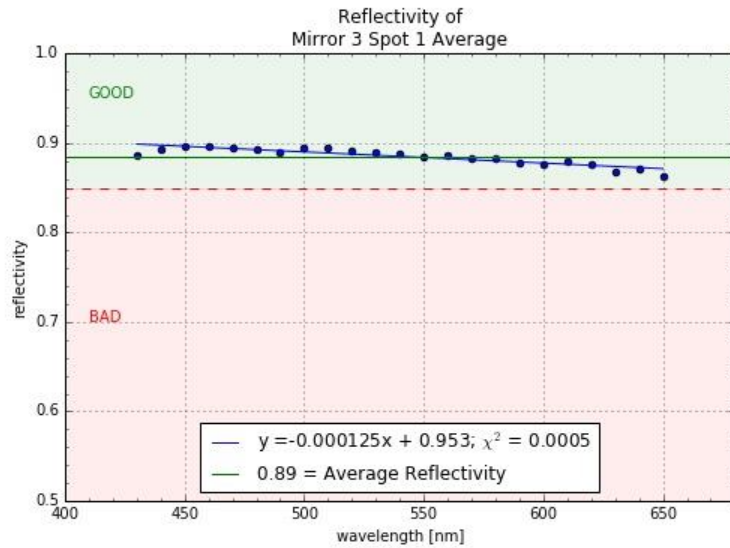
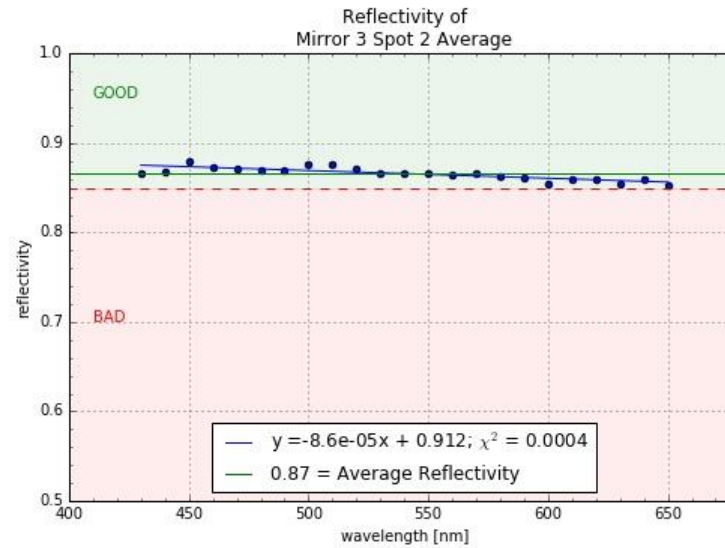
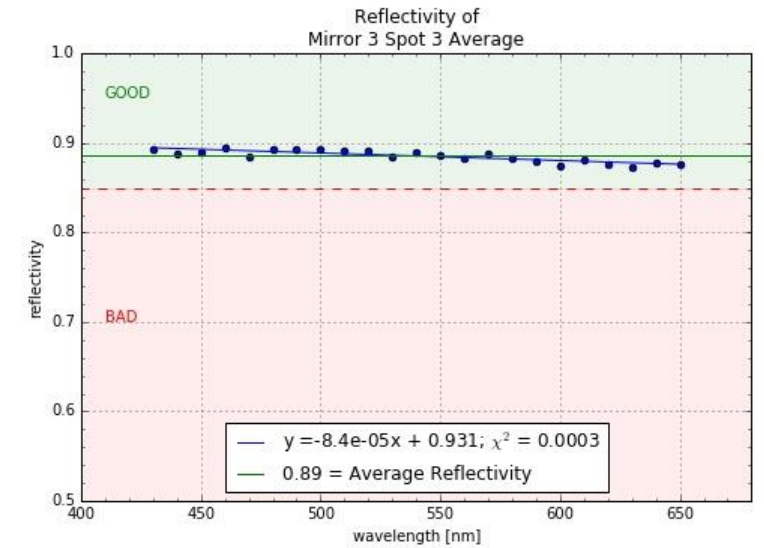
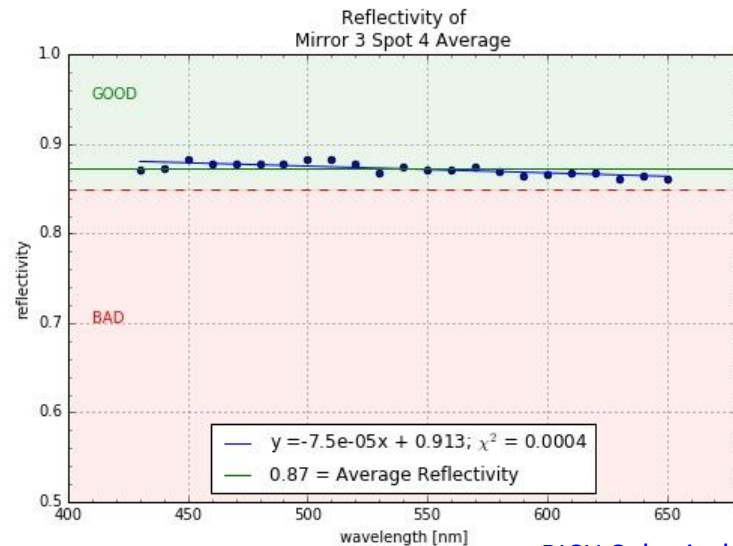
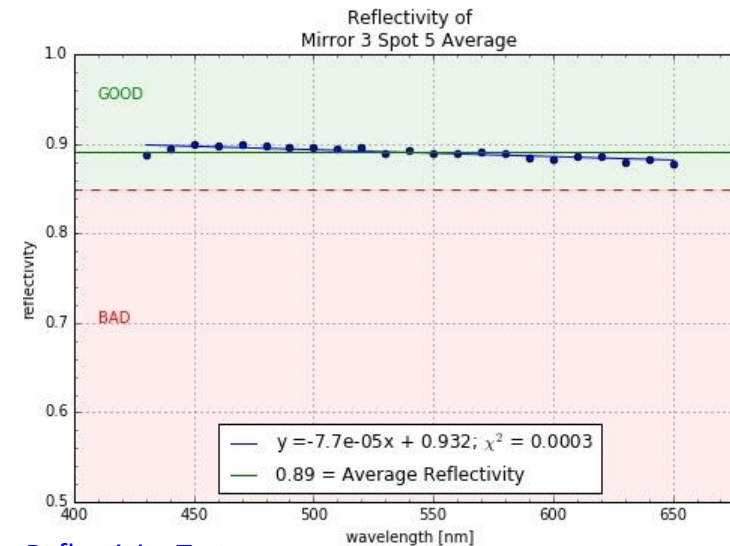
# Mirror 3 Reflectivity Results: Spots 1 – 5

Spot #	Visual Quality of Spot	Reflectivity [%]
1	GOOD	89
2	GOOD	87
3	GOOD	89
4	GOOD	87
5	GOOD	89
6	BAD	83
7	BAD	82
8	BAD	73
9	BAD	84
10	BAD	77
11	BAD	84
12	BAD	86
13	BAD	84

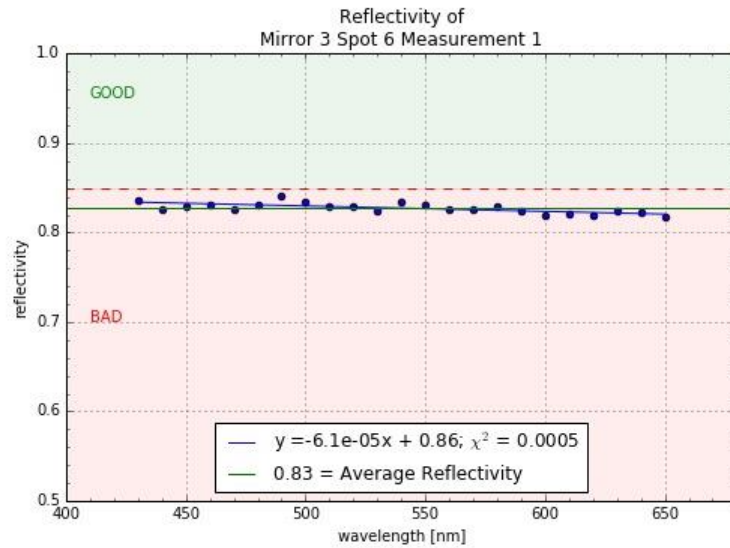
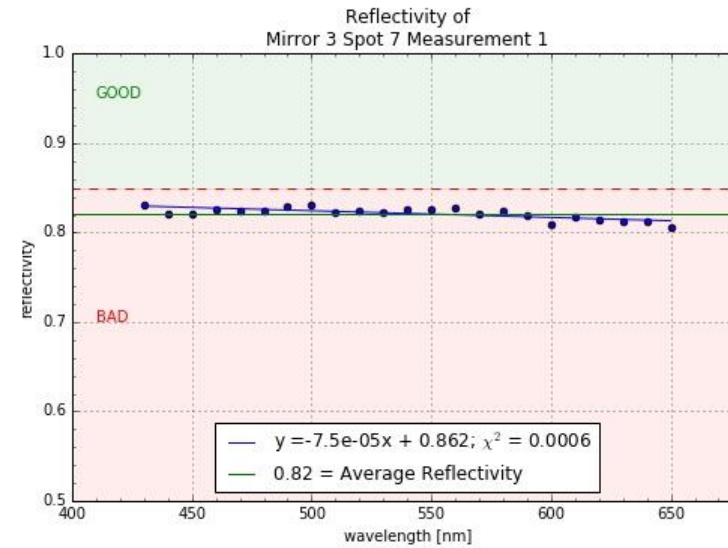
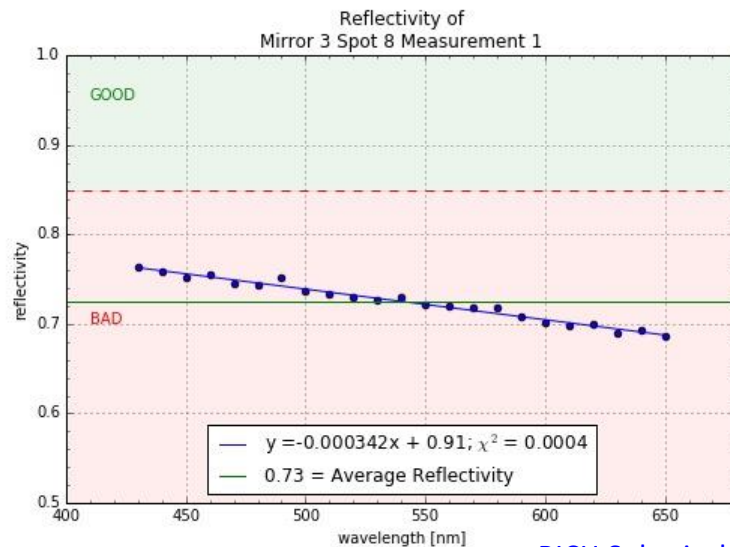
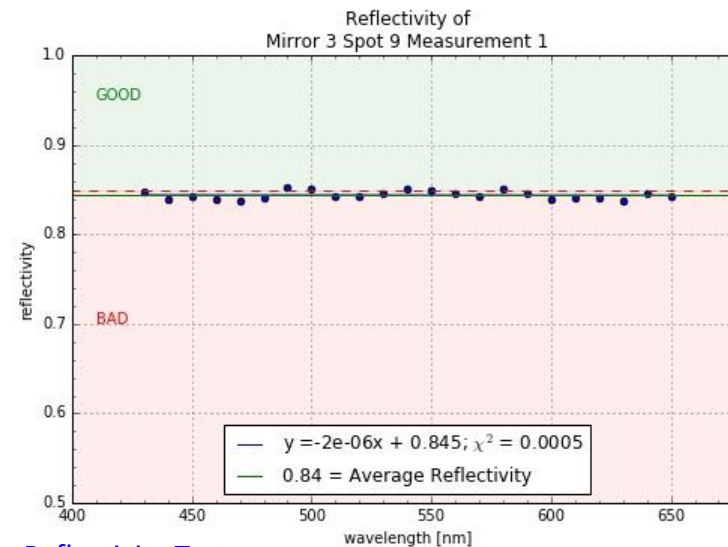
# Mirror 3 Reflectivity Results: Spots 6 – 9

**NOTE:**  
**Alignment on scratches may not have been precise enough to get bad reflectivity result.**

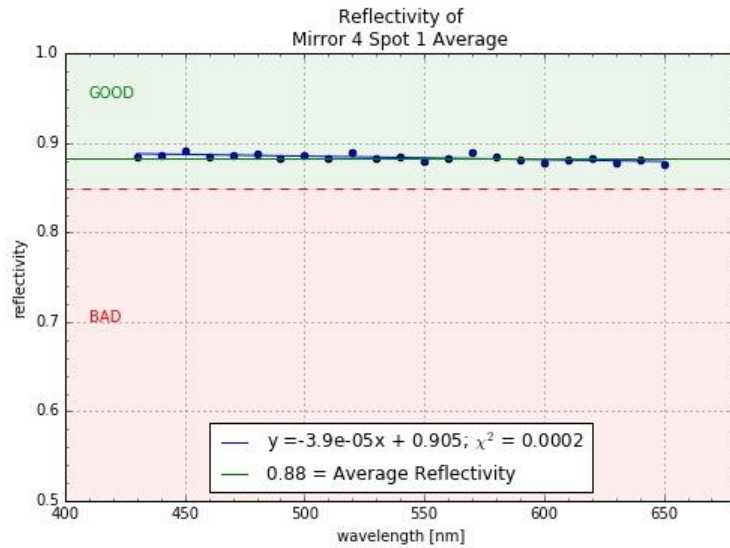
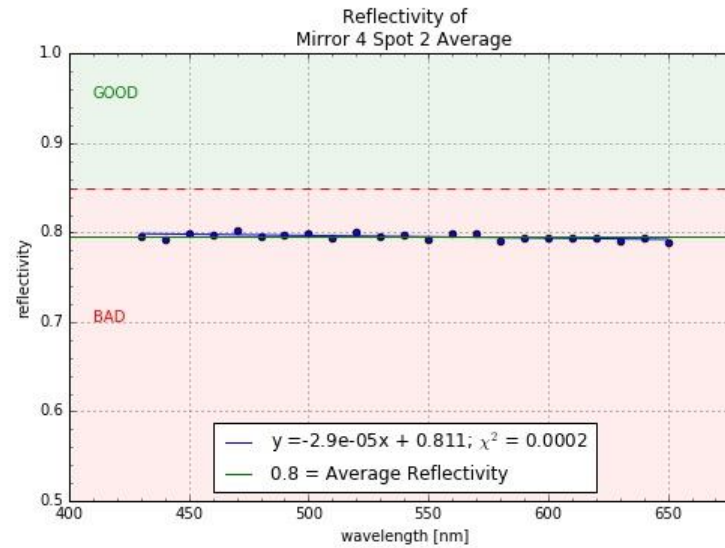
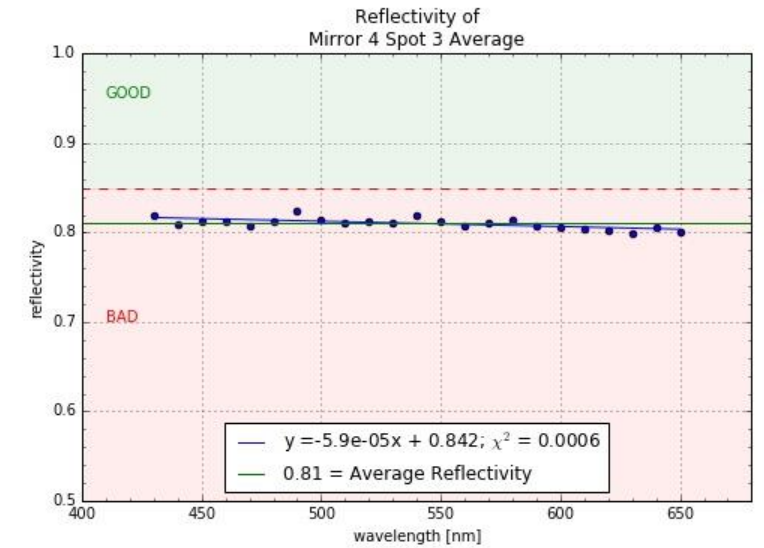
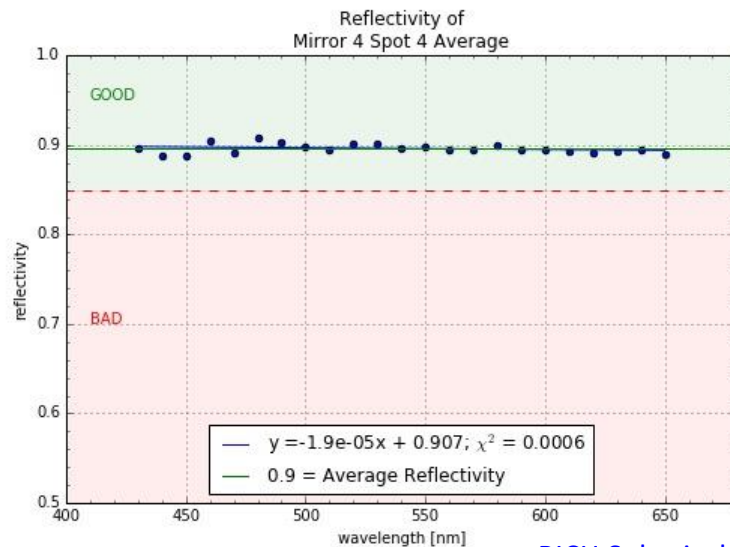
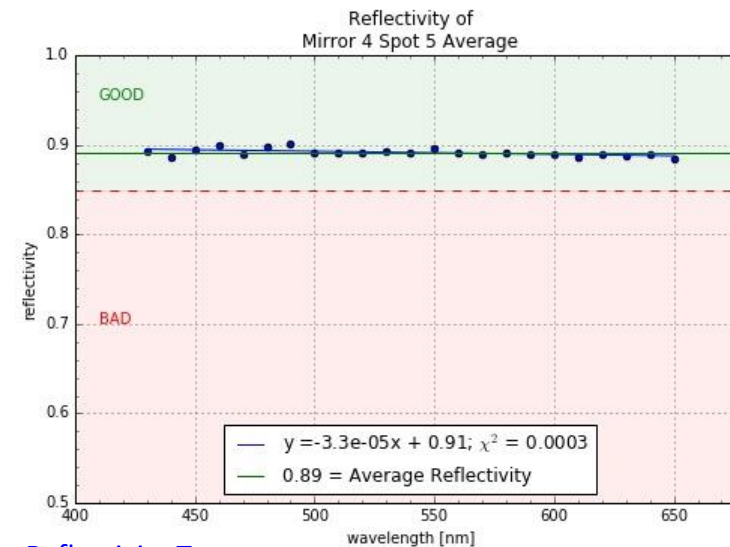
# Mirror 4 Reflectivity Results: Spots 1 – 5

Spot #	Visual Quality of Spot	Reflectivity [%]
1	GOOD	88
2	GOOD	80
3	BAD	81
4	GOOD	90
5	GOOD	89
6	BAD	77
7	BAD	62
8	BAD	67
9	BAD	67
10	BAD	81
11	BAD	76

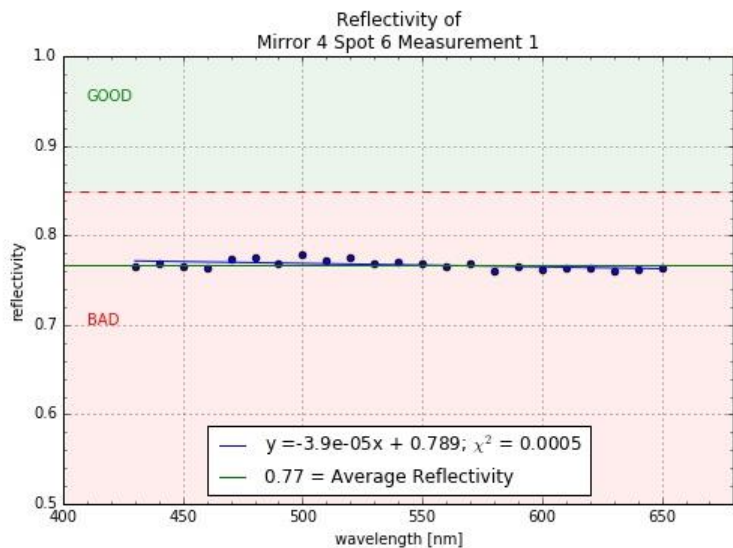
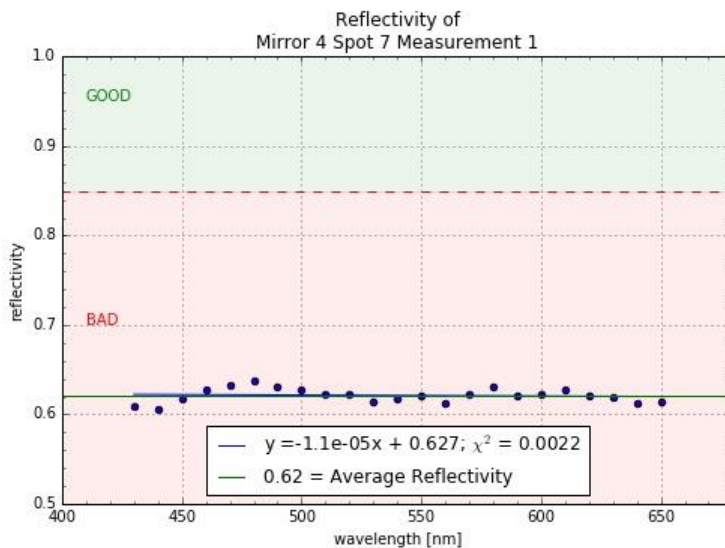
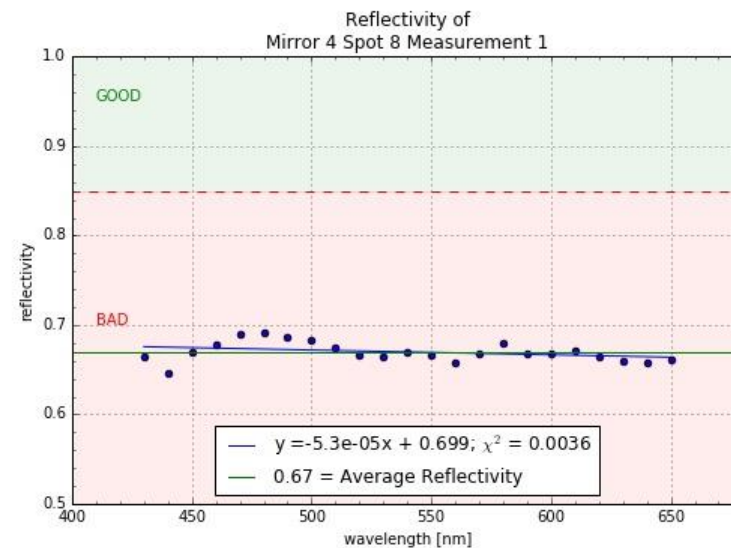
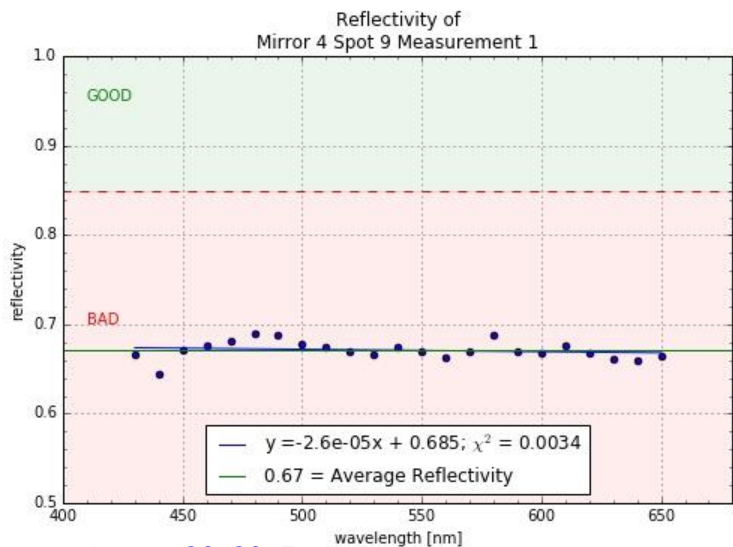
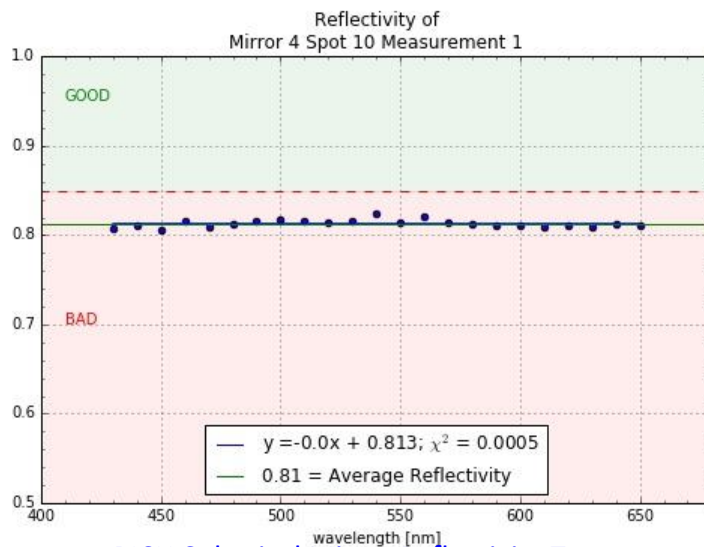
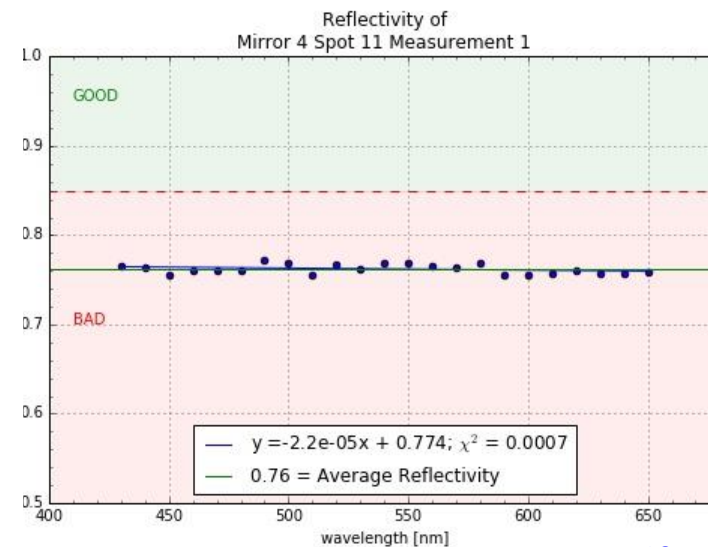
# Mirror 4 Reflectivity Results: Spots 6 – 11

- Good spots have reflectivity close to 90% specification.
  - Lower results could be due to:
    - Bad surface quality
    - Inherent error in test station alignment
- Bad spots have reflectivity ~85% or less.
  - Exceptions possibly due to alignment precision.
- Mirrors are being sent back to CMA for rework.
  - Large areas with bad surface will be fixed.
  - Mirrors 1, 2, 2C, 3C, 4C, 5, 5C, 6 at CMA.
  - Mirrors 3 and 4 shipped, will arrive August 30, 2017 at CMA.
  - After rework, mirrors go to Evaporated Coatings, Inc. for final reflective coating.
