## Report on the polarized target failure

### ***Brief Description of UVa polarized target***

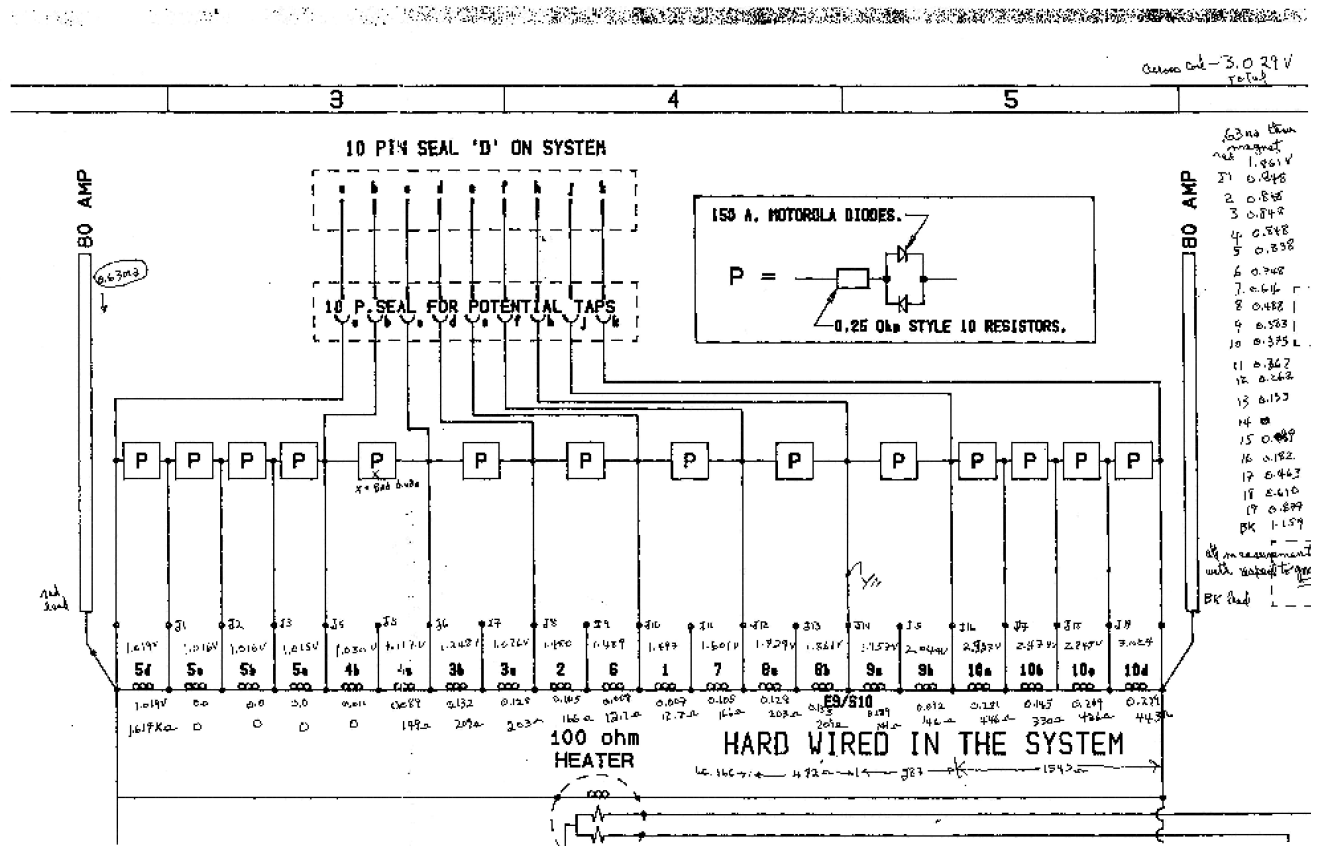
Fig. 3 is a circuit diagram showing how the coils are connected together and how the quench protection is incorporated. The quench protection circuit consists of a 0.25 Ohm resistor and pair of barrier diodes (denoted by “P” in Fig. 3). One half of the Helmholtz pair consists of 10 coils ( labeled 5a-d, 4ab, 3ab, 2 and 6 in Fig. 3) and the other half is matching set of 10 coils ( labeled 10a-d, 9ab, 8ab, 7 and 1 in Fig. 3). Leads for the superconducting coils are brought out of each coil and superconducting connections

are made from one coil to the next at the top of the magnet. The superconducting joint is made by soldering together the ends of 4ft of cable (from each coil) that has been first twisted together. This joint is placed in a cup that is then filled with Woods metal and a connection to the quench protection circuit is made. Taps are connected to circuit at selected points for diagnostics (This is indicated as 10 pin seal "D" in Fig. 3). The lead from the power supply is connected to coil 10d and the opposite power supply lead is connected to coil 5d. The power supply leads are connected in parallel to the persistent switch (resistance of 100 Ohms).
