Notable Event Worksheet

Title of Event			
Event Title:	Potential Electrical Hazard in Building 36		
Date and Time of Occurrence:	June 20, 2012 Approximately 10:30am	<u>Notable Event Number:</u>	ENG-12-0620
Event Location:	Building 36, Room 102	Date Notable Event Report is Due*:	07/20/2012

Building 36 Electrical Incident Causal Analysis
06/22/2012

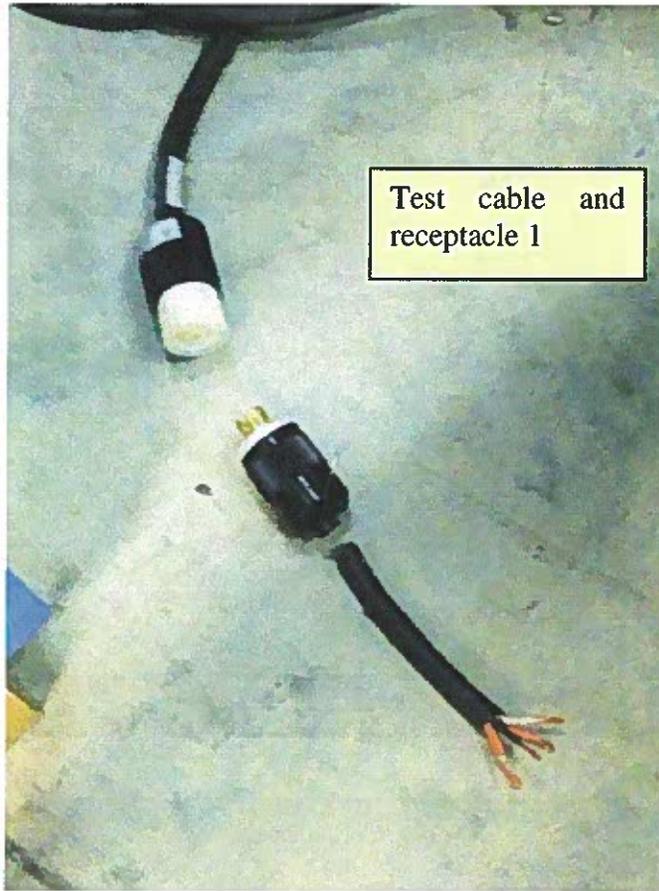
Associate Coordinator and Engineer arrive at about 10:25am and install a power supply to test into rack TL05B06.
 Engineer plugs the power supply into another unpowered receptacle (Rec. 2) in rack TL05B06.
 Associate Coordinator energizes the receptacles by turning on the P2 breaker associated with Rec. 1 and Rec. 2.
 P2 breaker immediately tripped. It was later discovered that the upstream breaker (L4/7,9,11) also tripped.
 Upon investigation of the cause the Associate Coordinator and an Electrical Tech II, who was in the area, discovered the practice cable installed in Rec. 1. This cable had an assembled connector on one end but the other end had bare exposed wires, which shorted, causing the fault.
 Engineer attempted to reach for the cable and was stopped by Tech II.
 Associate Coordinator verified the power was off with a volt meter.
 Associate Coordinator removed the cable and the Engineering Support Manager cut the cable, making certain it could not be used again.

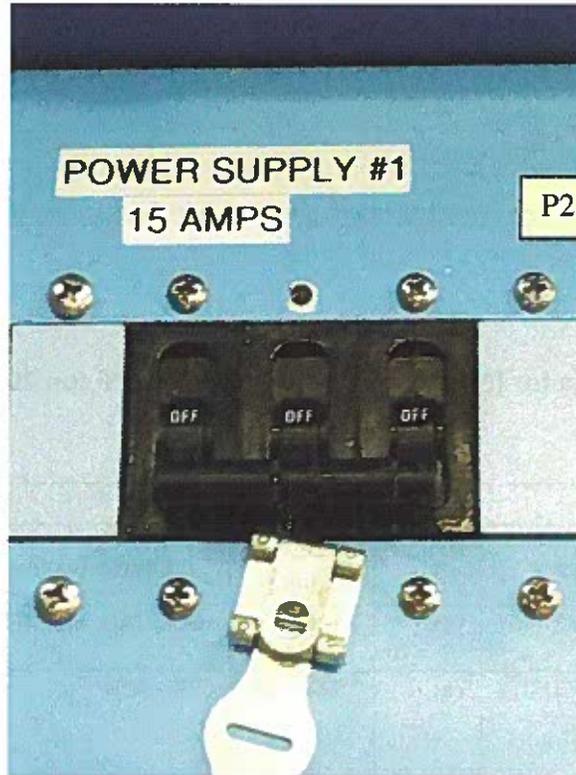
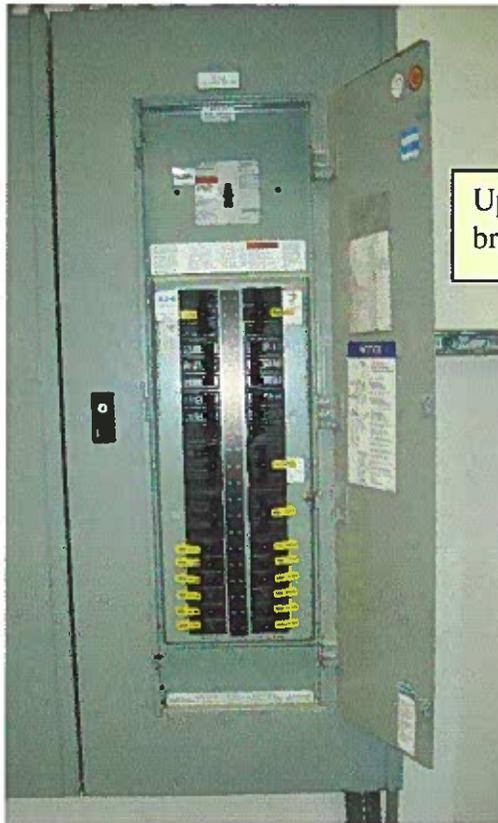
I was making some new AC connector yesterday afternoon around 5pm, I tried to test if the new plug was fit and tight enough, and forgot to unplug it before I left work. [Associate Coordinator] turned on the power switch this morning and tripped the circuit breaker, after we reclosed it, the power is back. This is what [the Engineering Support Manager] told [the Associate Coordinator] and me this morning, quote "Nobody is insured [*he meant injured*] and it's not a big incident to report". I apologize if this has caused a problem to any of you.
