**Notable Event Report**

Title of Event			
<b>Event Title:</b>	Employee Shocked While Using a JLG Manlift- No Injuries		
<b>Date and Time of Occurrence:</b>	08/29/2016 ~ 10:00AM	<b>Notable Event Number:</b>	PHY-16-0829
<b>Event Location:</b>	Hall A	<b>Date Notable Event Report is Due*:</b>	09/29/2016

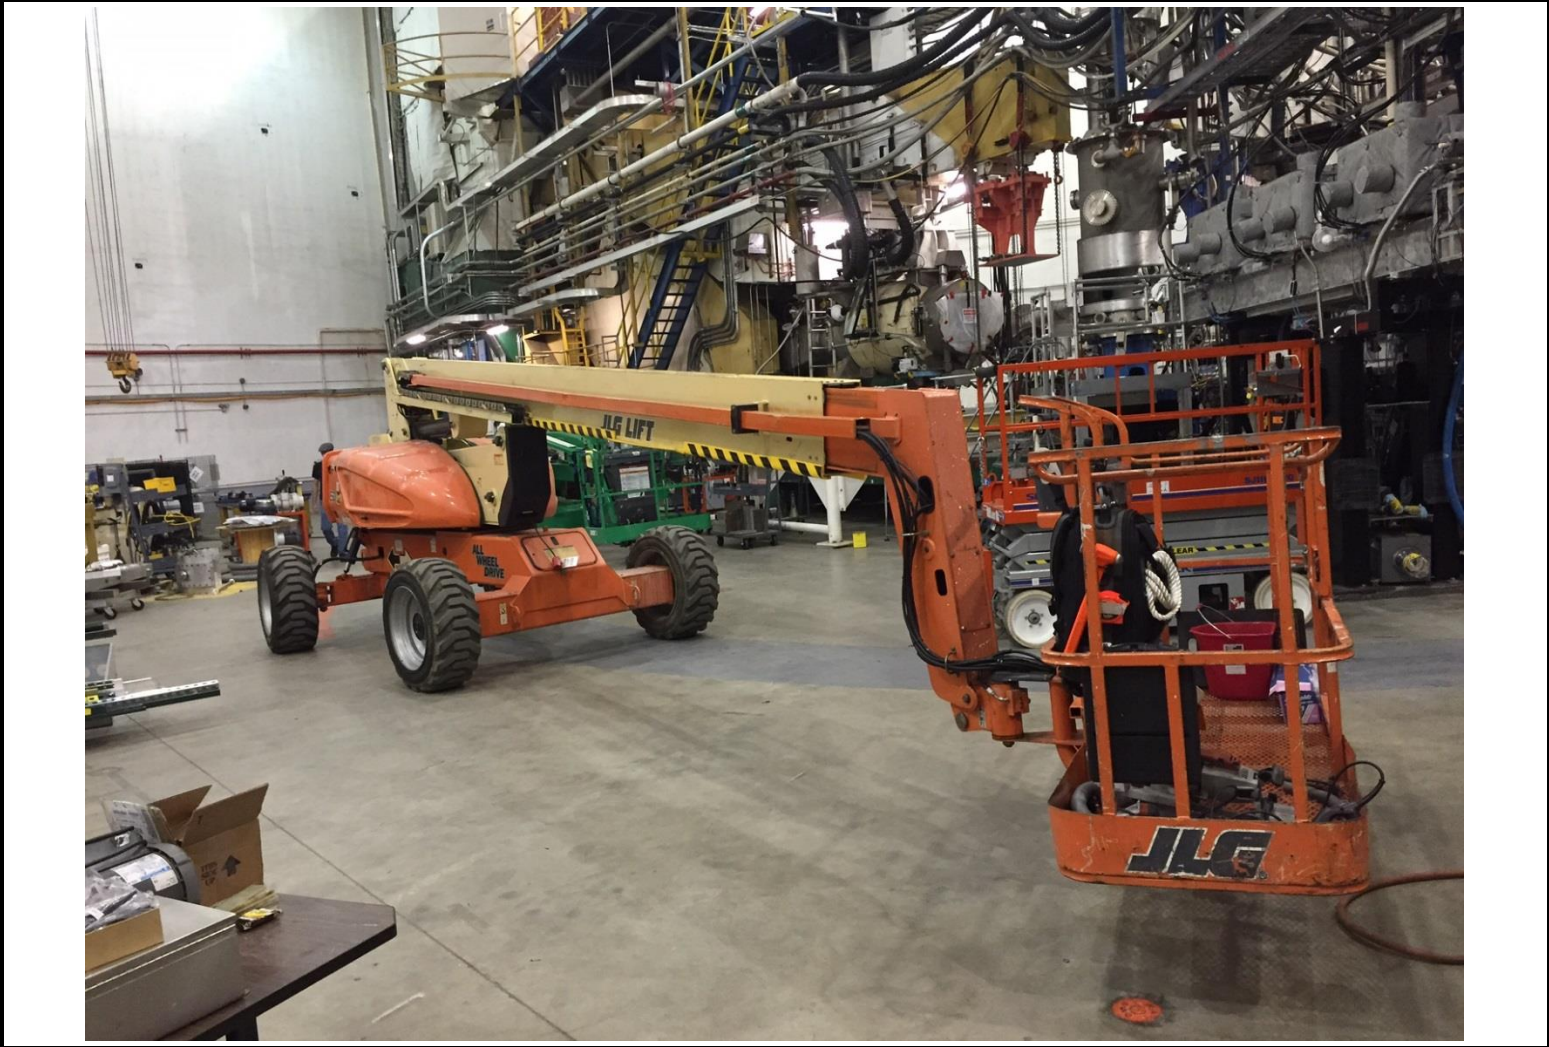
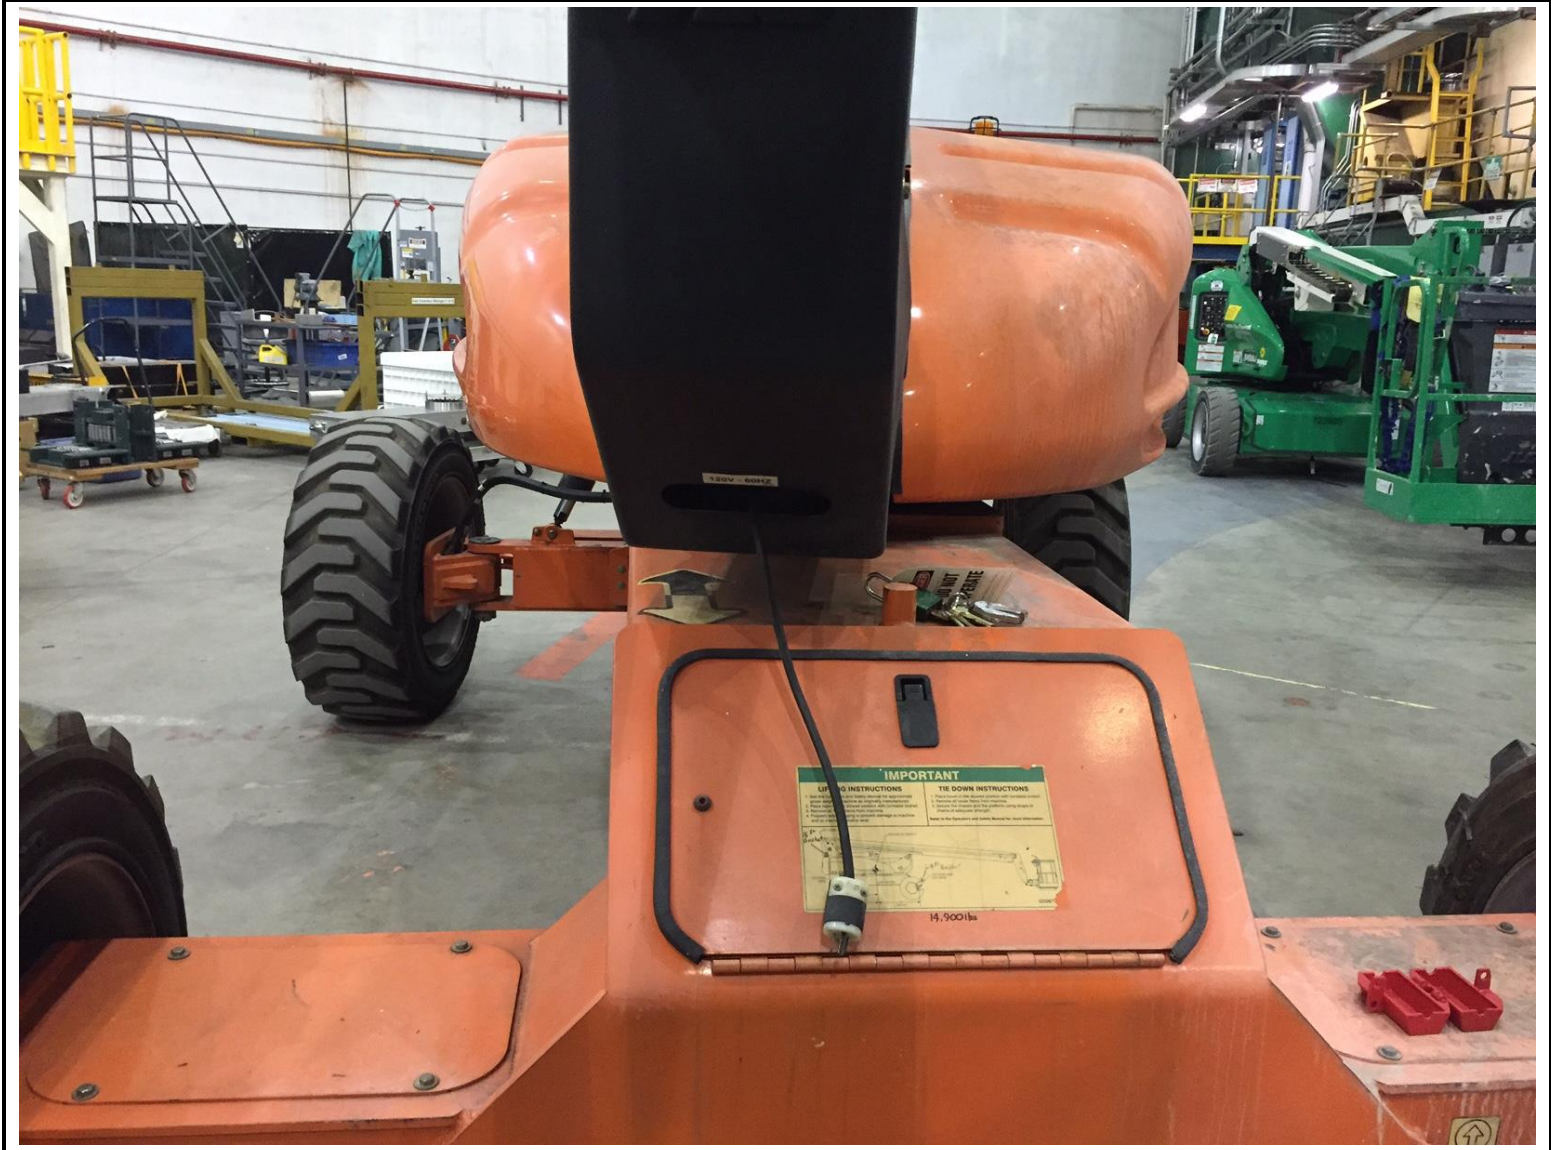
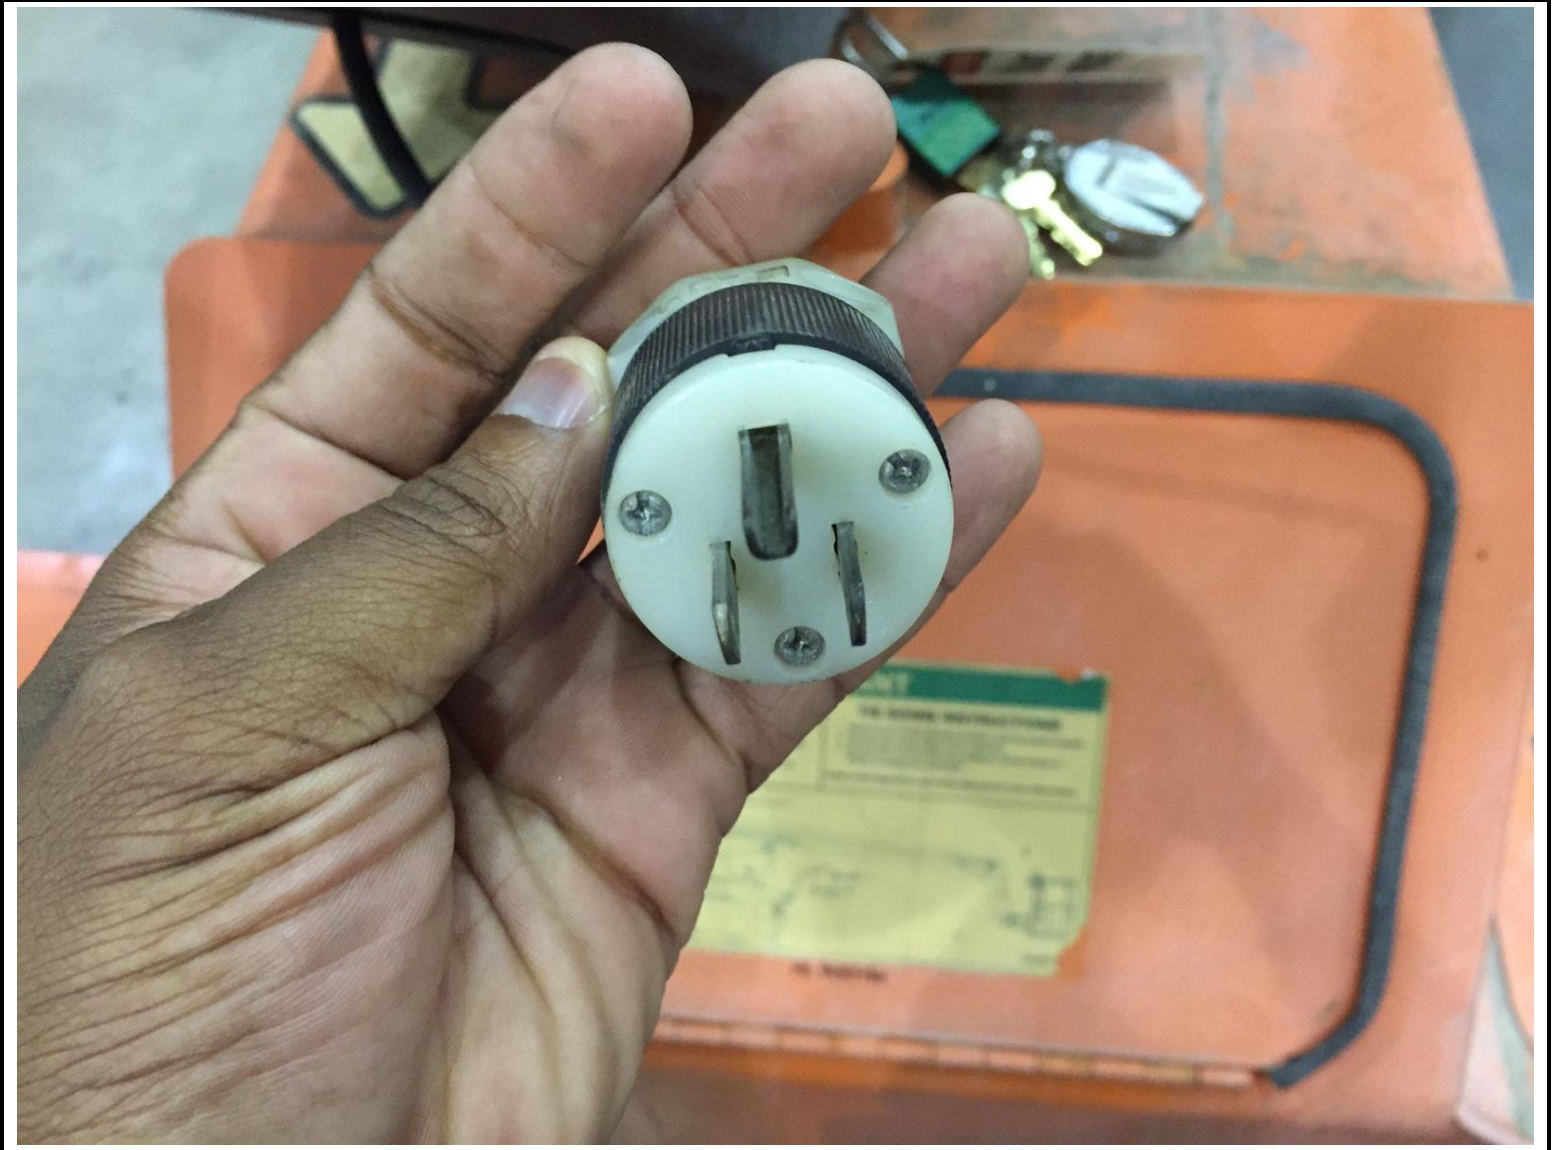
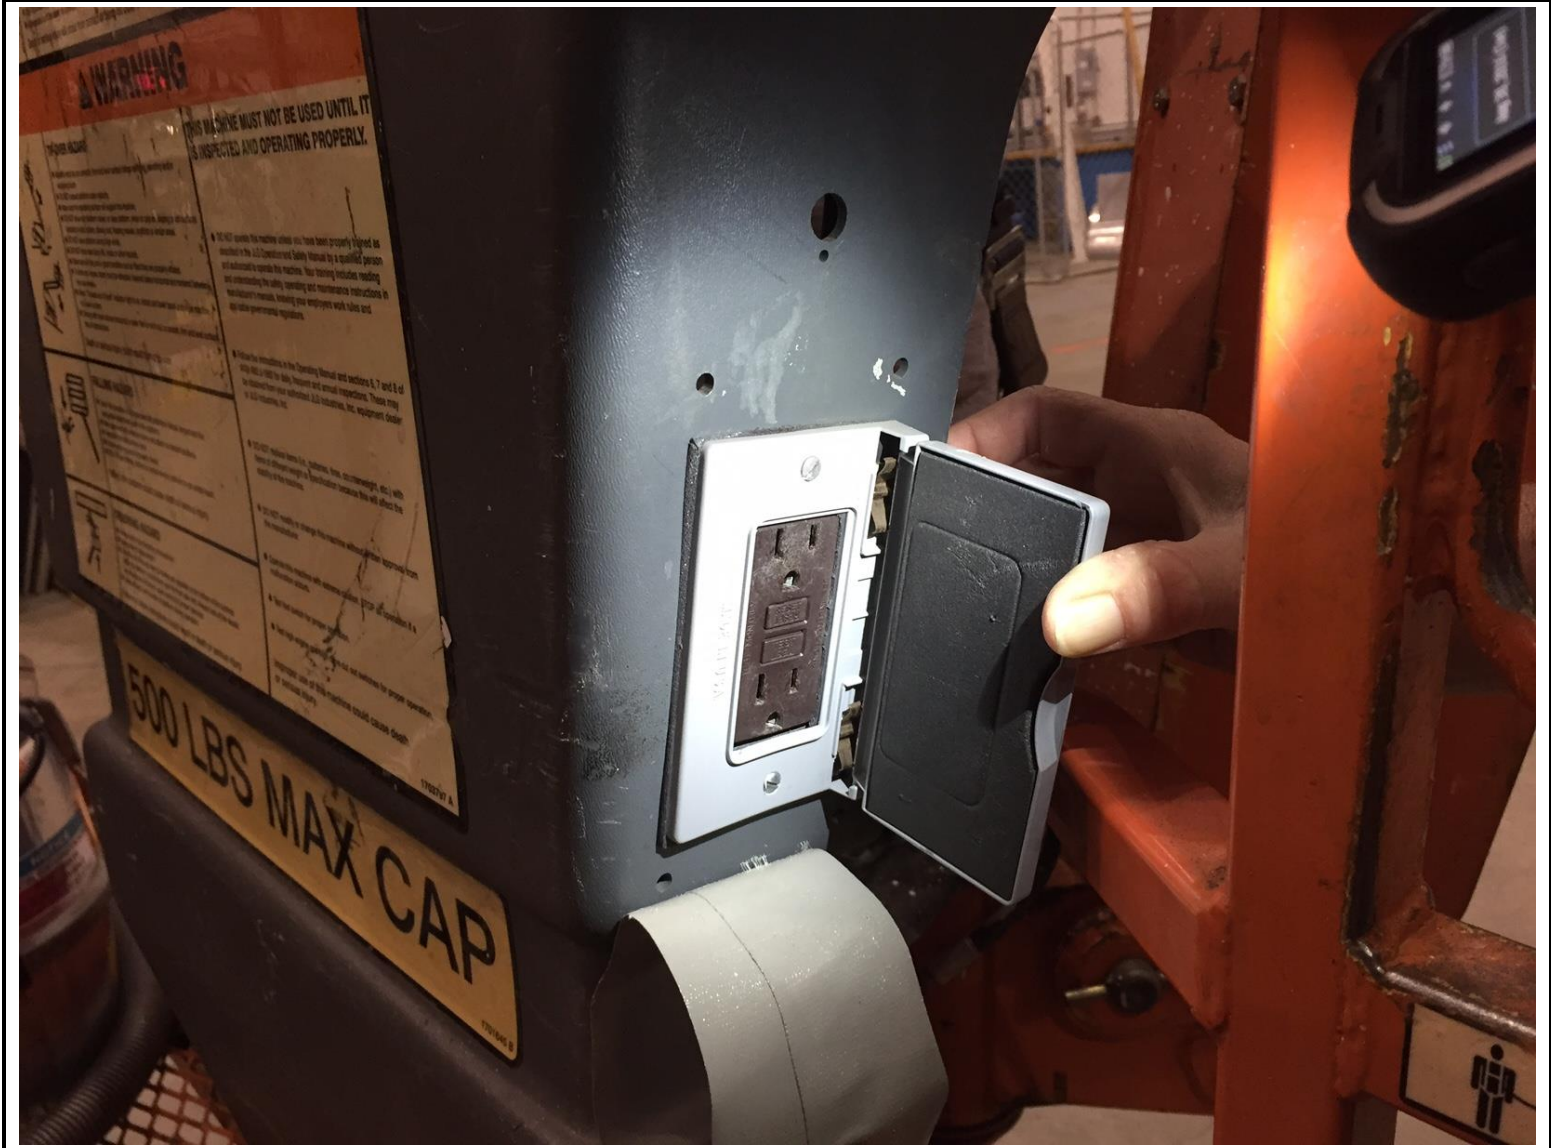
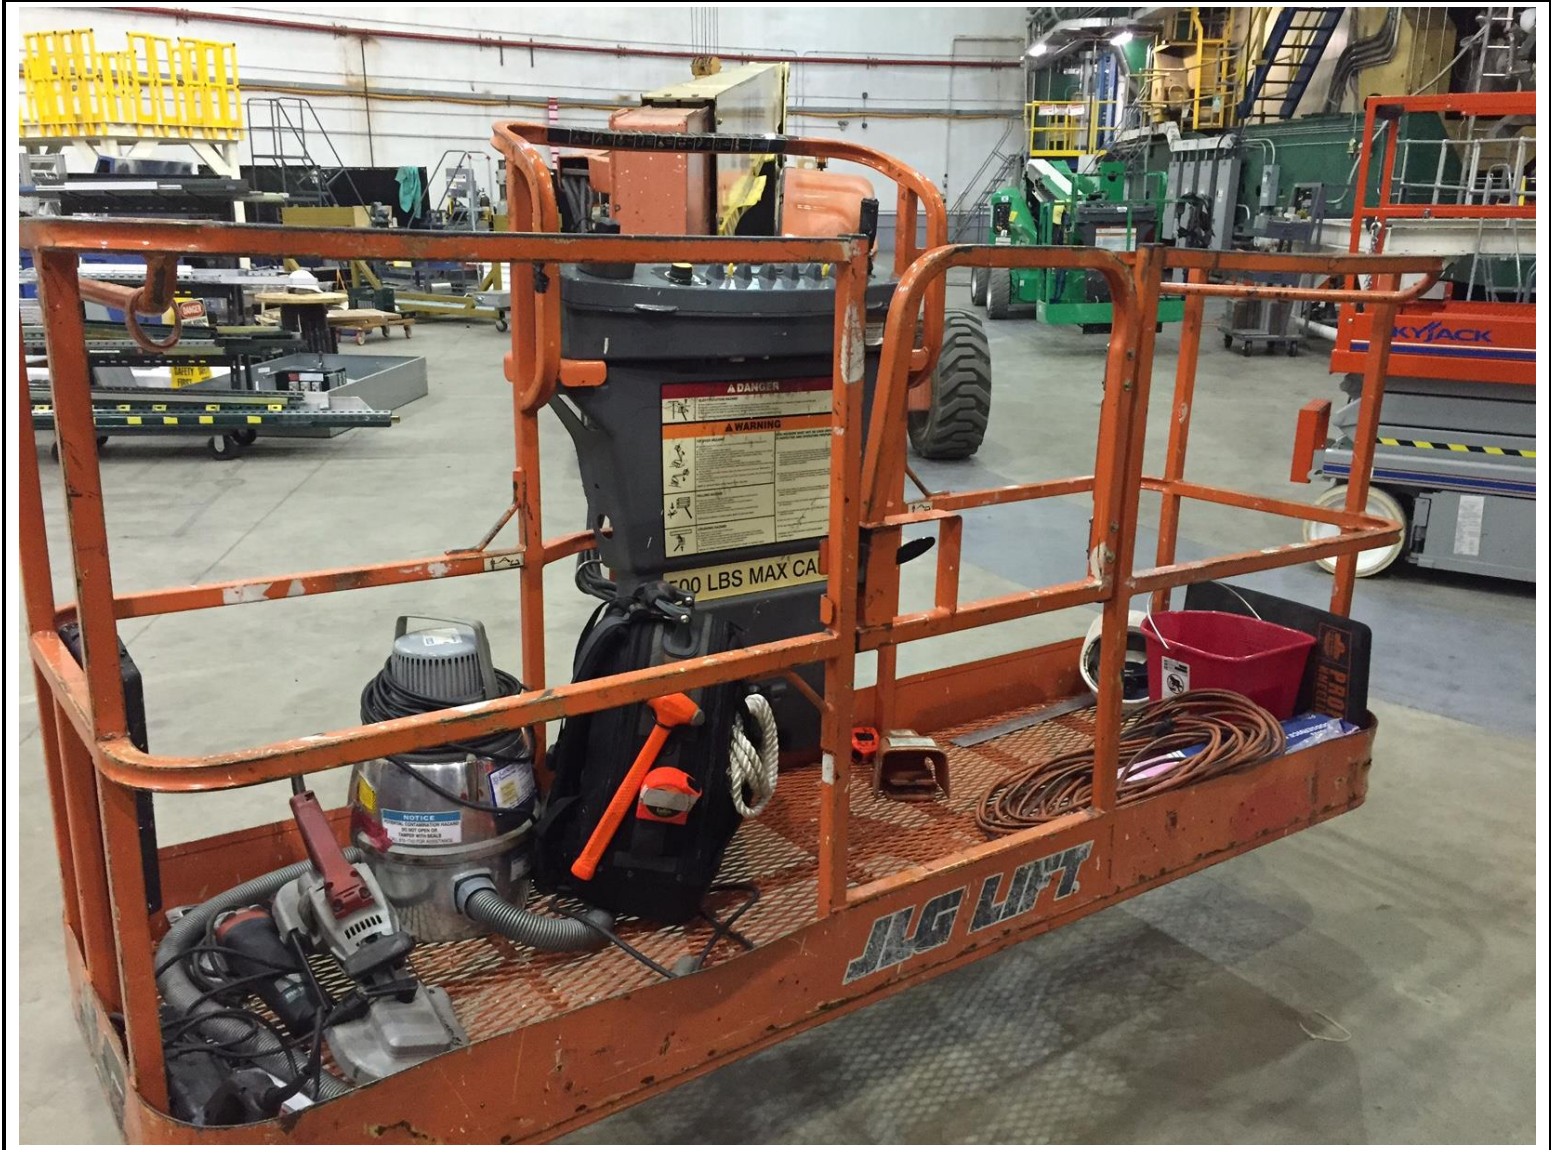
**Records, Documents, Pictures, and Other References:** (Copy and paste, use attachments or document links as necessary)

The manlift was tested and it revealed approximately 48 volts AC (VAC) from the structure of the man lift to an earth ground. The connection to the manlift 120 volt circuit was locked and tagged out. There was no indication of damage to the manlift or the electrical system. Facilities Management and Logistics subcontractors inspected the equipment on August 30, 2016 and it was determined by process of elimination using a volt/ohm meter that the internal power cord must be damaged. When the internal power cord was plugged in to 120 volts AC wall power, there was a repeatable 48 VAC between the body of the man lift and earth ground and then when power was removed from the internal power cord the 48VAC disappeared. Discussions with hall staff and the Facilities Management and Logistics subcontractors determined that the internal cord had leakage to the body of the man lift. The internal cord was replaced.

A check of the Hall C manlift was also checked since the internal power cord was also replaced and it also was exhibiting ~30 VAC to earth ground when the manlift was powered through a 120 volt wall receptacle.

After further follow up investigation it was determined that the 30 VAC may be from what the industry refers to as a “Ghost” voltage. Ghost voltages occur from having energized and non-energized wiring located in close proximity to each other, such as in the same conduit or raceway. This condition forms a capacitor and allows capacitive coupling between the energized wiring and the adjacent unused wiring. In the case with the JLG manlift, the 120 volt internal cord is ran alongside and bundled with other cords and hydraulic lines.

The final disposition is the ~30 VAC being measured is a “Ghost” voltage that is capacitively coupled from the energized internal power cord and that was being recorded with a high input impedance multimeter. Since the “Ghost” voltage is a physical phenomenon involving very small values of capacitance, it cannot energize a load or cause physiological damage to a person.

Corrective Action(s)	<u>JLab CATS Number</u>	Target Date	Action Owner
Have the contractors inspect, diagnose and fix the failure in the defective manlift.  Evidence of completion: Report or email from contractor with the results	NE-2016-18	10/30/2016	Manny Nevarez
ISM poster to increase awareness of the requirement and proper use of GFCI protection when using extension cords to supply power to equipment used by a worker.  Evidence of completion: ISM poster.	NE-2016-18	1/31/2017	M.J. Bailey
