Notable Event

Event Title: PHY-21-0721-Student Receives two 120V shocks - No injury

Date Submitted: 08/02/2021 02:01:05 PM

Event Location: 90_1.109

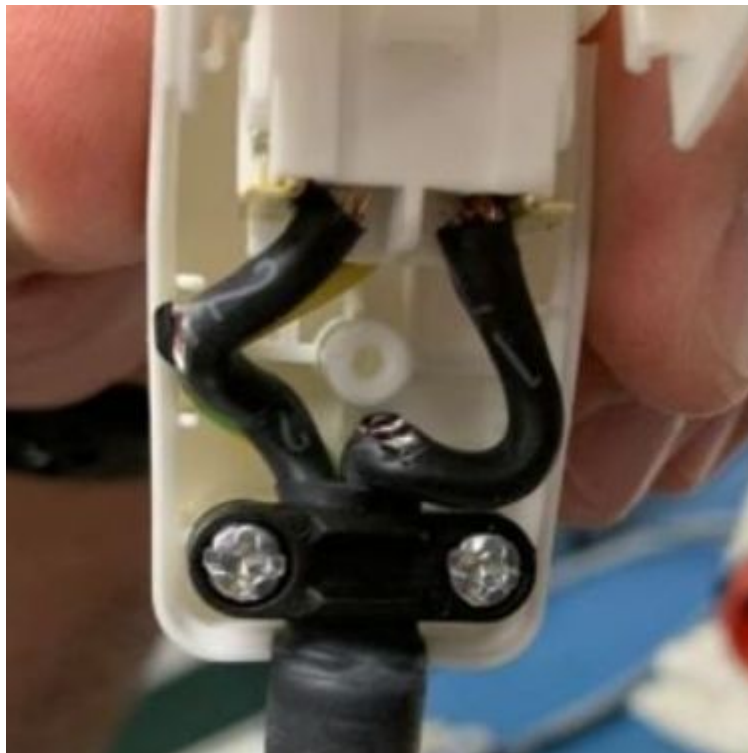
A preliminary investigation found the student was shocked when they touched a defective 120 volt plug supplied by the manufacturer with the VME crate. After the event, the suspect plug was disassembled and the insulation of a conductor was found to have been penetrated by a retaining screw on the plug shell when it was fabricated. This defect would expose anyone touching the plug to 120 volt and would not have been recognized by visual inspection only.

A student received two 120V shocks because a Cannon-plug lock-ring was installed incorrectly by the manufacturer and did not "lock" the plug into place (see Photo 1). Instead the lock-ring could rotate and the "hot" channel could be inserted into the "ground" channel and energize the crate. The discovered defects were not visible at the time of the incident.

The Jefferson Lab Technical Representative notified the vendor of the two failure modes, with pictures and explanation of events.
