EIC Beamline Teststand Sensor Upgrade

Marc McMullen
2023-07

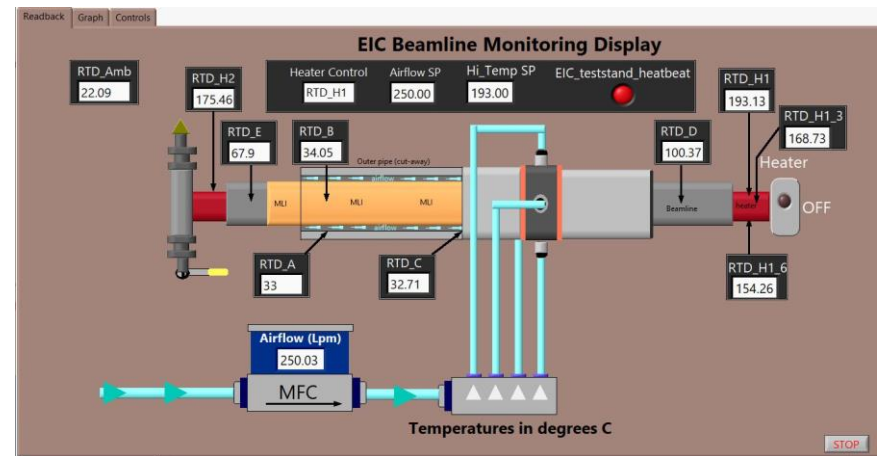
The EIC Beamline GUI was updated with the additional RTDs on the heater pipe (RTD_H1_3 and RTD_H1_6)

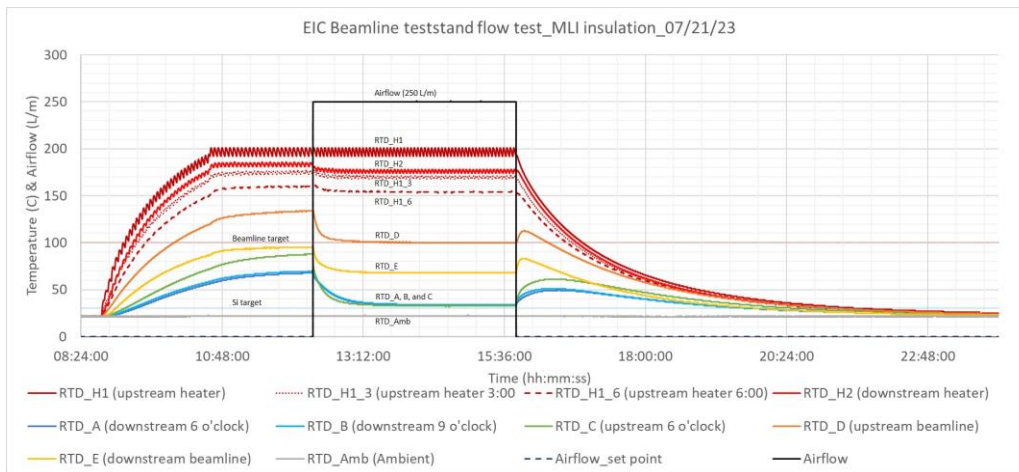
A plot from 07/21 shows the teststand temperatures have stabilized during a ~3 hour flow test. The beamline is at 100°C, while the Si surface is ~32°C.
