Detector Support Group

Weekly Report, 2017-09-13

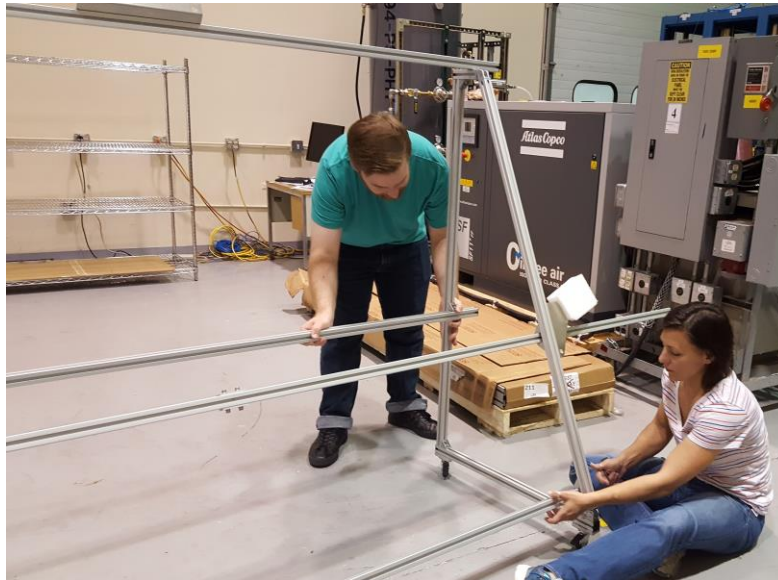
Mindy Leffel and Tyler Lemon assembling RICH frontal panel assembly cart.

- Frontal panel assembly cart assembled.

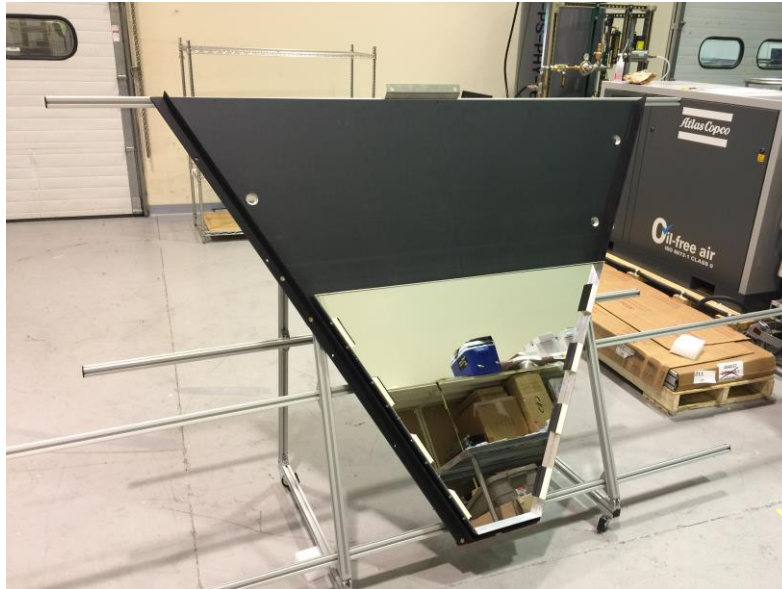
Lower RICH frontal panel with a planar mirror anchored to panel.

- Lower frontal panel with planar mirror test-installed on assembly cart.

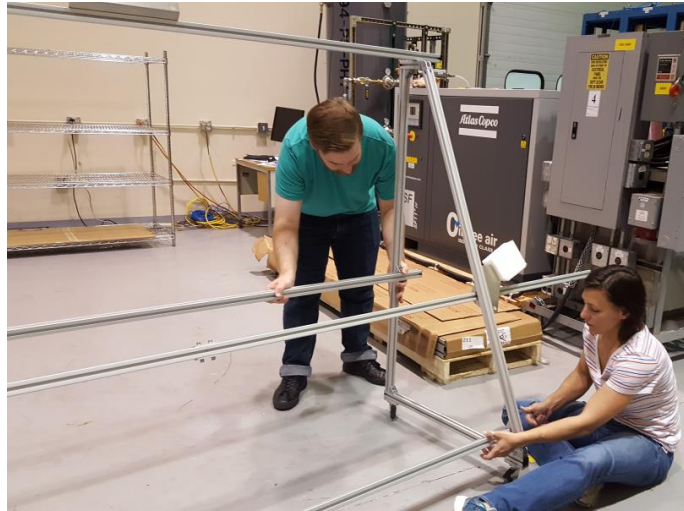
Mindy Leffel and Tyler Lemon assembling RICH frontal panel assembly cart.

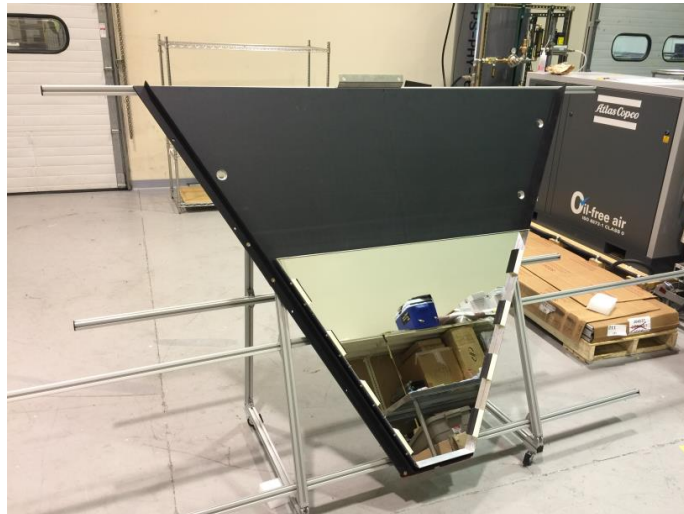
- Test-installed lower frontal panel with planar mirror on assembly cart.
 - ★ Panel and mirror test-fit to check mirror anchors.

Lower RICH frontal panel with a planar mirror anchored to panel.
