# Detector Support Group

## Weekly Report, 2018-03-21

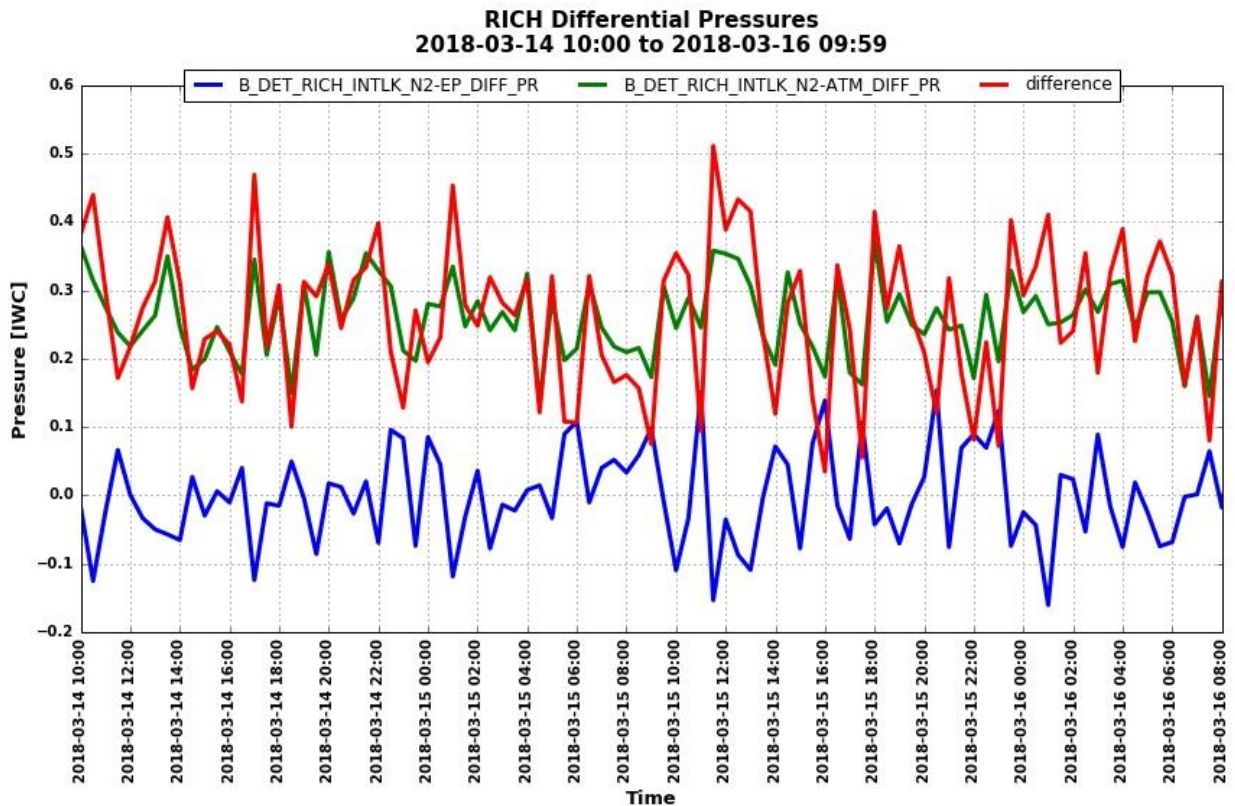
- ★ Plot shows signals from N2-ATM differential pressure transducer (green, average:  $0.258 \pm 0.061$  IWC), N2-EP differential pressure transducer (blue, average:  $-0.002 \pm 0.068$  IWC), and difference between the two pressure transducer readings (red, average:  $0.260 \pm 0.107$  IWC).
- ★ The difference between the two pressure transducer readings is an approximation of the pressure inside the EP. For both N2 volume and EP volume, pressures are above atmospheric pressure, indicating RICH as a whole is over-pressured and external air is not being taken in through the bubbler or through leaks.

- Third cRIO chassis complete.
- Readout indicators added for differential pressure transducers and air-cooling buffer tank water concentration to Hardware Interlocks EPICS screens.
- Plot generated for differential pressure transducers.
