Summary

Detector Support Group

Weekly Report, 2020-01-29

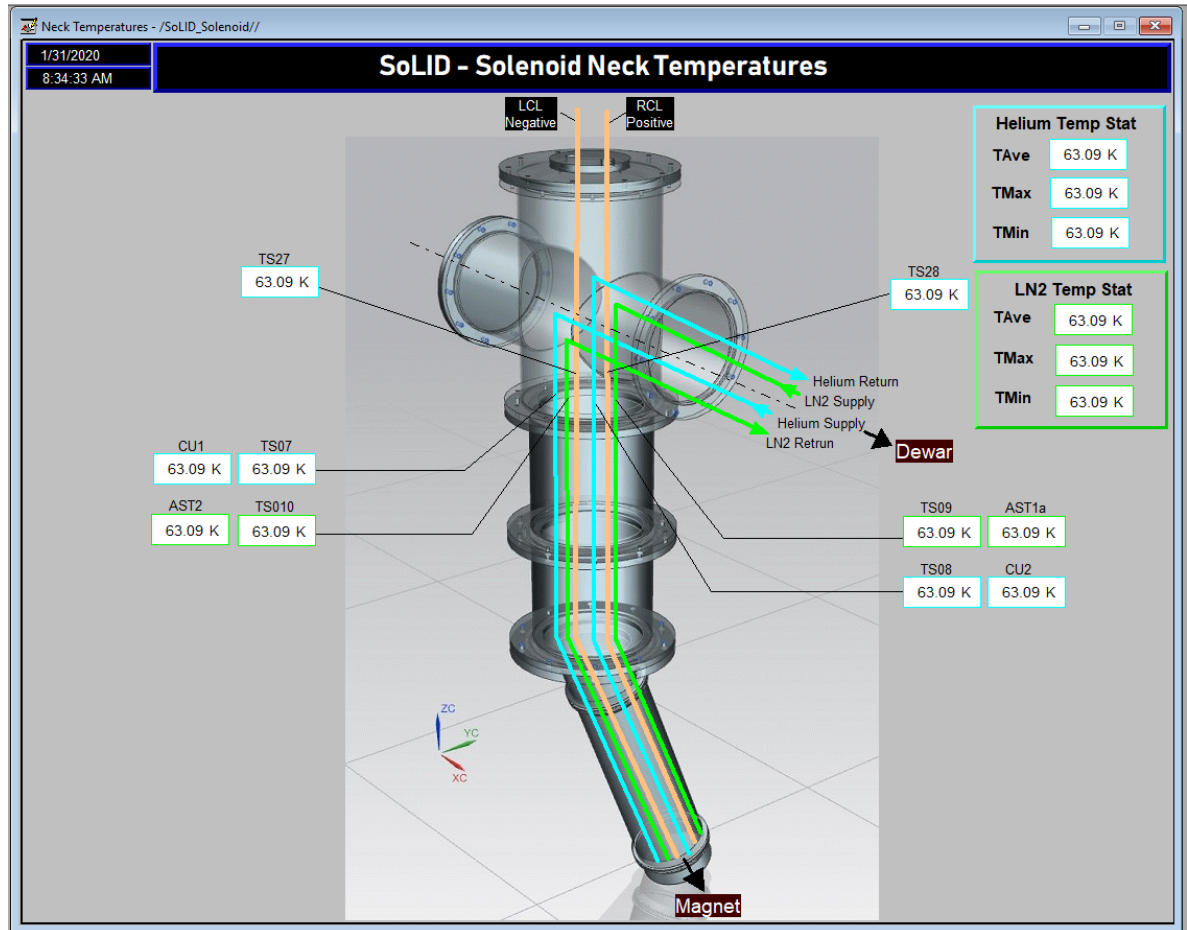
- Reviewed design and the components of the Constant Current Source (CCS) PCB.
- Developed CCS circuit simulator program to confirm operation of board design.
- Completed isometric view of the SoLID magnet “Neck” section in NX12.
- Developed HMI screen to show temperature sensors’ location in the Neck of the magnet

SoLID Solenoid Neck Temperature screen

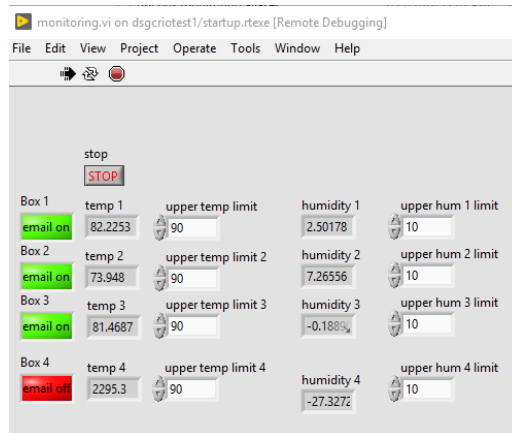
- Set up monitoring cRIO to notify if humidity in the aerogel storage dry boxes increases
 - ★ Box 1 and 3 work fine; box 2 has leaks.

Screenshot of cRIO program running while monitoring dry boxes. Only dry box 1-3 are monitored.

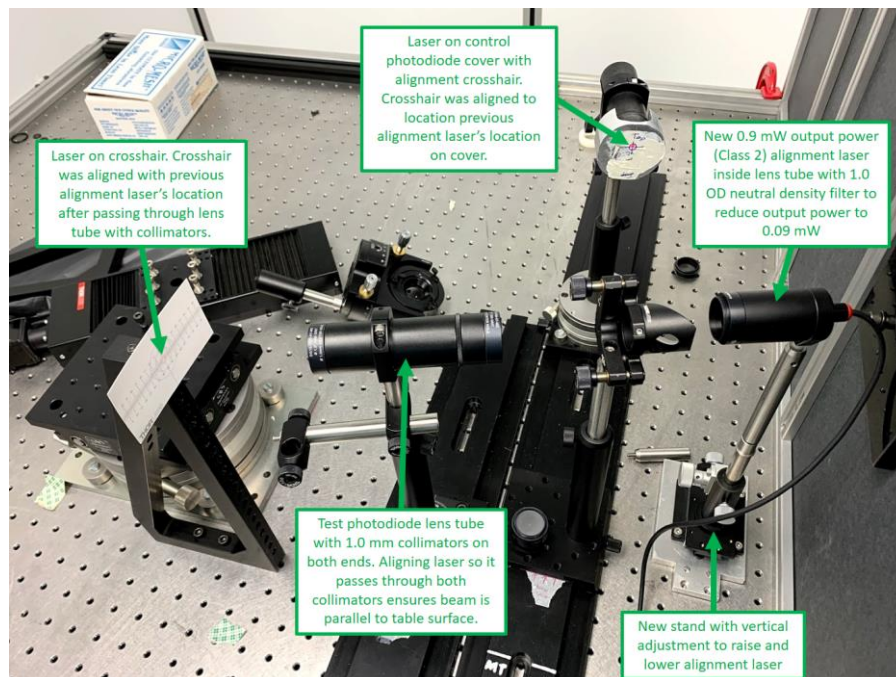
- Procured and set up a new alignment laser in mirror reflectivity test station.
 - ★ New alignment laser is moved in and out of place using a vertical adjustment knob on its stand, allowing it to be consistently moved into the correct location.

New alignment laser in reflectivity test station.

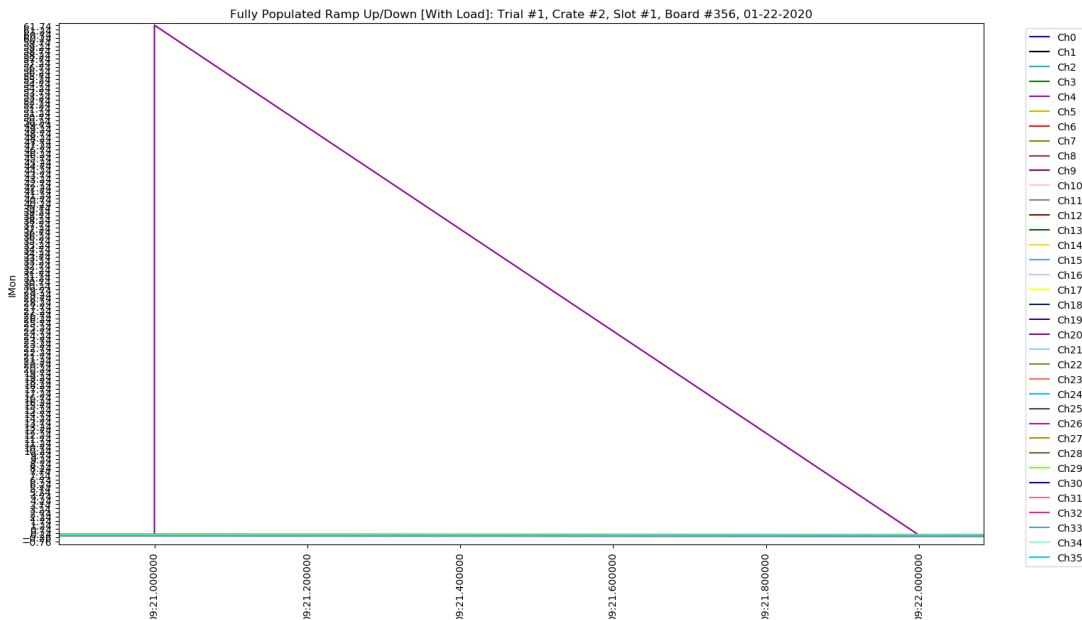
- Completed bread board test for multiplexer circuit.
- Started schematic and printed circuit board parts creation for the multiplexer circuit.
- Noted a one-second, 61.78 μA current spike Channel #20 on Board #356 in Slot #1 of *hvcaentest2* during a fully-populated ramp test with load connected to a different board

- ★ Channel set to output 1500 V at time of spike.
 - ★ Since load was not connected to board, the current should have been ~0 μA
 - ★ The board that was connected to the load (Slot #0 Board #353) had no issues

Monitored current for all 36 channels of board #356 in Slot #1 of *hvcaentest2* during ramp test showing one-second, 61.78 μA current spike of Channel 20 (pink).

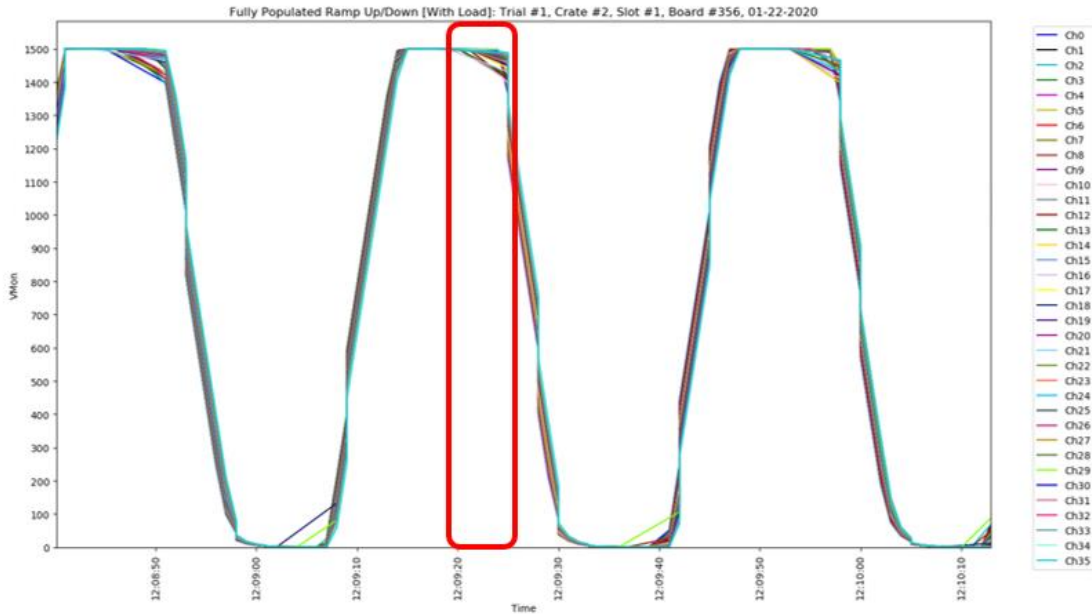
Normal and expected voltage behavior for all channels on Board #356 in Slot #1 during test. Approximate location of current spike on Channel #20 denoted by red box.

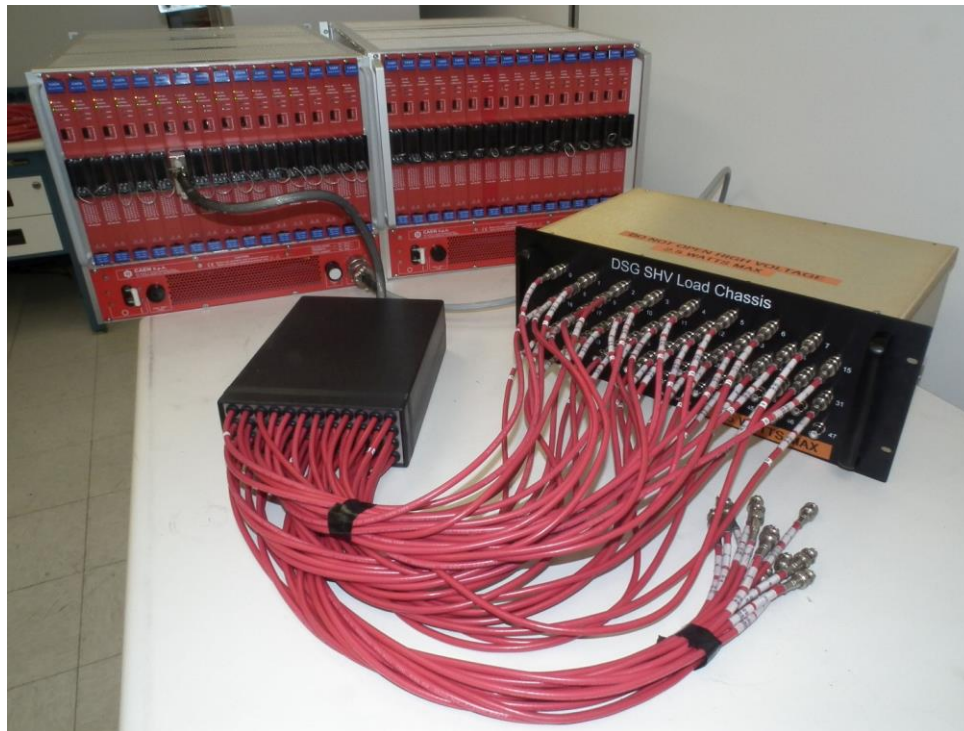
- Modified the 2 MΩ HV load chassis to dissipate heat by adding spacers to box sides to allow airflow while still preventing physical contact with circuit.

CAEN HV test set up with two fully populated crates and one card connected to a Radiall-to-SHV adapter chassis and then to the Load Chassis.

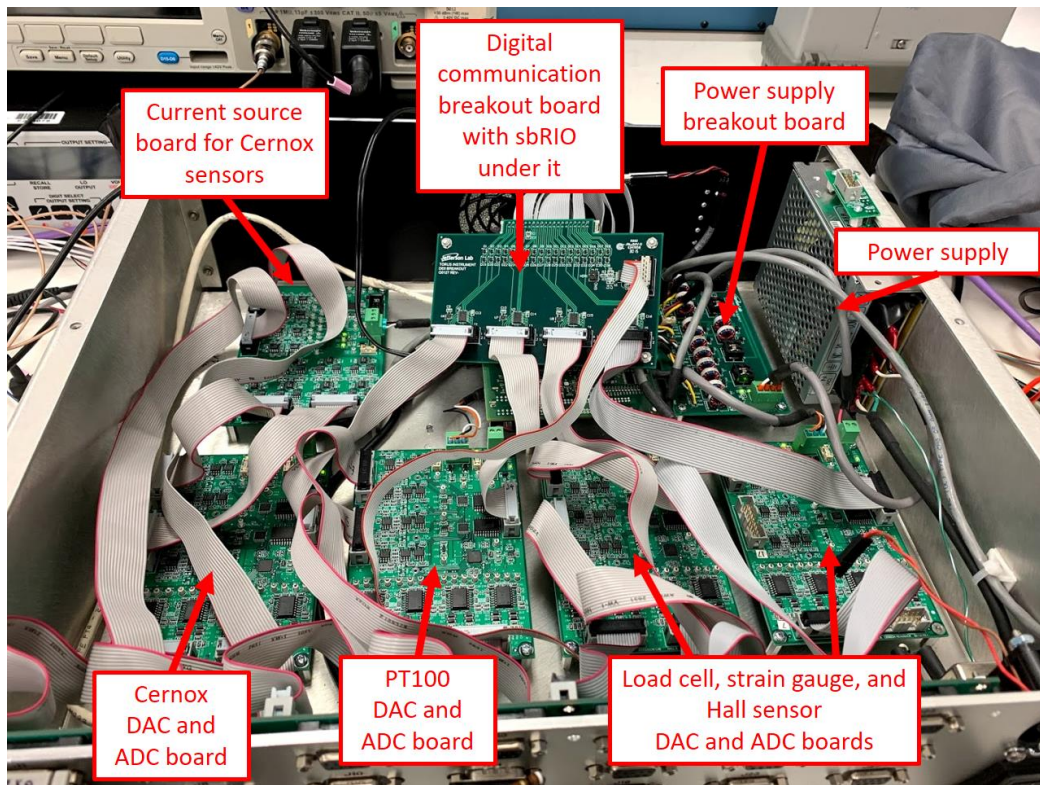
- Corrected Cernox readout issue.
 - ★ All sensors in chassis can now be read by sbRIO.
- Fabricated test loads to mimic Cernox sensors.
- Debugging new failure PT100 readout.
 - ★ Issue may be due to a bad capacitor or broken solder joint on board.

MSELV Chassis with internal boards labeled.
