# Hall B Drift Chamber Re-establishing Region 3 Gas Supply

B. Eng/M. McMullen  
Detector Support Group  
06/22/20

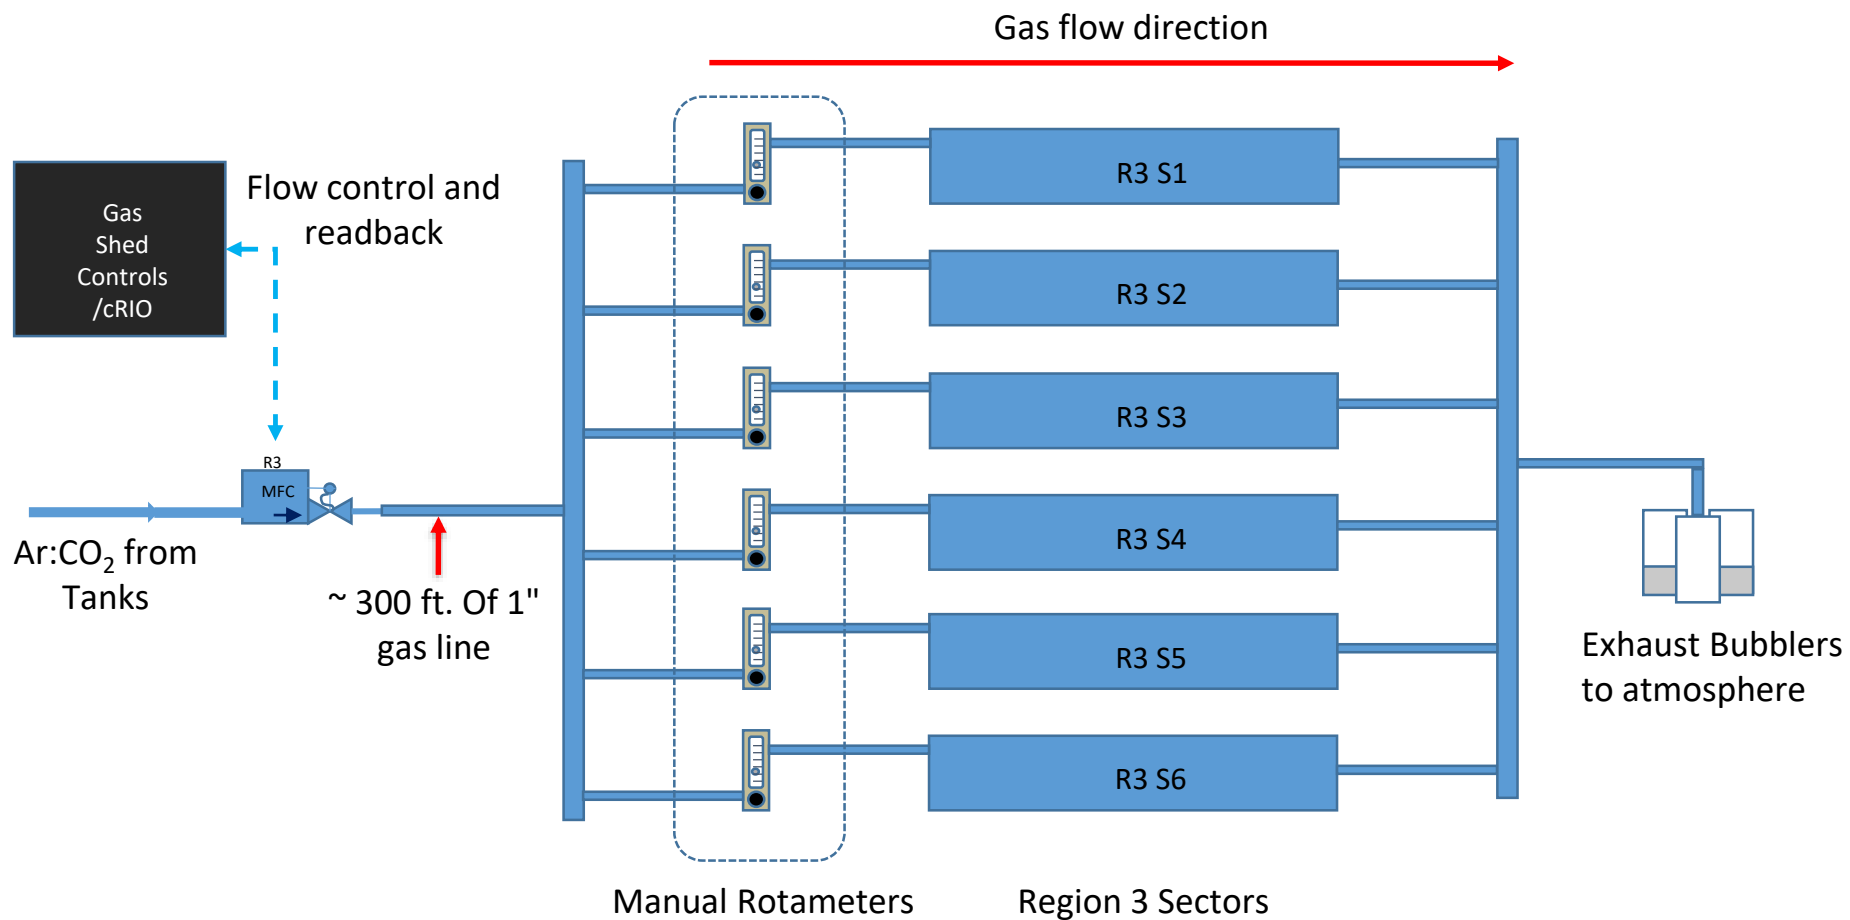
# Region 3 Six Sector Gas Supply Diagram

- R3 mass flow controller (MFC) supplies gas via rotameters to sectors
- Rotameters balance gas flow to sectors
  - Used since tubing length isn't equal and sectors have different leak rates
- Gas exhausted via bubbler
  - Bubbler controls over/under pressure

- Change gas flow mode back to normal operations
  - Mixing Ar and CO<sub>2</sub>
  - Normal flow rates
- All MFCs resumed their normal flow rates except for R3
  - Couldn't flow more than ~20 lpm, lower flows worked okay
- After troubleshooting, determined rotameters needed to be reverted to previous settings
  - Rotameters were causing flow restriction after MFC, not allowing enough flow
