Summary

Detector Support Group

Weekly Report, 2018-05-16

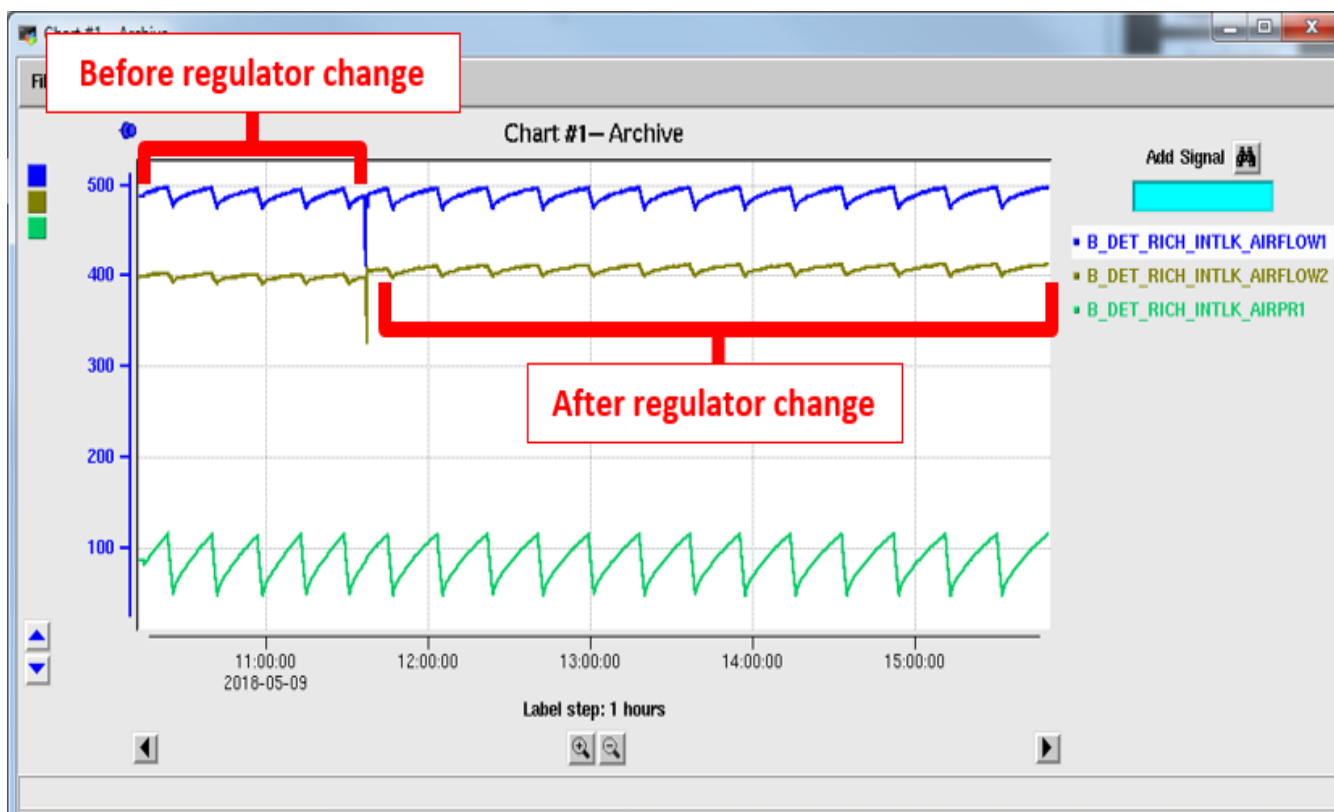
Archived airflow data from before and after regulator change. There was no observable change in airflow behavior after adjusting regulator.

- ★ Problem unique to N2 cRIO; EP cRIO does not have same issue.
- Tried making cooling-airflow independent of compressor's on-off cycle.
 - ★ Air-cooling system's pressure regulator adjusted from ~45 psi to ~35 psi.

- ★ Change in regulator had no effect on airflow; still saw airflow following on-off cycle of compressor.

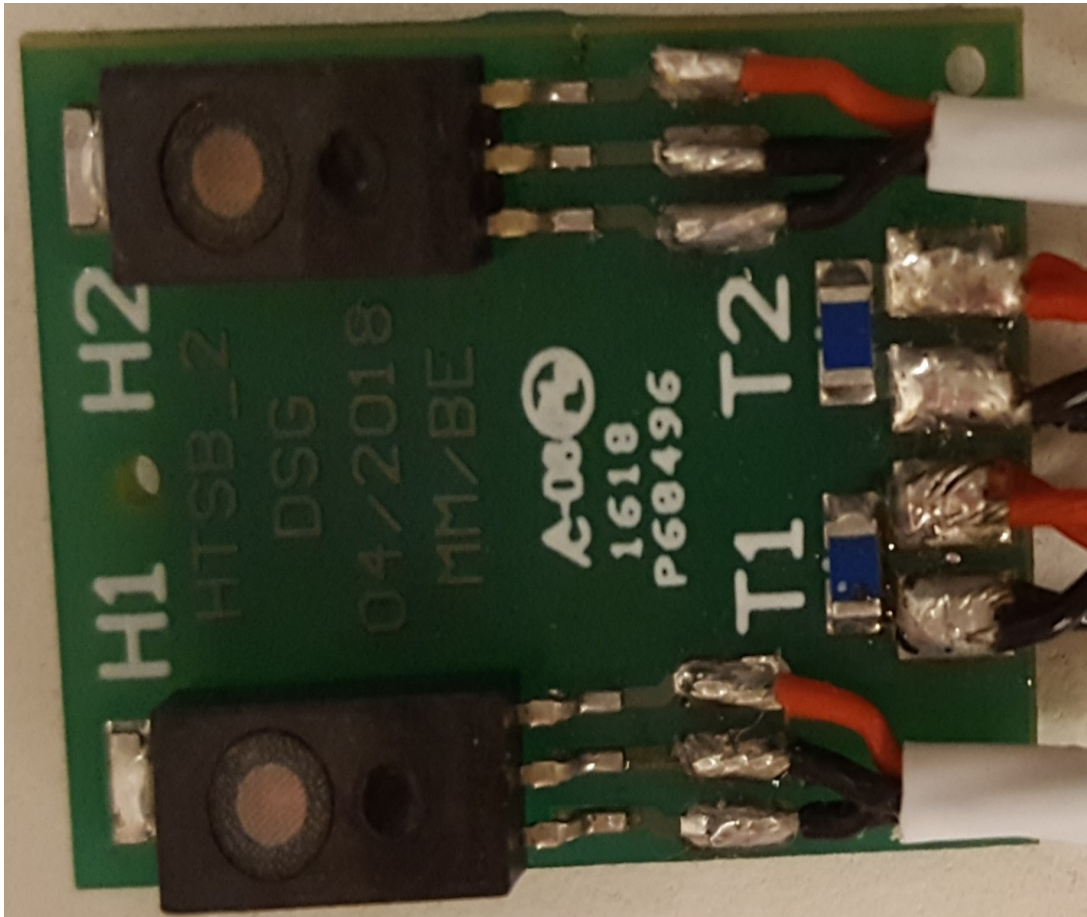
Humidity and temperature sensors on new HTSB2 board

- Fabricated three HTSB2 cables.
- Tested the 3 HTSBs using the new board design.

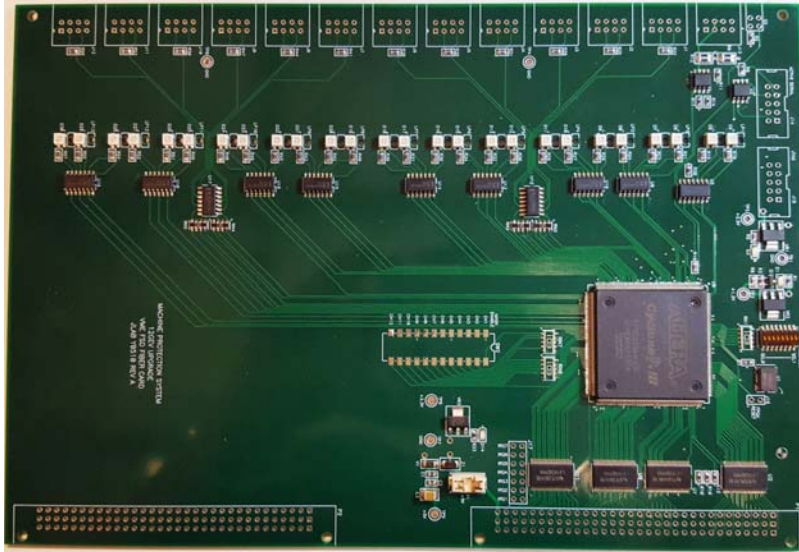
VME FSD fiber card - front view

- Populating VME FSD fiber card boards for Machine Protection System.

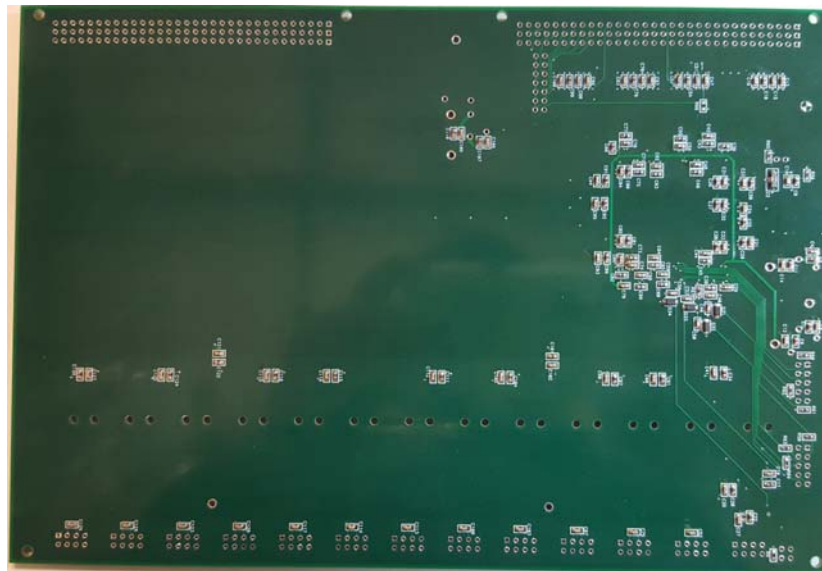
VME FSD fiber card – back view

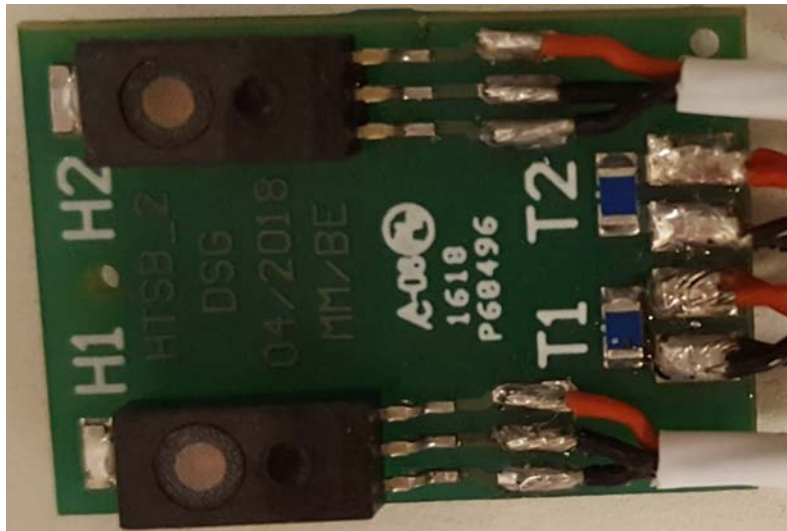
Humidity and temperature sensors at HTSB2 board

- Fabricated three HTSB2 cables for SVT.

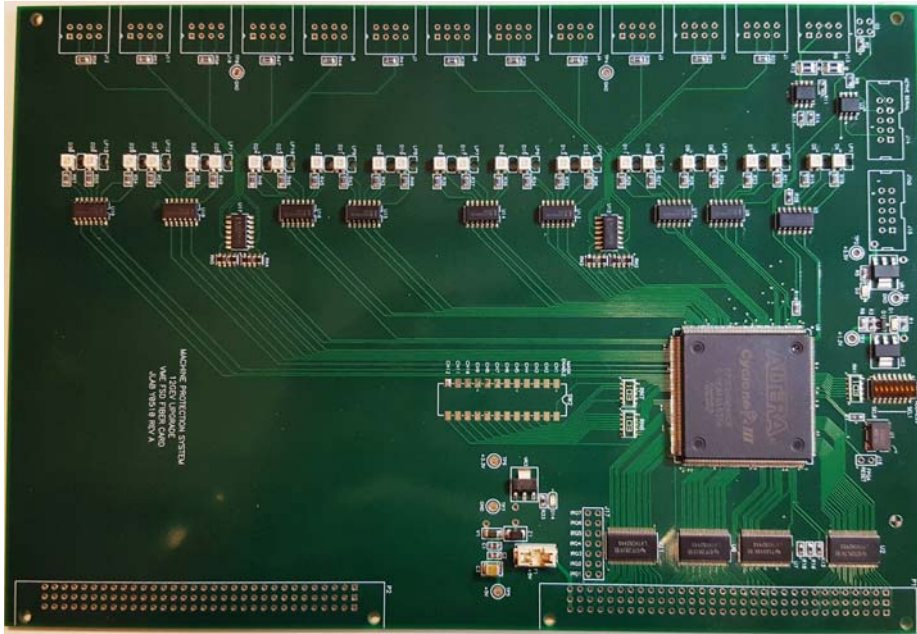
VME FSD fiber card - front view

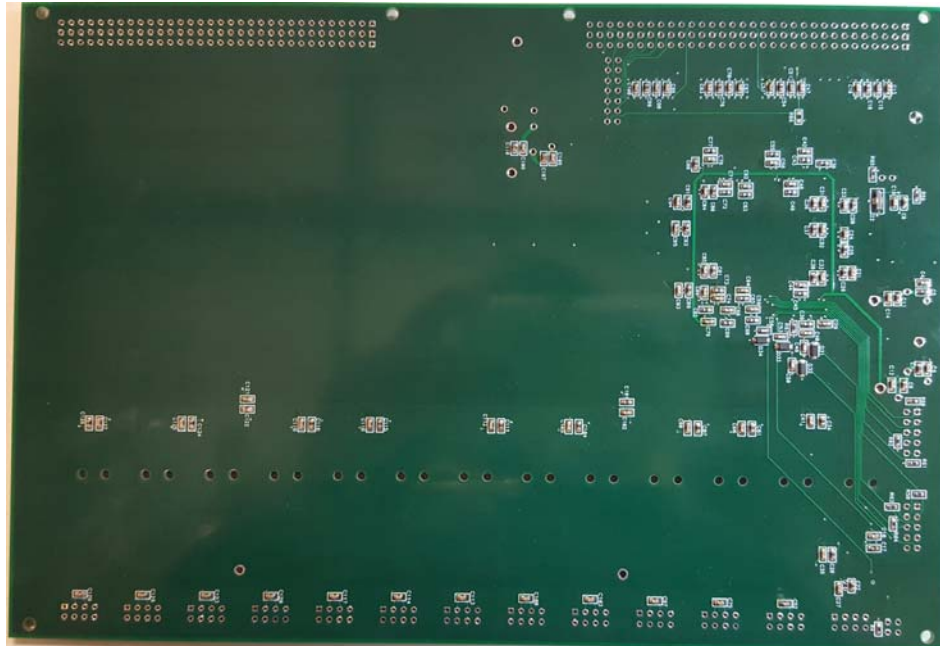
VME FSD fiber card – back view

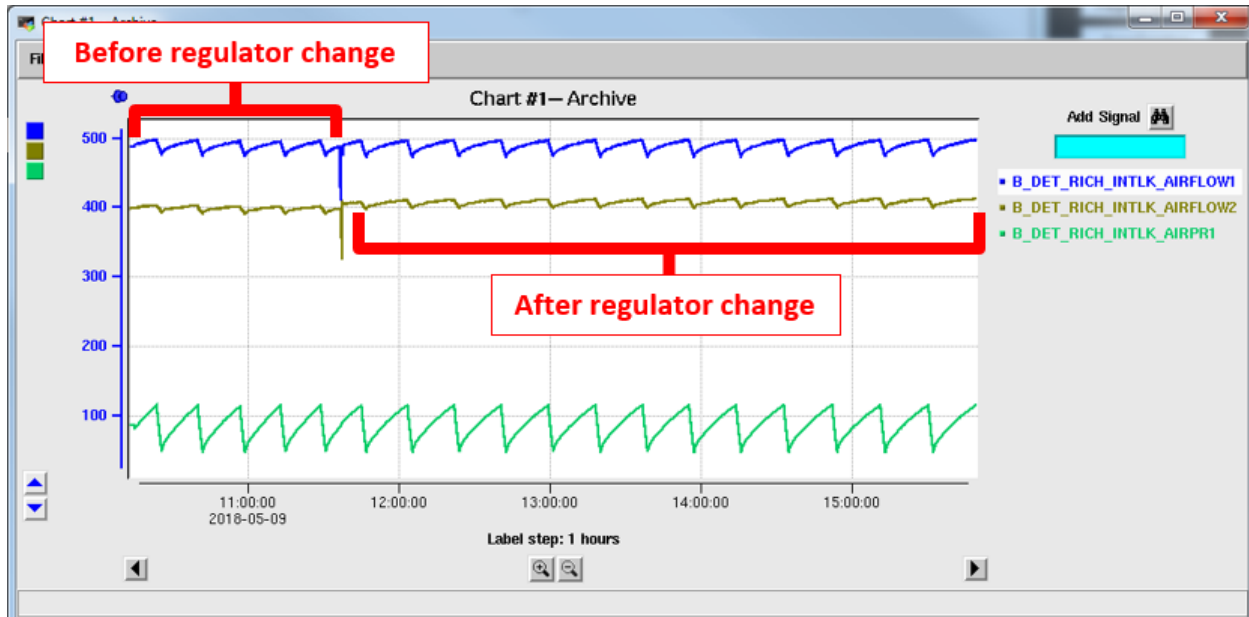
Archived airflow data from before and after regulator change. There was no observable change in airflow behavior after adjusting regulator.

- * PVs were not being read by softIOC after a cRIO reboot.
- * Nathan Baltzell found on softIOC side that connection to cRIO was not reinitialized after cRIO is rebooted.
- * Problem is unique to N2 cRIO; EP cRIO does not have same issue.
- Powered down RICH compressor for summer shutdown with Pablo.
- Adjusted air-cooling system's pressure regulator from ~45 psi to ~35 psi with Pablo in attempt to make cooling-airflow independent from compressor's on-off cycle.
 - * Change in regulator had no effect on airflow; still saw airflow following on-off cycle of compressor.
