Hall A– GEM Gas Systems

Detector Support Group

Weekly Report, 2019-09-24

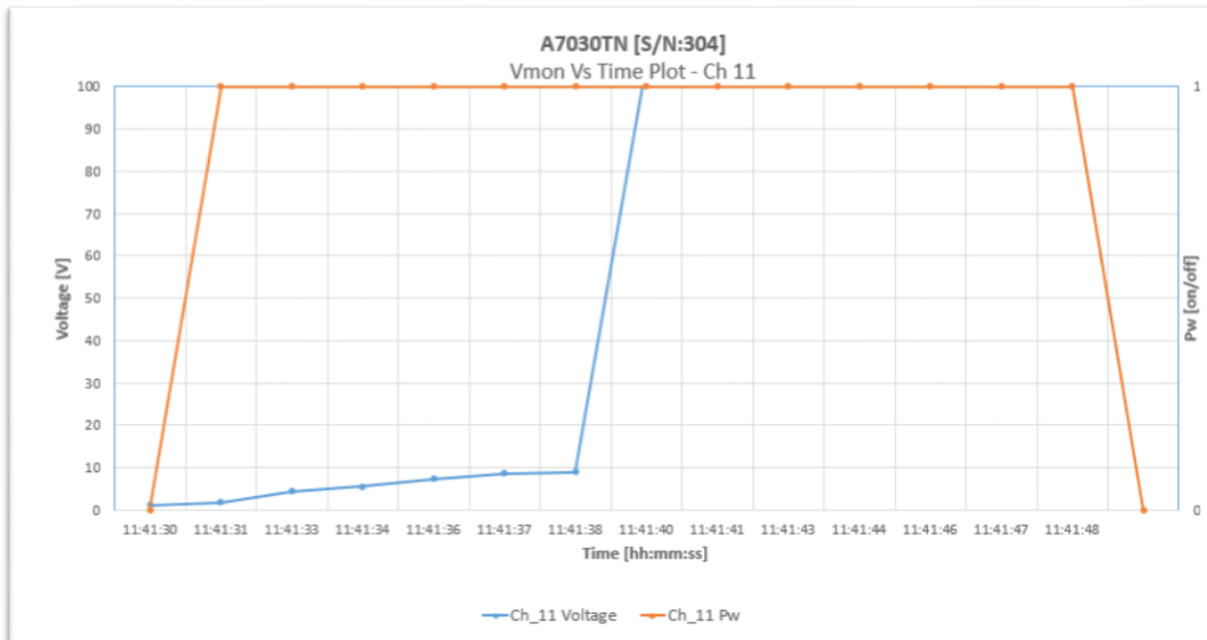
Example of latency issues during Trial 3 for A7030TN S/N: 304 board – Plot shows channel 11 ramped ~10 s after Pw parameter was set to 1 (channel turned on), data log shows the same values as *Voltage Ramp Test – Slot 0 CSS-BOY screen*

- P_w PV readout for channel 23 had an update latency of ~10 s while ramping to set voltage. Issue occurred twice and recovered by itself in next cycles. See figures below.
