Detector Support Group Weekly Report, 2017-11-22

RICH

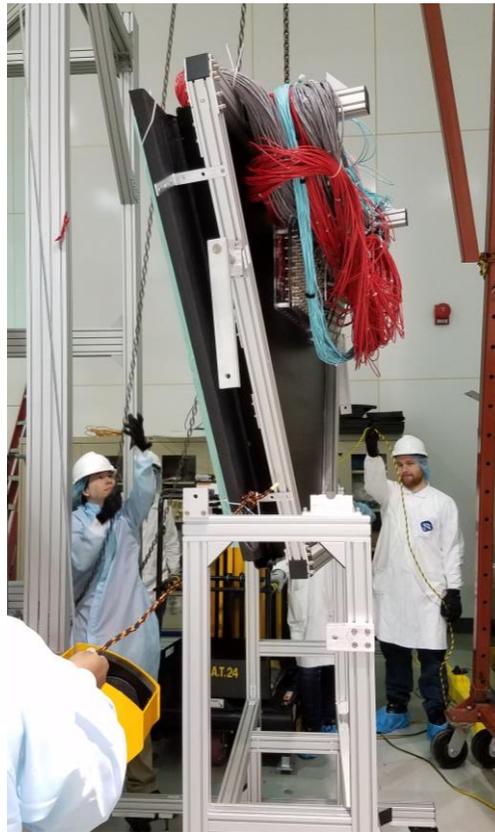
Tyler and Brian lifting E-panel with gantry crane.

- Installation preparation of electronic panel:
 - ★ Horizontal bar of stiffening tool removed, giving more clearance between RICH shell and assembly structure for electronic panel installation.
 - ★ Winch rope removed from rigging used to rotate detector shell to vertical.
 - Winch rope would block path electronic panel needs to take if not moved.
 - ★ Test lift of electronic panel performed to determine if panel was balanced and its center of mass was in plane of electronics.
 - Lifted panel only a few inches until clear of its support.
- Electronic panel installed on detector shell.
 - ★ Electronic panel lifted over assembly structure and lowered into place on detector shell.
 - ★ Support frame of electronic panel and stiffening tool prevented panel from being able to be placed directly on shell.
 - Used threaded rods to assist in dropping electronic panel the last few inches.

- Prepared for installation of electronic panel.
 - * Removed horizontal bar of stiffening tool, giving more clearance between RICH shell and assembly structure for electronic panel installation.
 - * Removed winch rope from rigging used to rotate detector shell to vertical.
 - Winch rope would block path electronic panel needs to take if not moved.
 - * Performed test lift of electronic panel to determine if panel was balanced and its center of mass was in plane of electronics.
 - Lifted panel only a few inches until clear of its support.

- Installed electronic panel on detector shell.
 - * Electronic panel lifted over assembly structure and lowered into place on detector shell.
 - * Support frame of electronic panel and stiffening tool prevented panel from being able to be placed directly on shell.

- Used threaded rods to assist in dropping electronic panel the last few inches.
- Rotated RICH from vertical to horizontal after installation of electronic panel.
