SAFETY FLASH

June 2016

Eyewash Unit Failed to Deploy

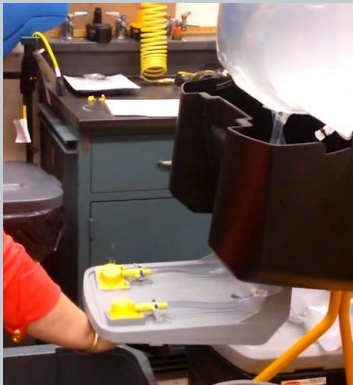
The following is a video of the Encon Aquarion portable eyewash unit being tested. Notice that considerable force may be necessary in order to deploy the water appropriately. Continue to press down hard on the black handle until the flow is adequate.

The supplemental bottles will be deployed to each division consistent with their request. The bottles are a stop-gap measure in the event that the Encon does not deploy correctly, to provide an immediate capability until one can get to another suitable location.

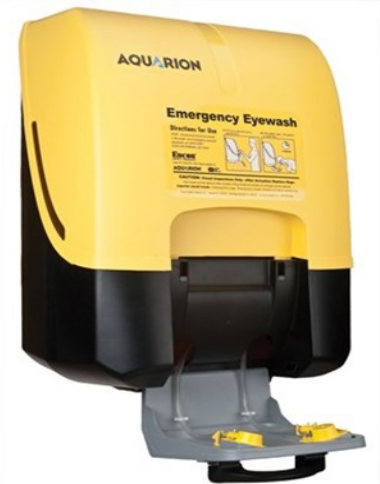
The Encon manufacturer's representative arrived this morning and a series of tests were conducted. While some units operated as intended, many units did not deploy properly – some deployed on one side and not the other, others would deploy only after forcefully pushing down the handle and some never deployed properly. OSHA 1910.151(c) requires the availability of eyewash units where the eyes or body of any person may be exposed to injurious corrosive materials. RSS question 7.8 asks "Does operation involve chemicals or wastes that are caustic or corrosive, e.g. acids or bases?" Based on the tests conducted, ORNL has determined these units to be unreliable and additional actions are necessary to provide redundancy until the issue is completely resolved.

- Communicate this Safety Flash to affected research and operations staff in the work areas where the Encon units are located. Emphasize that considerable force may need to be applied to the handle in order to deploy the water appropriately.
- Each division needs to delegate a point of contact to identify areas where these units are located and where caustics or corrosives, e.g. acids or bases, are used. For these areas, we are purchasing supplemental bottles for appropriate redundancy. Each point of contact must notify Bobby Buckner (865-253-6068) immediately of how many and where supplemental units are needed.
